Corrosion durability of high performance steel fibre reinforced concrete

Third International Conference on Sustainable Construction Materials and Technologies http://www.claisse.info/Proceedings.htm

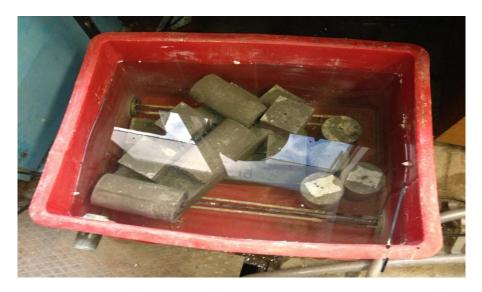
Figure 1. Hot curing of concrete specimens

Mixing and casting of concrete was carried out in accordance with the current British Standard BS 1881-125 (1986). Fibres were the final material to be added to the fresh concrete and mixing continued for 4 minutes to ensure dispersion of the fibres throughout the concrete. A mixed metal oxide coated titanium rod was placed in each specimen as part of preparation for accelerated corrosion test. On demoulding at 24 hours, all concrete specimens were cured in hot water curing conditions for 7 days (50° C \pm 2° C) and then transferred to corrosion tank containing 3% chloride salt solution.

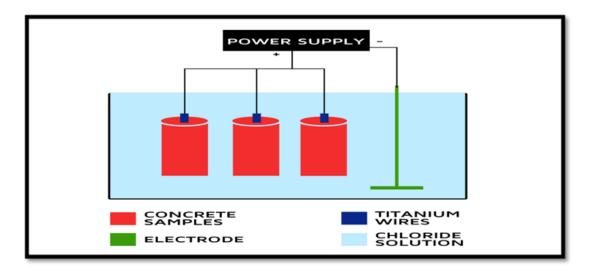
Figure 2. Schematic diagram of the accelerated corrosion test used

All specimens were placed in the tank containing salt solution and connected to the positive end of the power supply at titanium rods using cupper core cables. The negative connection of the circuit was provided using a piece of bare steel electrode partly submerged in the solution. Figures 2 and 3 show the accelerated corrosion test setup. A constant 3A current was passed through the solution and specimens for 1 month. This is equivalent to approximately 50-60 years life of a typical bridge exposed de-icing salts. In this arrangement steel fibres acted as a consuming anode to maintain the current flow through the concrete

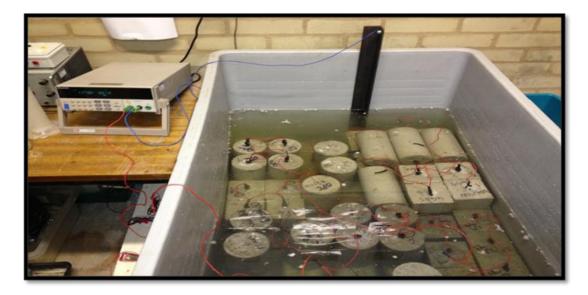
Figure 3. Corrosion tank used for accelerated corrosion test

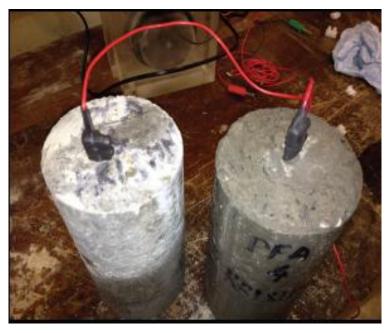
Figure 4. Concrete specimens before accelerated corrosion test

Concrete specimen were examined after 1 month exposure to the accelerate corrosion condition. Expect surface corrosion and a few microcracks in the control OPC sample no sign of significant corrosion or spalling was observed. Figures 4 and 5 shows the state of specimens before and after accelerated corrosion test. It was found that steel fibres were less susceptible to corrosion. This is likely to be due to discontinuity of steel fibres in the mix or small surface of fibres.

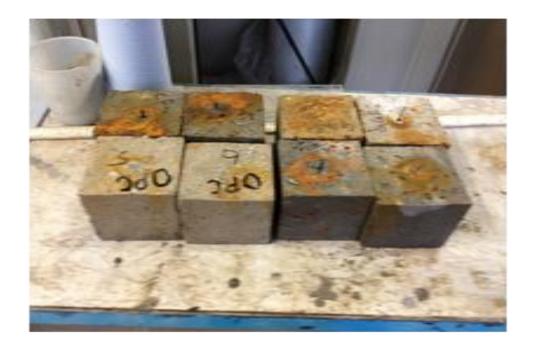
Figure 5. Concrete specimens after accelerated corrosion test

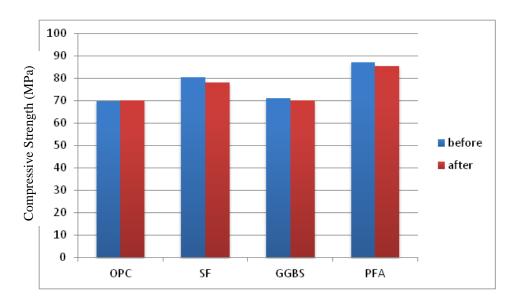
Figure 6. Comparison of compressive strength before and after accelerated corrosion

Figures 6-9 show mechanical properties of specimens before and after corrosion. It can be seen that specimens did not suffer from any significant strength or stiffness loss.

- 3) From flexural and tensile behaviour of corrosion steel fibre concrete it was observed that the performance of specimens was not reduced by corrosion attack. The same conclusion can be extended to compressive results, which showed that, even if specimens are externally corroded, this has no influence on the compressive strength of the specimens. Marginal increase in the strength of specimens after corrosion test is likely due to the age of the specimen.

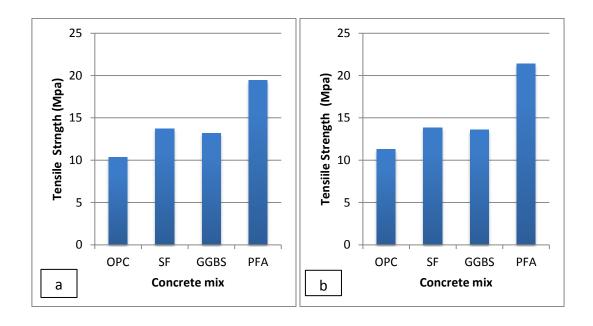
Figure 7. Comparison of indirect tensile strength a) before and b) after accelerated corrosion

The data show that indirect tensile strength of specimens containing cement replacement materials increased marginally during accelerated corrosion test. This is in line with expected high performance of these mixes. The flexural strength and stiffness of the concretes tested thus far was consistent and correlated with the compressive strength data. In general results indicated that steel fibre concrete specimens were not significantly affected by corrosion except minor surface rust stain.

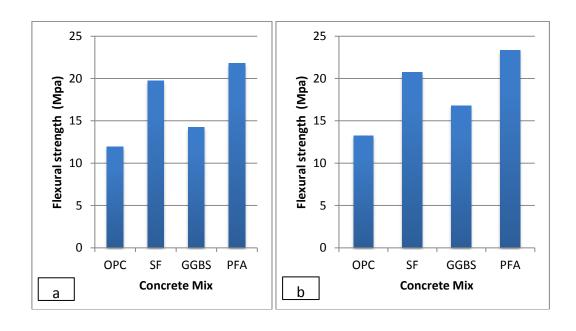
Figure 8. Comparison of flexural strength a) before and b) after accelerated corrosion

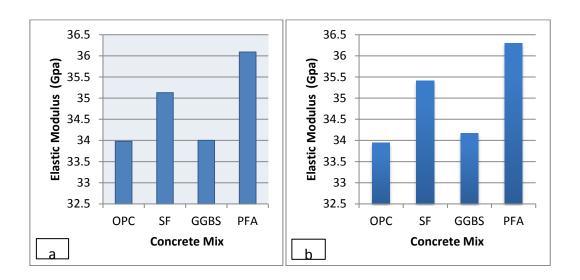
Figure 9. Comparison of elastic modulus a) before and b) after accelerated corrosion
