### Charred Timber Cladding: Performance Investigation

*Award date:*  
2017

Performance Investigation

Masters by Research

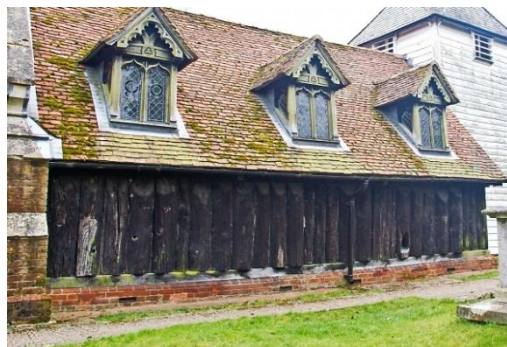
*Figure 1 Stave wall Greensted Church (Design, n.d.)*

One of the oldest examples of a structural timber wall in the United Kingdom is that of Greensted Church in Essex, UK. Built in approximately 1056, the walls are constructed of whole tree trunks that are split in half and arranged vertically to form the buildings structural wall as well as the weatherproof envelope. This type of construction method is known as a stave wall. Figure 1 Stave wall Greensted Church and Figure 2 Greensted Church show how this method is used in the building.

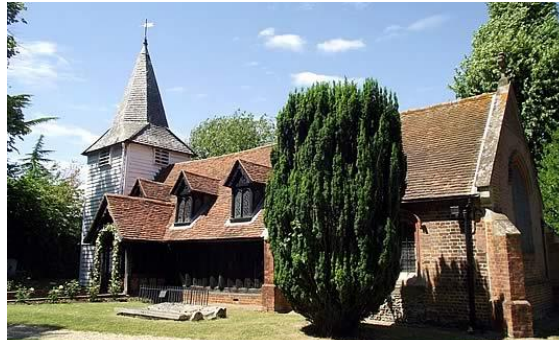
Figure 2 Greensted Church (Design, n.d.)

In fact, it is thought that Greensted church is the oldest timber church in the world and is the only known building of its type in the UK. (Hewett, 1980)

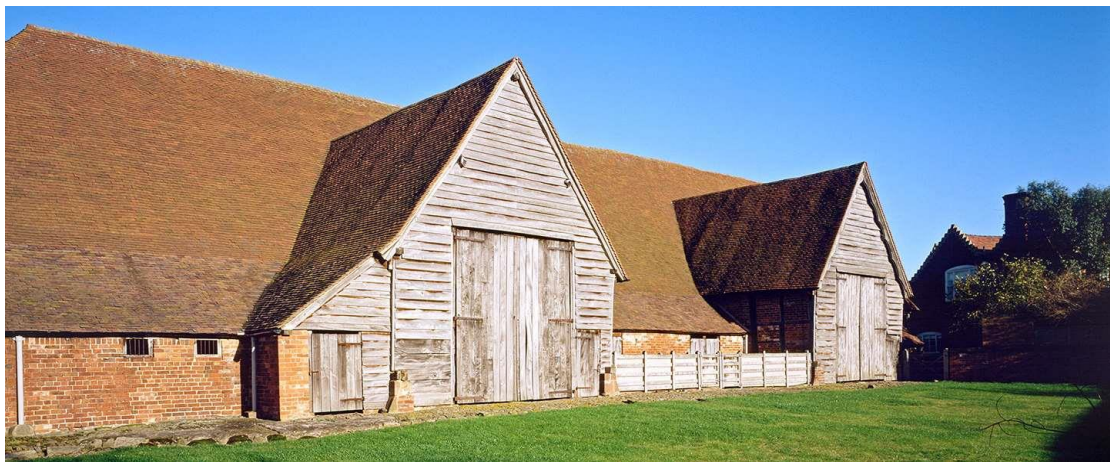
Figure 3 Leigh Court Barn

A good example of cladding-on-frame construction in the historic context is Leigh Court Barn in Worcestershire, as pictured in Figure 3 Leigh Court Barn. The barn was built by the Pershore monastery to store and thresh grain and is the largest surviving cruck frame structure in the UK. (English Heritage, 2017). The cladding provides no structural support but protects the structural timber frame from the external environment. This particular barn is clad with Elm boards fixed horizontally to a structural frame.

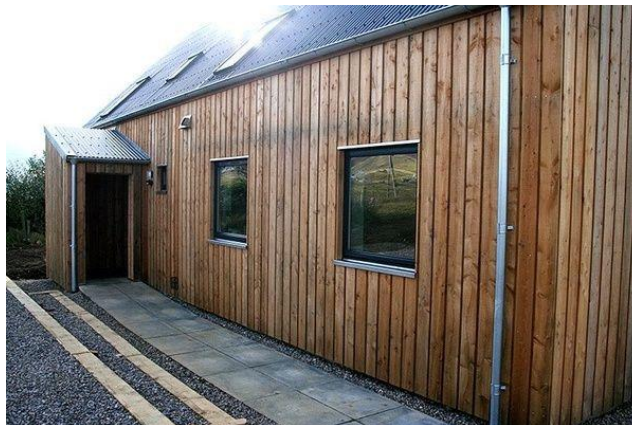
*Figure 4 Vertical cladding (Cromartie Ltd, 2010)*

Figure 4 Vertical cladding shows cladding fixed vertically in an arrangement that has 2 layers of timber. The first layer is fixed with a 50mm gap between each board then the second layer is fixed across that gap to cover the wall behind. This method allows for shrinkage and expansion due to varying moisture content.

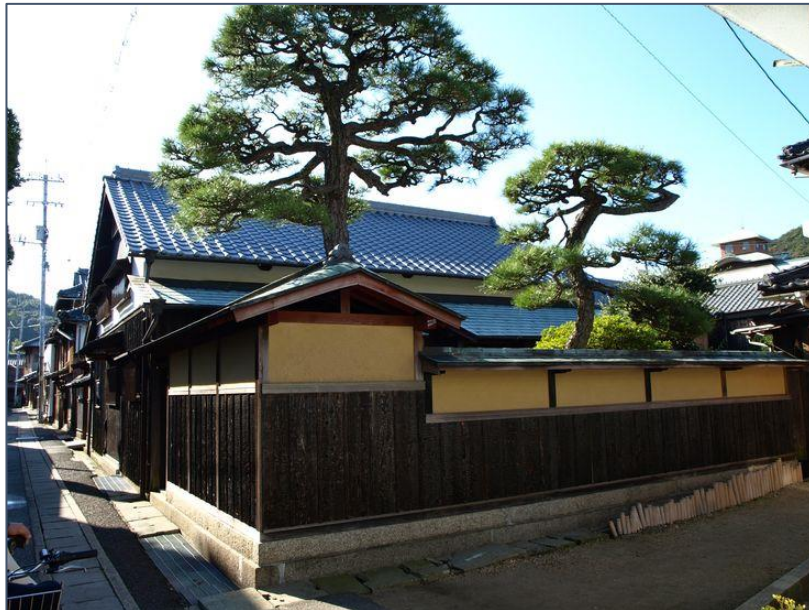
*Figure 11 Charred cladding in Japan*

Japan has a great many building that employ charred timber as a cladding material but the author was unable to identify any written justification as to why this technique was adopted. Other articles, also unsubstantiated, claim some areas of Europe also used charred timber as a cladding material, especially in Switzerland (although no dates or details are given). It seems that the history of this technique has mostly been lost and forgotten. All that remains are some basic instructions of the original methods of producing charred timber, mostly in practical demonstrations posted in videos online. These films have been a useful resource, as they have provided a good starting point for the production of some cladding for testing purposes. Figure 11 shows a typical use of charred timber in Japan.

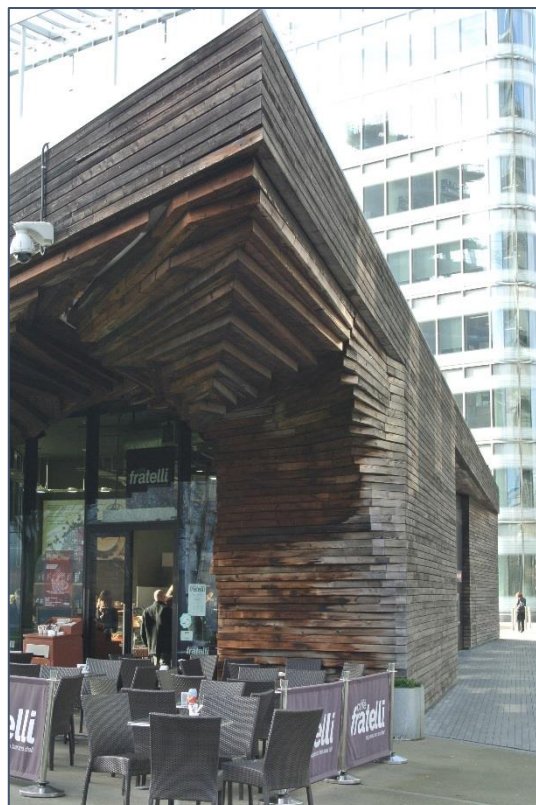
Figure 15 Parkside kiosk front

The building features charred Siberian larch rain screen cladding, manufactured in the UK by Martin Childs Limited. The geometry of the façade is complex in arrangement, with a large overhang forming a canopy to offer some protection to coffee shop patrons. The geometric design increases in size from bottom to top, creating an imposing effect to the seating area.

The cladding is well designed and detailed and acts as a rain screen cladding system that allows some of the driven rain and moisture to pass through and drain from the bottom of the façade. From available technical drawings the façade appears to be designed in line with TRADA's good design practice. (TRADA, 2013) The cladding strips are not interlocking and have a small gap between them to allow water to drain and dry out.

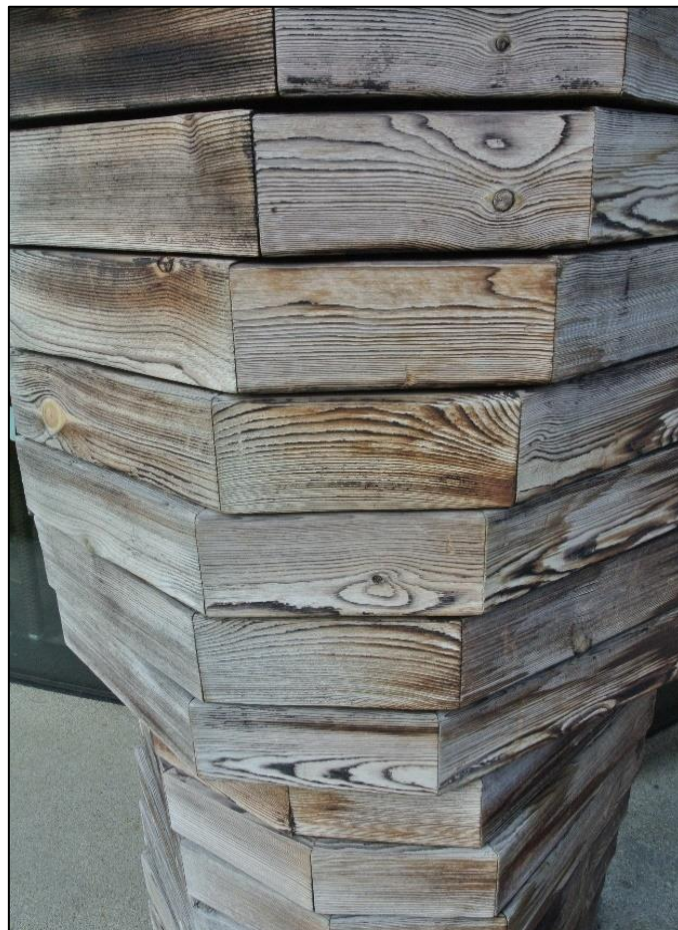
*Figure 18 Parkside Kiosk 2014*

Figure 19 Parkside Kiosk 2007 Figure 18 Parkside Kiosk 2014 show a comparison of the façade when fitted in 2007 and the façade as photographed in January 2014. Over this period it can clearly be seen that the charred surface has faded and the timber has turned a silver/grey colour. The silvering of the timber would be expected and poses no detrimental effect to the timber.

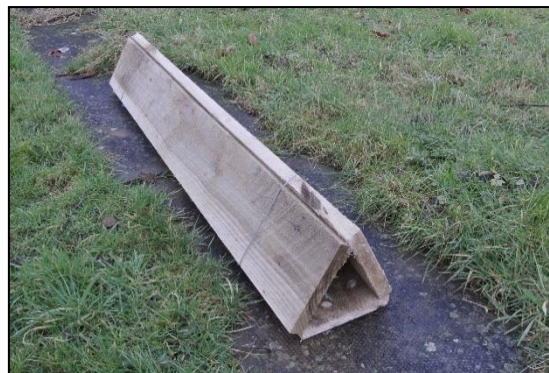
*Figure 20 Boards prepared for charring*

**Step 1** – Three boards are selected and the boards are wired together to form a triangular “chimney” as shown in Figure 20 Boards prepared for

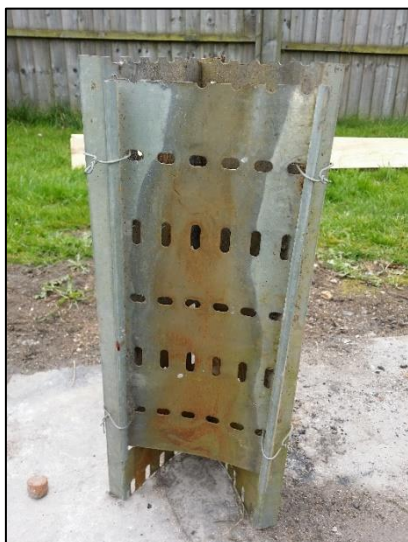
*Figure 21 Brazier*

**Step 2** – Figure 21 shows how the small brazier is prepared and a small fire is set inside. (A triangular brazier is used to allow the triangular chimney to sit easily on top)

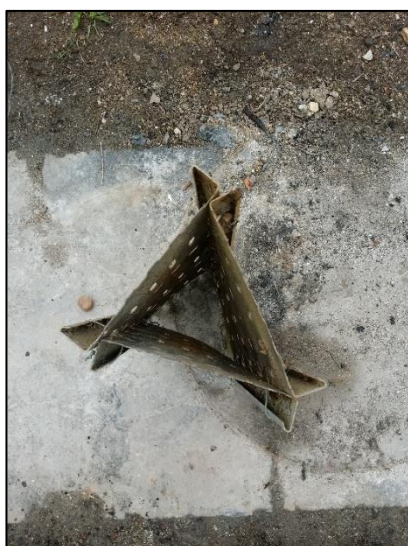
*Figure 22 Brazier top view*

**Step 3** – The fire is lit using waste timber and enough fuel is added to the brazier so as to achieve an appropriate amount of heat to ignite the inside of the timber chimney. As the method is not an exacting science there are no guidelines as to an appropriate amount of fuel. For this test approximately 10 25x25x200mm pieces of timber were used with a small amount of kindling to aid the initial ignition.

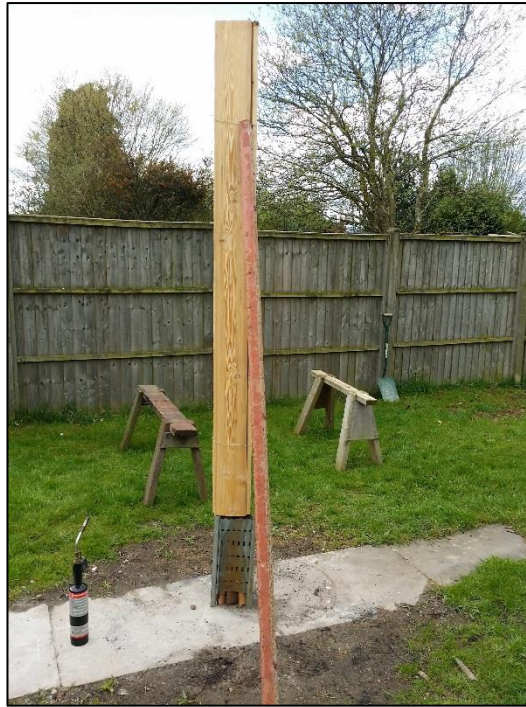
*Figure 23 Boards on brazier*

**Step 4** – The timber boards were placed over the fire and the flame is drawn up through the tube. The effect of this is 2 fold. Firstly, the chimney effect intensifies the fire, making it burn more quickly which speeds up the process. Secondly, flame and heat is distributed more evenly throughout the tube, making the charring more even. The boards are reversed and the fire allowed to char the tube from the other end. This ensures the entire internal surface is charred. This can be seen in figure 23 and figure 24.

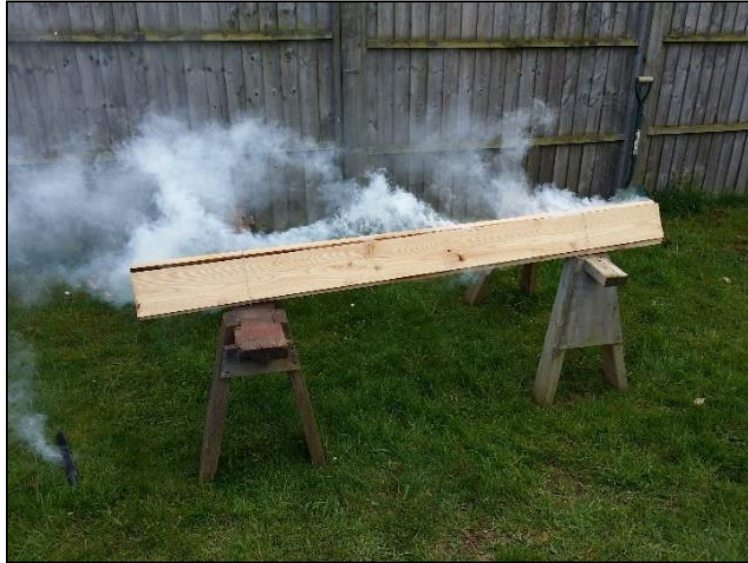
*Figure 25 Boards after charring*

**Step 5** – Once the boards have reached the required level of charring, they are removed from the brazier and the wires holding them together are cut as shown in figure 25. At this point the flame on the boards is already extinguished, but the boards require cooling. This was done by spraying with a hosepipe but this could also be done by pouring buckets of water over the timber or submersing the boards in a tank of water. The required level of charring is completely subjective and varies on the desired surface finish.

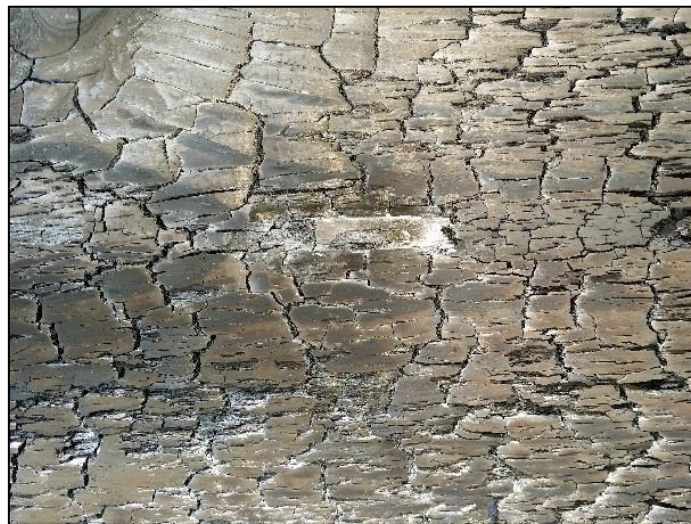
*Figure 26 Surface of charred board*

Figures 26 and 27 are of the finished cladding. The charring has penetrated the surface relatively deeply compared to the western method of charring.

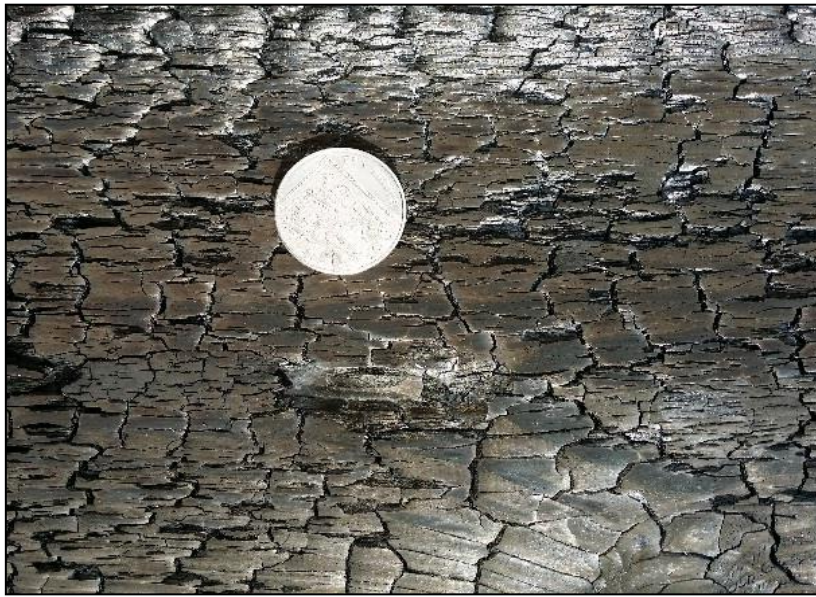
*Figure 27 Charred surface comparison*

Figure 27 shows a board with a 10 pence coin for scale. The cedar boards have resin pockets that heat up and pop when they are burnt causing part of the surface of the timber to become friable. For reference, a 10 pence coin has a diameter of 24.5mm.

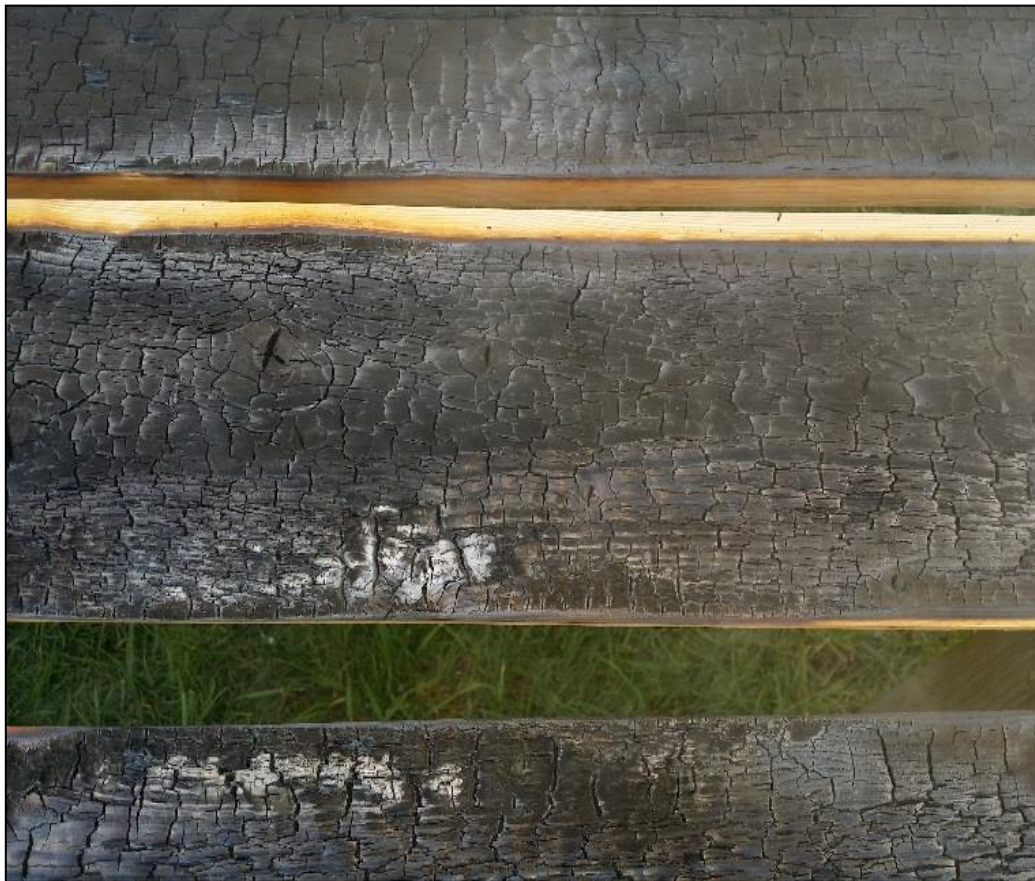
*Figure 28 Charred surface coverage*

Figure 28 shows how some areas of the boards have not charred. As the flame is only on the inside of the chimney the edges that overlap slightly tend to not get charred at the same rate as the rest of the board leading to this unevenness.

There may also be an issue with water being trapped in the fissures left by the charring process. They are deep and will most certainly hold water. This would, over time, lead to decay. Another problem can be seen in the last picture – uneven charring. This is not really a major issue as the uncharred areas could be charred after over the brazier but this is an extra process.

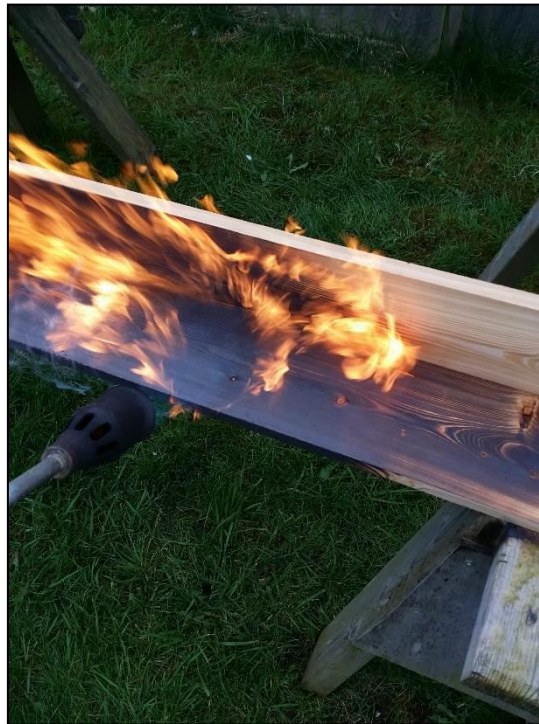
*Figure 29 Charring with propane torch*

To speed up the process the boards here are arranged in an L shape so as to contain the flame and char two boards at the same time as shown in figure 29.

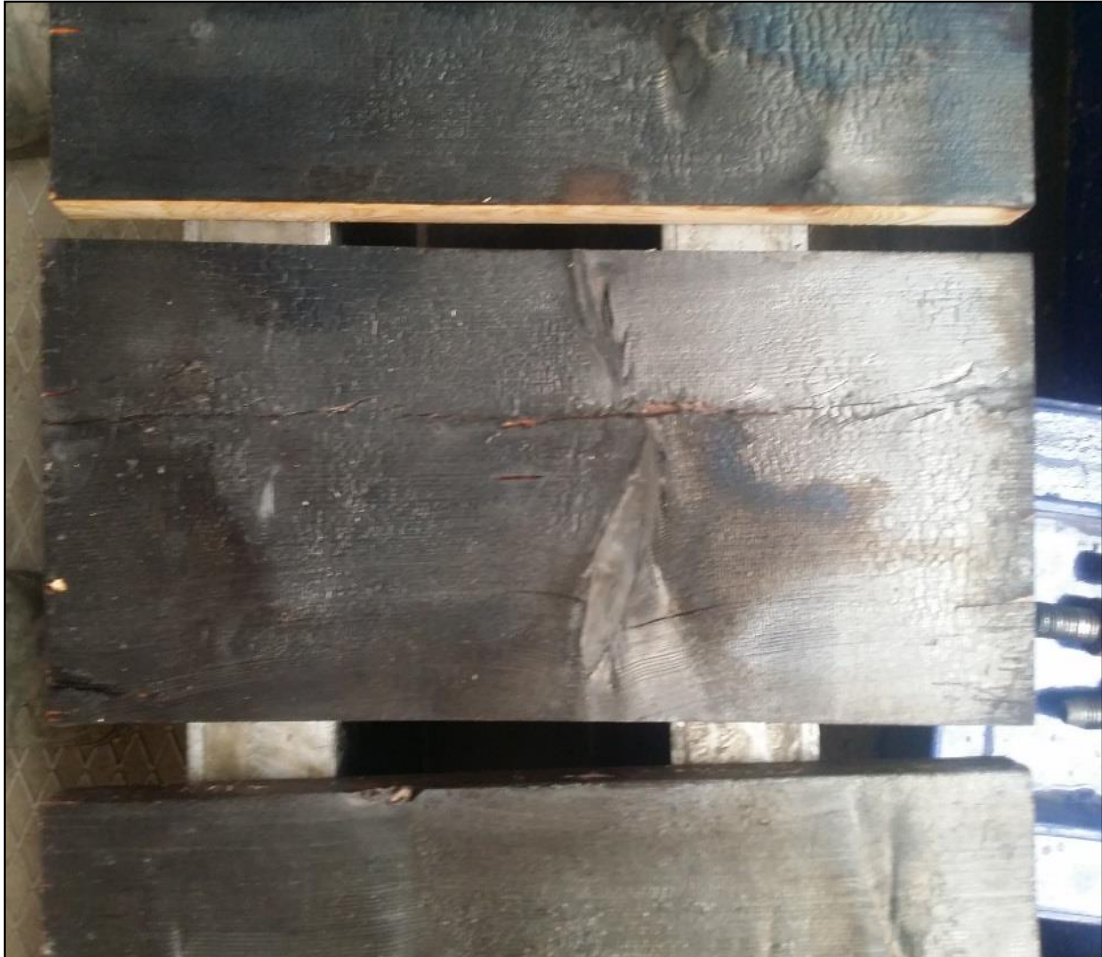
*Figure 30 Specimens after charring*

Figure 30 shows the finished cladding. This is a specimen made for testing in both the environmental test chamber and long term external weathering testing. It shows how even the charring is compared to the traditional method of production.

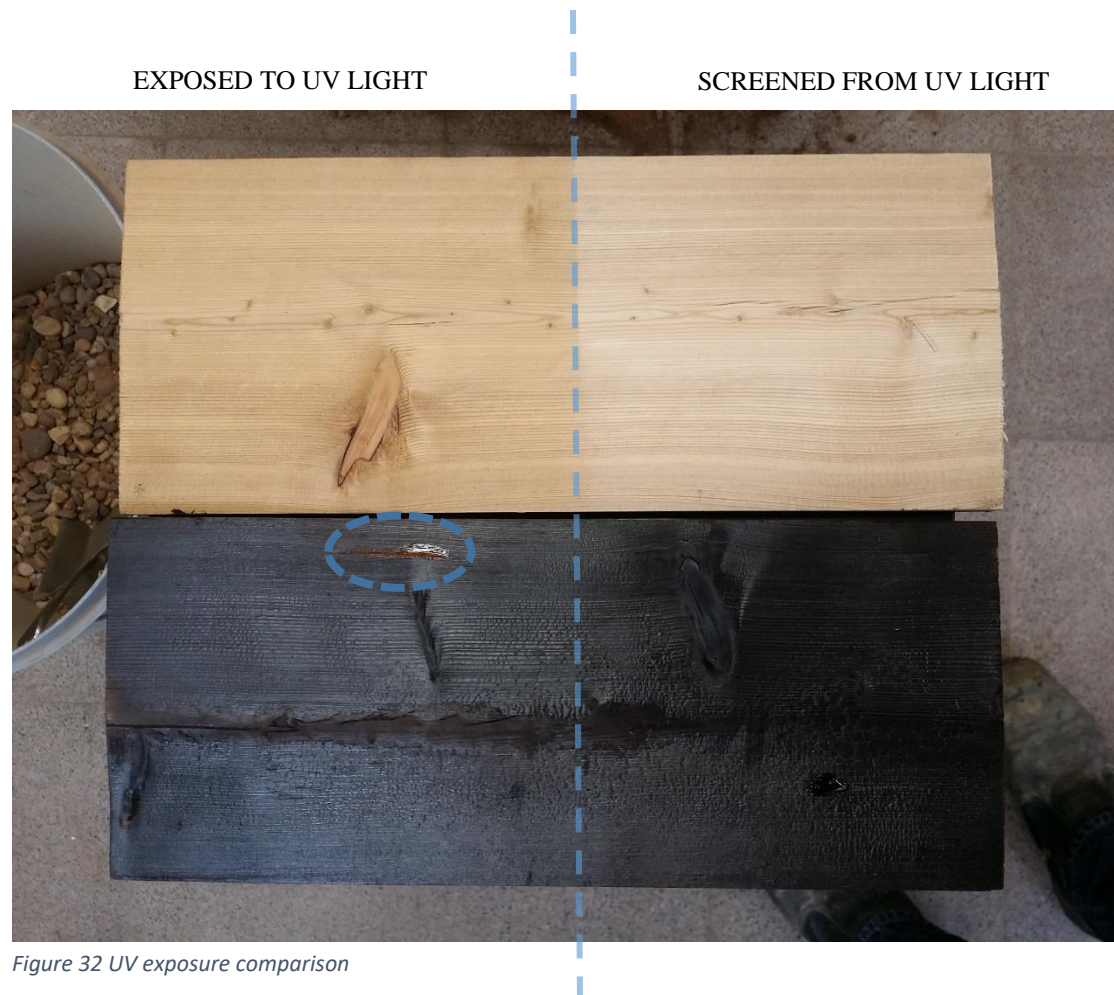
Figure 32 UV exposure comparison

Figure 32 shows the two specimens immediately after removal from the test apparatus.

a significant level of change in surface colour whereas the charred specimen shows no detectable change in surface colour. The only notable change that was observed in the charred timber sample was that there was a small amount of resin that had leached from a small resin pocket on the timber surface (this is circled on the image above).

The unexpected element of the results were the lack of change to the surface colour of the charred timber sample. It was expected that there would be some minimal change to the colour but there was no visible change at all. The only detectable effect of the UV light was the leeching of the sap from fissures on the timber surface. As the species of timber used was Siberian Larch it is possible that the sap would leech from the surface regardless of surface treatment although this is pure conjecture. The leeching was most probably caused by the heat from the UV light source or from the heat during the charring process.

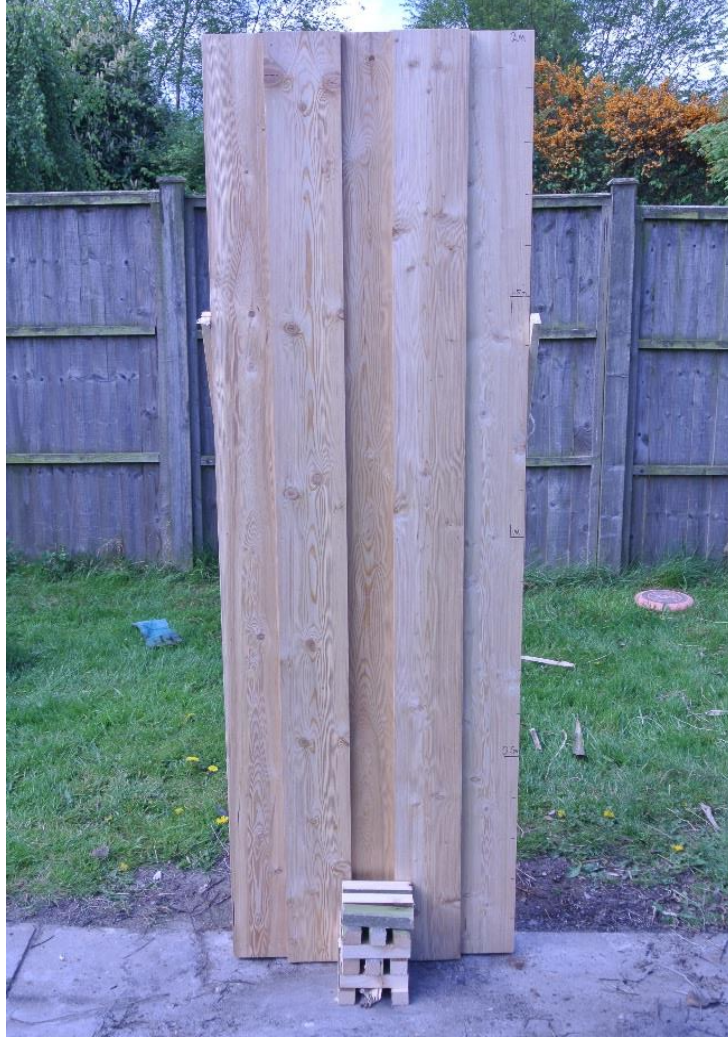
*Figure 33 Flame spread test setup*

Figure 33 shows how the panel was set up. The cladding is fixed to a softwood frame in a “hit and miss” pattern. This type of cladding arrangement has become popular over recent years as the boards don’t need any special edge mouldings and as the boards are installed vertically they have a good geometric resistance to trapping water, increasing their durability. The boards have a graduated scale in increments of 0.5m marked on the side of the sample to help with the analysis during and after the testing is completed. The charred cladding panel was set up in exactly the same way.

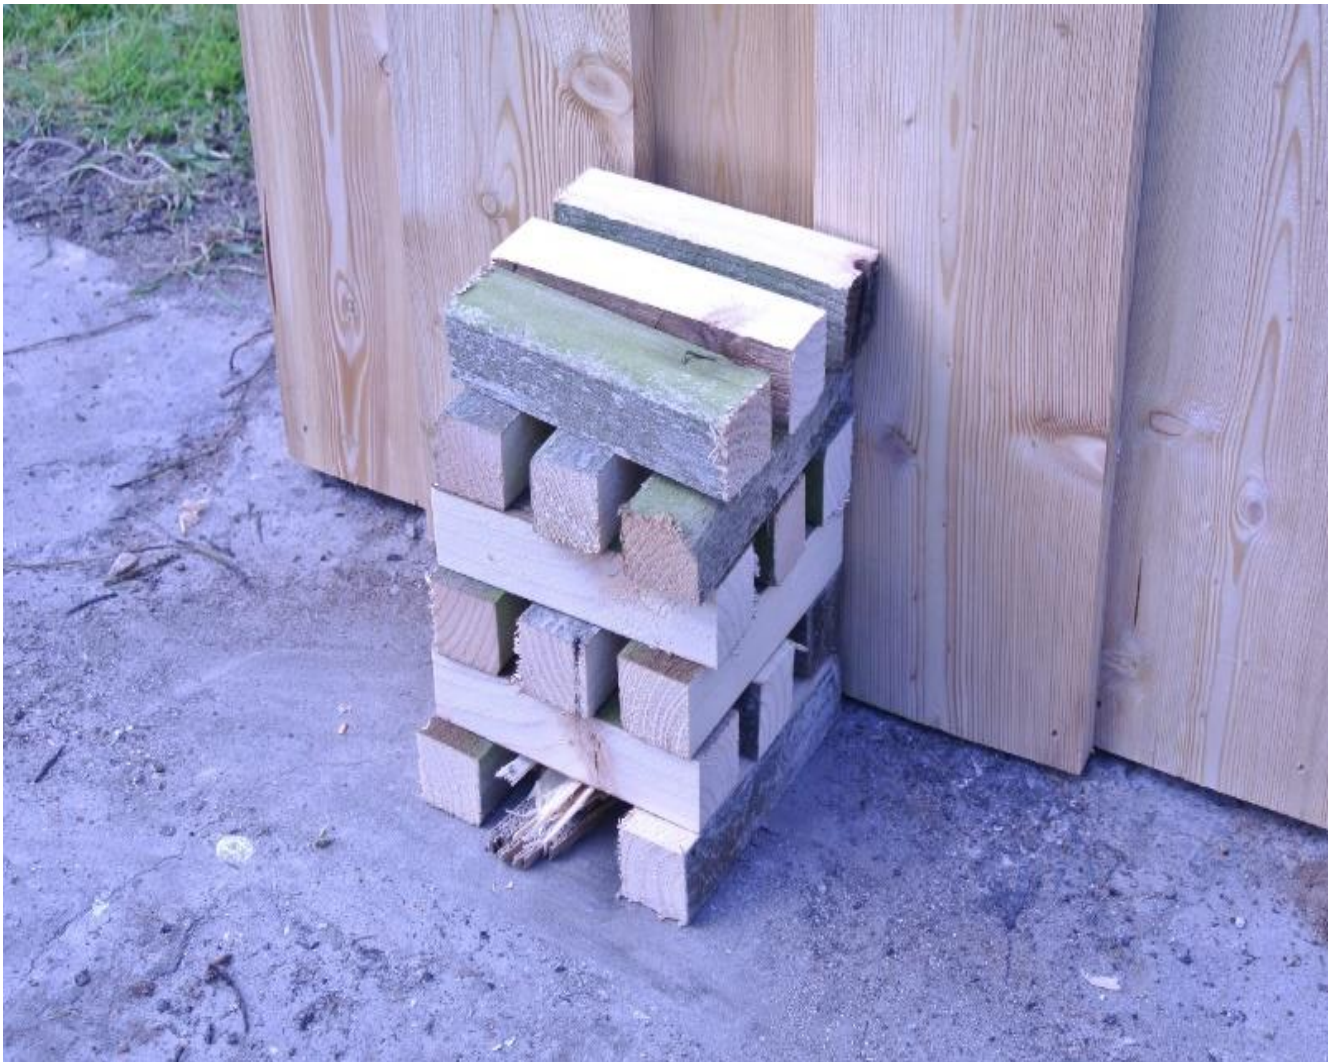
Figure 34 Fire crib

The pieces of timber for the fire were all cut from one board that was kiln dried and then cut into the required size for the fire. The pieces were then left for 28 days to normalize the pieces moisture content. The same number of pieces were used for the fire in both tests. Figure 34 shows the crib arrangement immediately before starting the test.

The purpose of this crib type fire arrangement is to mimic a situation where a fire starts at the base of a wall that is clad with a combustible material. The crib arrangement allows the fire to spread rapidly and easily. The resulting flames then spread from the crib fire up to the cladding.

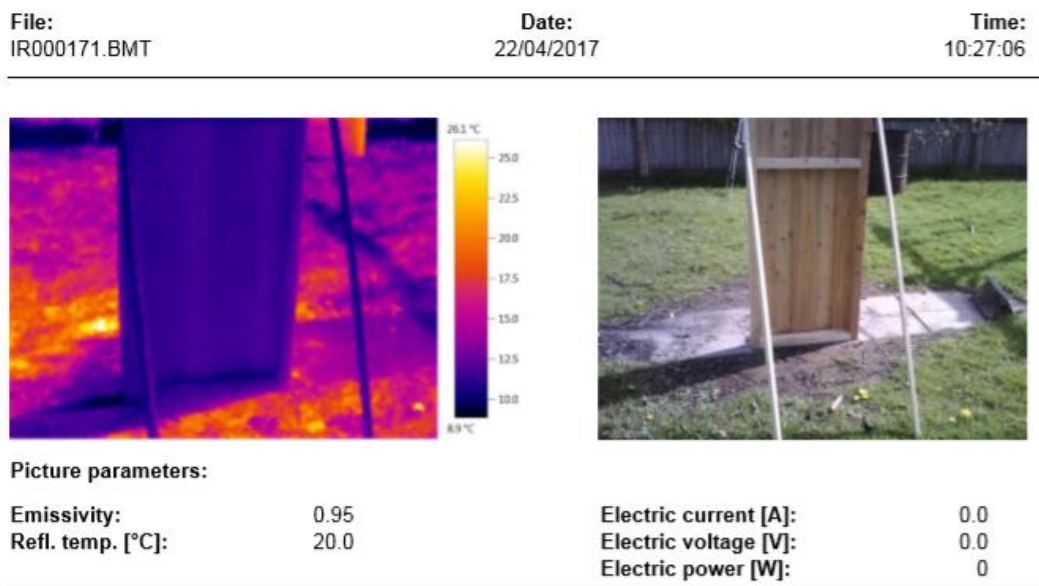
Figure 37 Thermal image comparison

Figure 37 shows the surface temperature of the rear of the test panel immediately before the start of the test. The surface temperature of the boards is approximately 11°C.

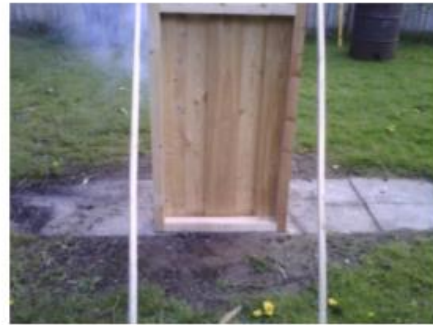
Figure 38 shows the rear of the panel 7 minutes into the test. The standard image shows no signs of any damage due to the fire. The surface temperature has risen to approximately 13.5°C. This is not a significant rise in temperature as it appears that the timber is having a significant insulating effect.

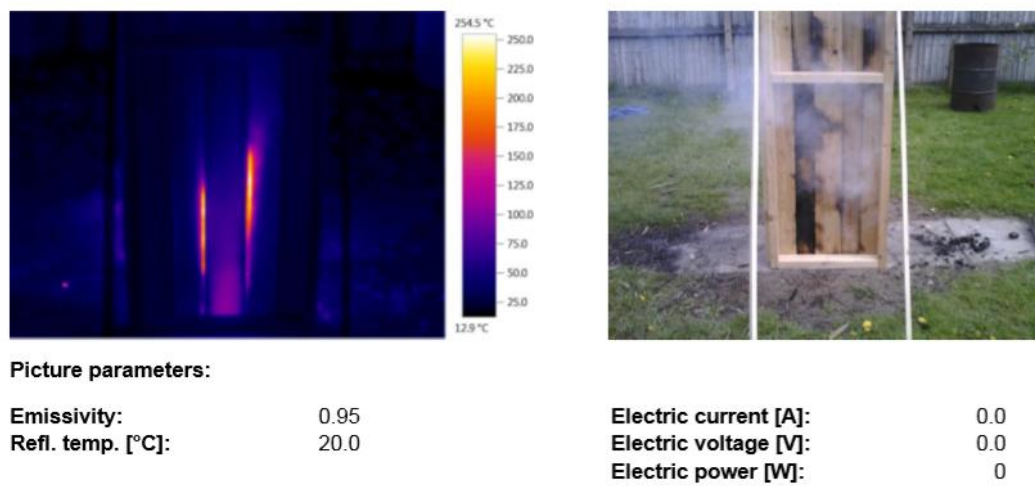
Figure 41 Thermal imaging comparison

Figure 41 shows the infrared images 14 minutes after the start of the test. The image shows that the heat has spread higher up the panel than the uncharred panel at the same point in the test.

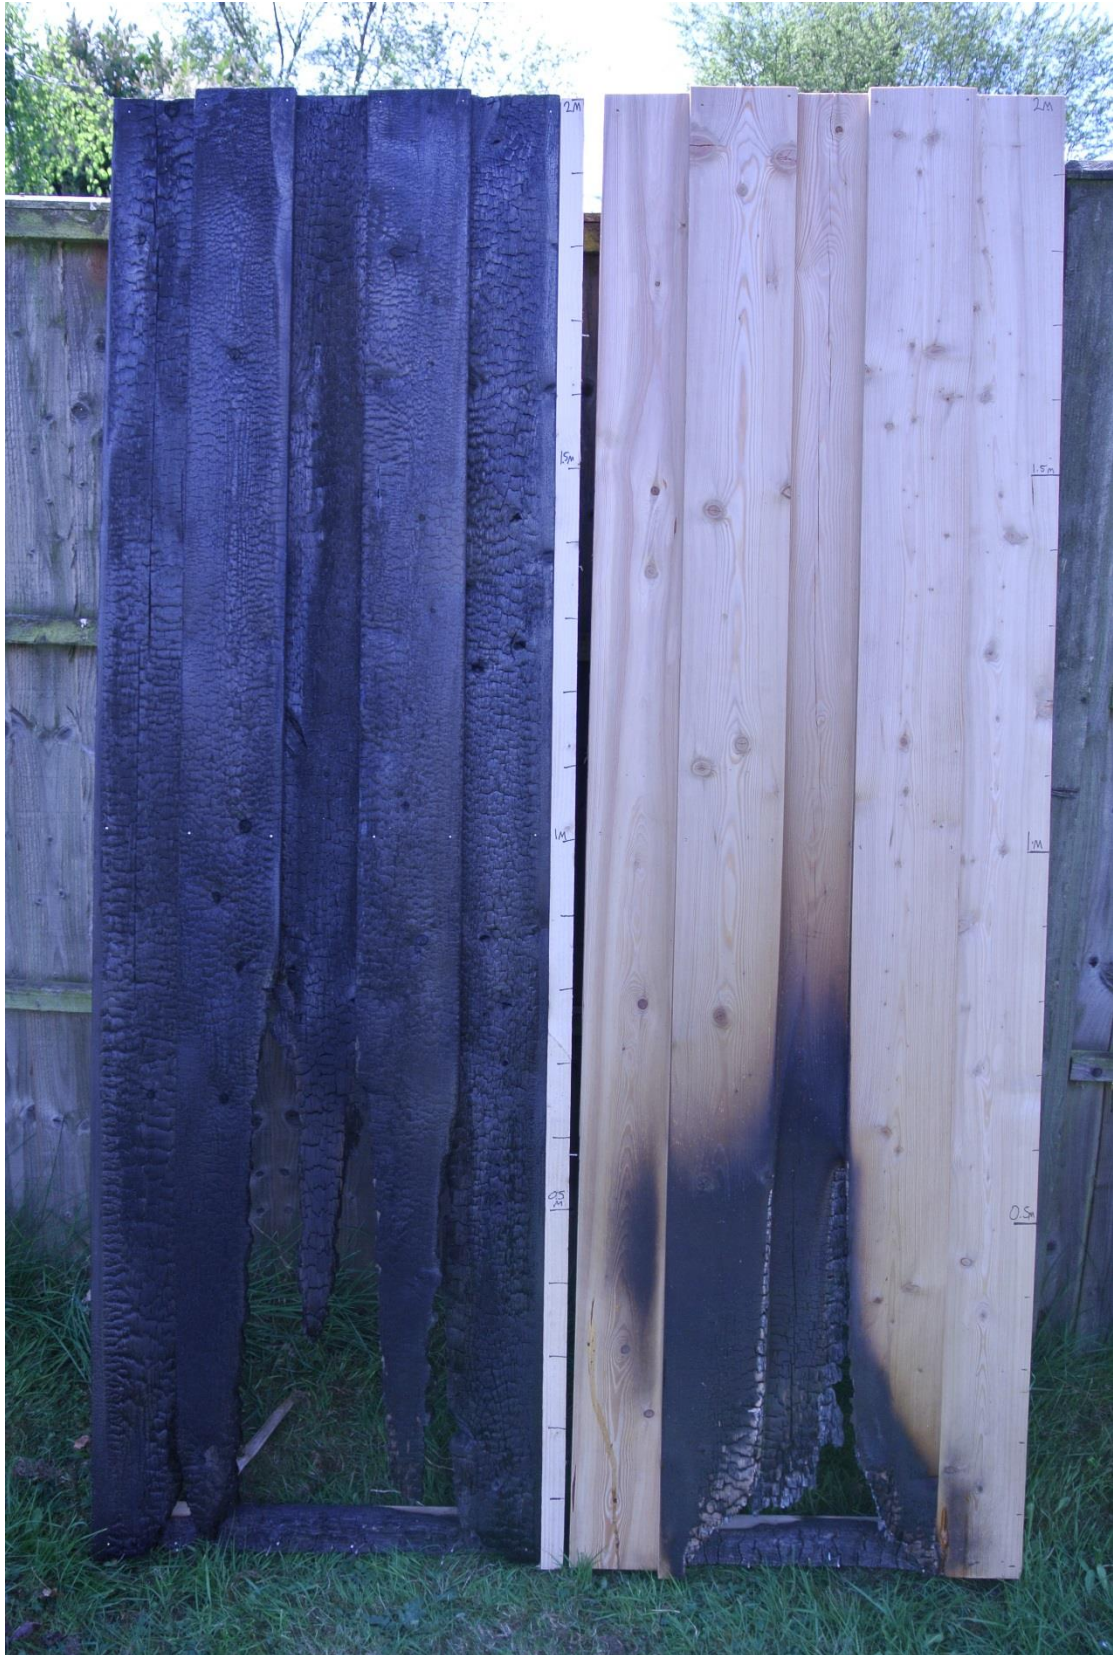
Figure 42 Flame spread test comparison

Figure 42 is a comparison of the samples immediately after the test was finished.

Figure 42 shows how the resulting fire has burnt the through the panel. It can be seen very clearly that the charred samples on the left of the image have burnt to a much greater extent than the uncharred sample. The charred sample burnt through to a height of 750mm from the base while the uncharred sample burnt through to a height of 575mm. It can also be seen that the width of the burnt area is larger on the charred sample. This equates to an increase of approximately 6 times the area burnt through the panel.

The tests show that there is no appreciable increase in fire resistance, either in ignition or resistance to the propagation of flame spread across the surface. In fact the charred sample shows a faster rate of ignition and an increase in damage from the fire than in the uncharred sample.

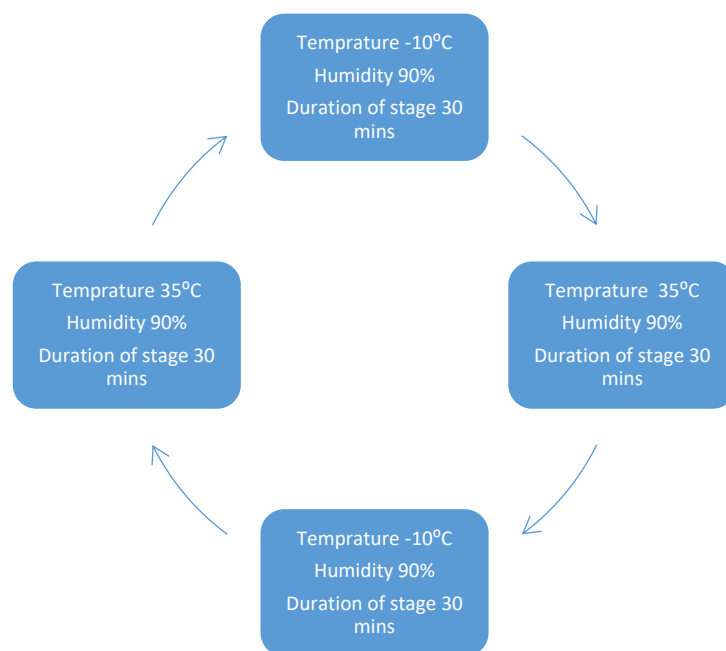
Figure 43 Environmental test cycle

The test parameters outlined in figure 43:-

The set points for this cyclic testing were based on the UK average temperature data from the Met Office. The temperature are the average maximums and minimums that the cladding could potential be subjected to in service conditions on a building façade.

The test cycle was repeated for 30 cycles. This was chosen to represent the upper maximum of 60 air frost days per year and allowed a year of frost events to be simulated in approximately 3 days.

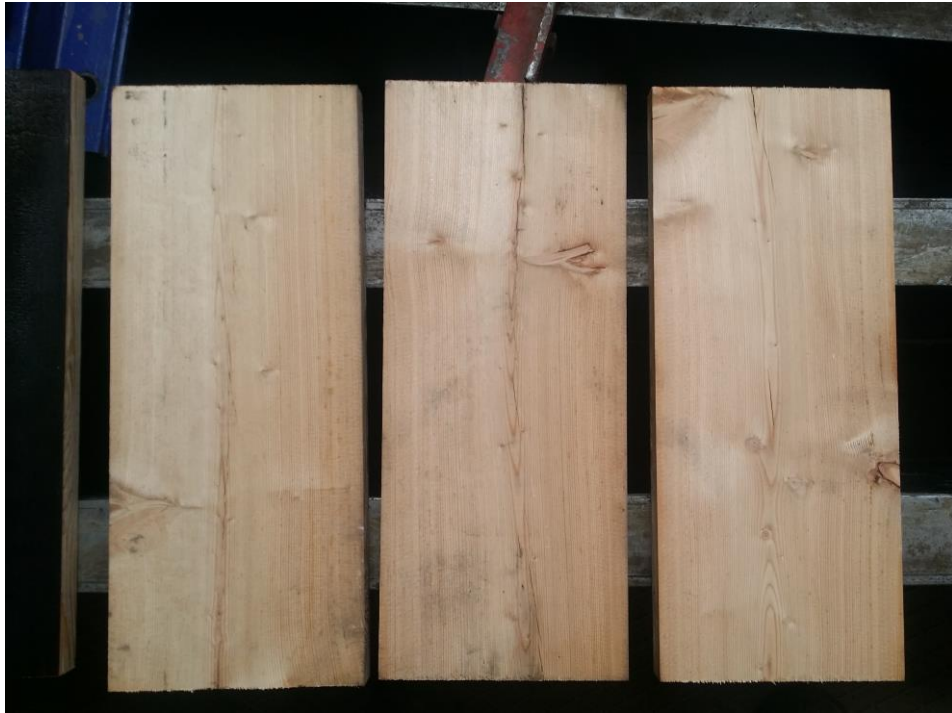
*Figure 44 Uncharred specimen*

Figure 44 shows the uncharred specimens immediately after the test was completed. There is little visual difference to the boards apart from a small amount of black staining to the surface of the boards, although this is localized.

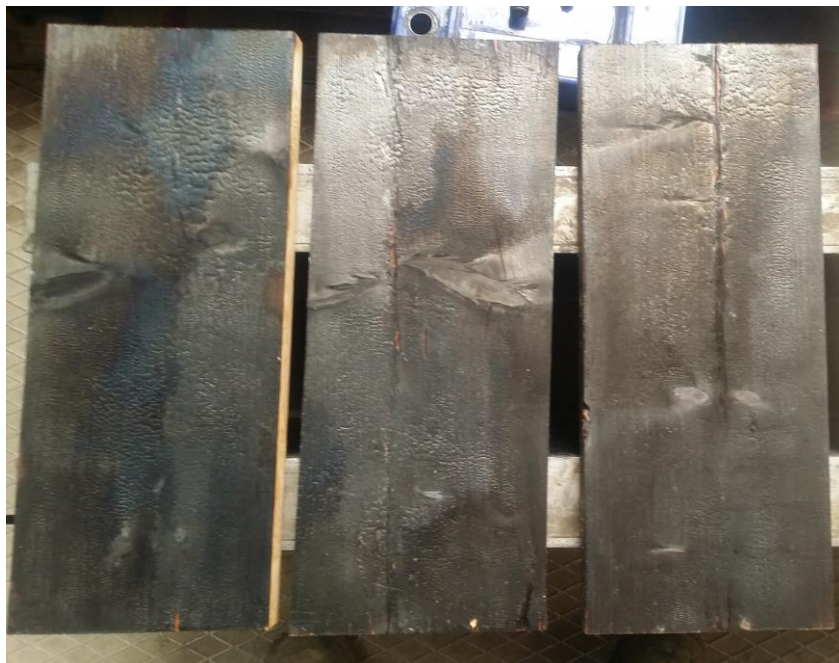
*Figure 45 charred specimen*

Figure 45 shows the charred specimens immediately after testing. The surface shows no signs of degradation. There is a fairly prominent area of what appears to be oil based staining over approximately 50% of one of the boards. This stain appears to be from the natural oils contained in the timber. This has migrated to the surface and spread across the char layer.

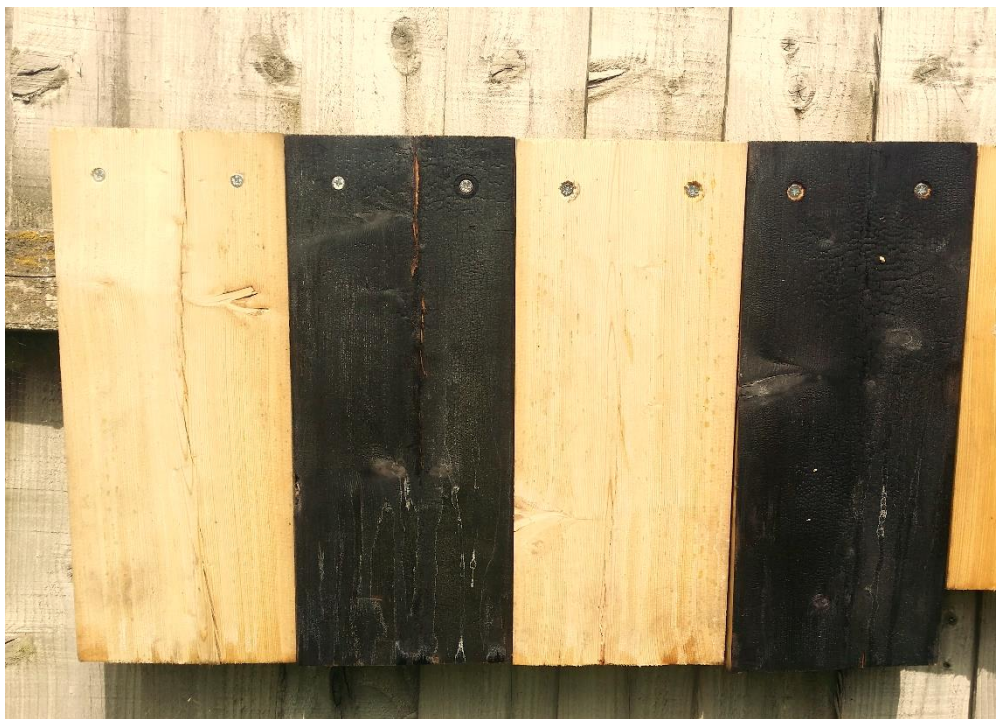
*Figure 46 pre exposure test image*

It can be seen in figure 46 that the saline solution has left a white stain on the face of the charred boards. This is the salt after the water from the saline solution has evaporated. There did not appear to be any significant staining on the uncharred boards.

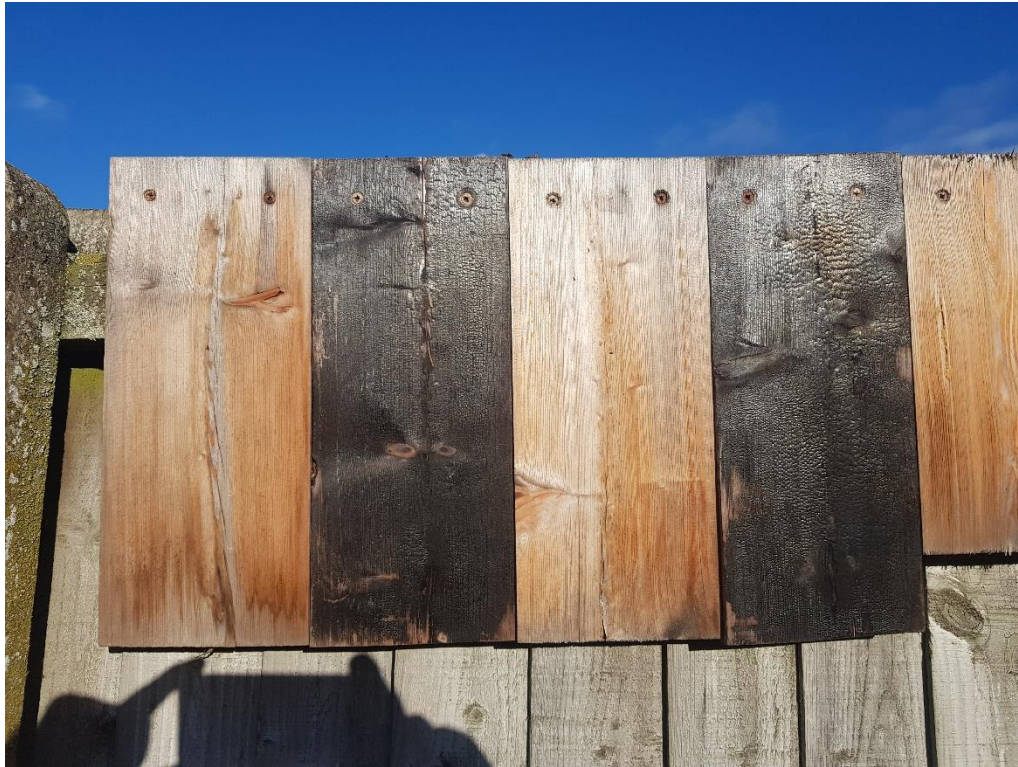
*Figure 47 post exposure test image*

Figure 47 shows the test specimens after the test period. It can be seen that the boards have discoloured significantly. In general, the charred sample has discoloured the least with less significant stains.

The saline solution that was applied at the start of the test has caused significant corrosion to the screws and this in turn has caused staining around the screw head. This is only apparent on the uncharred sample as the charred sample shows little to no signs of staining around the screw heads.
