Title: Concrete grandstands. Part I: experimental investigation.

Concrete grandstands. Part I: experimental investigation

Loading–unloading tests were carried out on uncracked (as delivered from the factory) and cracked (after the first loading–unloading cycle was completed) grandstand terrace units. The variation of parameters, such as displacements and strains, with the applied load was recorded and presented in a graphical form. The reduction in stiffness of the units owing to cracks was estimated from these graphs. The predominant mode of failure was found to be cracking initiated at the soffit of the units (tension zone) and mainly around the symmetry line (where maximum bending stresses congregate). These cracks propagated gradually towards the top. The measured and predicted strain distribution across the depth of the vertical part of the terrace unit (riser) was found to be predominantly linear, displaying tension at the bottom and compression at the top. A large portion of the horizontal part of the unit (tread) followed closely the behaviour of the riser, however, to reveal tension rather than compression at the top. This could have some implications for the design of t

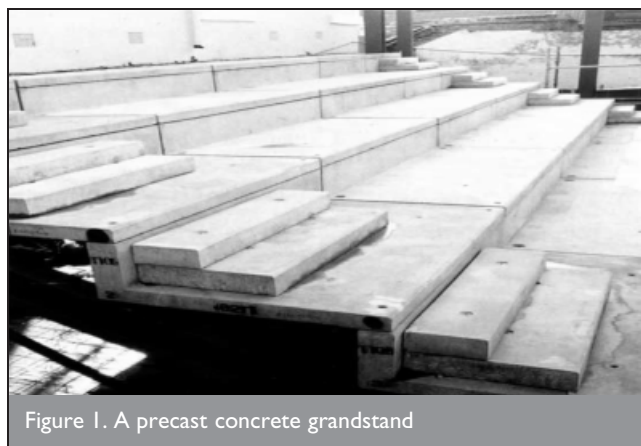
The most common construction of sports stadia today is that of a hybrid type where precast concrete terrace units span between inclined (raker) steel beams and rest on each other, thus forming a grandstand (Figure 1). The role of the third (resting) support is to stop the units from undergoing excessive twisting and, in general, provide extra stability. Accurate analysis and optimum design of these prefabricated units (elements), as well as the grandstand as a whole, requires a good understanding of their behaviour and performance under static and dynamic loading. Optimising their structural sections and improving economy, safety and comfort in use, is an ongoing engineering challenge with industry and academia working in tandem.

Figure 1. A precast concrete grandstand

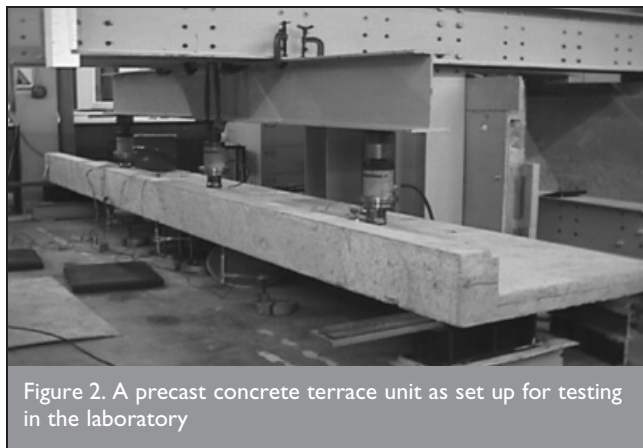
The L-section terrace units were designed, manufactured and transported to Coventry University. Owing to limited space in the laboratory the smallest actual size was ordered. They were approximately 4.8 m long, encompassing a 700 mm wide by 100 mm thick horizontal member (tread) and 150 × 275 mm upstand (riser), as per Figure 2. Their properties are shown in Table 1.

Figure 2. A precast concrete terrace unit as set up for testing in the laboratory

obvious reasons. Instead, two steel ‘stools’ were placed under the riser, spanning 4.5 m apart. A suitable UB-section was placed under the front edge imitating the riser of the lower unit on site. Elastomeric bearings (neoprene pads) were inserted between the two materials as per actual conditions.

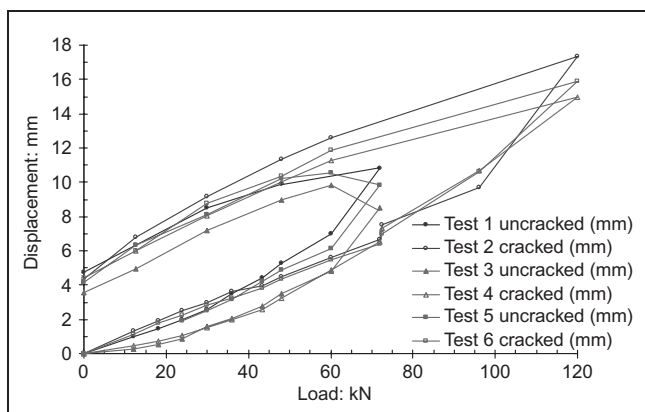
Figure 4 shows loading and unloading paths of maximum displacement measured at mid-span using linear variable differential transducer, (LVDT 2) for uncracked and fully cracked units. The same figure, showing the performance of the units in terms of their deflection, can be used as an index of their conformity. Tests 1 and 2, 3 and 4, and 5 and 6 refer to units 1, 2 and 3 respectively. Odd numbers denote tests on uncracked units.

Figure 4. Terrace units 1, 2, 3. Tests 1 and 2 (uncracked and fully cracked units). Comparison between maximum displacements (LVDT2). Loading–unloading

Units 1 and 3 are in good agreement while unit 2 shows a little variation. Table 4 summarises and presents the above in terms of their percentage difference. All differences were based on deflection values related to maximum loads reached—that is, 72 kN for the uncracked and 120 kN for the cracked units.

It is evident that the path described by curve test 2 is smoother and not characterised by any sudden 'strain jumps', until after it exceeds the maximum value of 72 kN met in test 1. Beyond this load further cracking takes place, producing another 'strain jump' and permanent deformation.

Up to a load of 30, possibly 32 kN, all slopes are similar, approximating linear behaviour and showing good correlation. This compares well with the ultimate design load of 36 kN allowed by the designer. After the first initial cracking in test 1 (above 30 kN), however, the two curves diverge. The displacement of the uncracked section becomes noticeably higher compared to that of the cracked. At 60 kN the corresponding displacements for the uncracked and cracked sections were 6.98 and 5.6 mm respectively. At 72 kN (the maximum load allowed for the uncracked unit) the corresponding displacements were 10.75 mm and 6.5 mm.

Static stiffness was estimated from the displacement–load graph in Figure 4. It was not possible to obtain a unique stiffness value as the slope of the $F-\delta$ curve changed each time a new crack appeared on the unit. The domain of $F-\delta$ curve of unit 1 was therefore divided into six convenient sub-domains and the ‘best-fit’ straight line was fitted in each one. The stiffness (slope) of the line was calculated based on the relationship

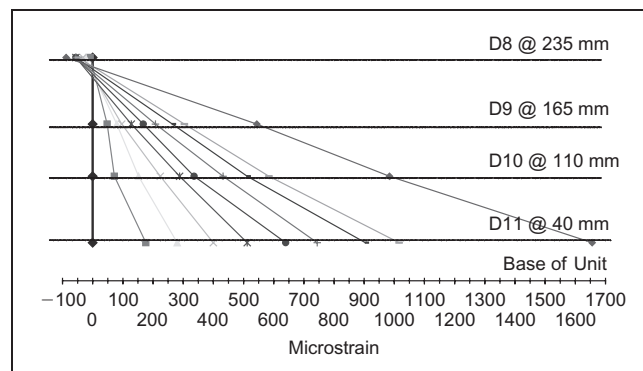
movement upwards of the neutral axis, reducing the area of section in compression. Figure 6 presents a similar account; this time the strain was distributed more smoothly. Once the cracks are developed, no sudden changes of strain are present during reloading. These cracks open wider following load increments, while strain readings reach higher values.

Figure 6. Terrace unit 1, test 2, strain distribution per load increment across the depth of the riser

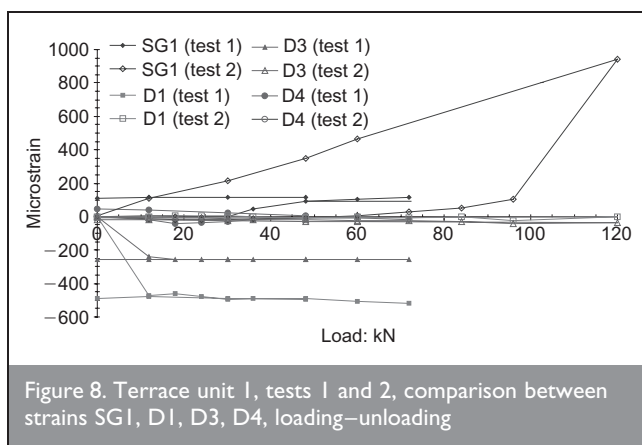
Figure 8 shows very similar strain patterns for demec pairs D1, D3 and D4, as expected, confirming the validity and accuracy of the readings obtained. D1 reached a maximum and levelled at $-500 \mu\epsilon$, D3 at $-250 \mu\epsilon$ and D4 hovered around zero. There was a noticeable gradual reduction in lateral compressive strain from the extreme support regions to the symmetry line. This indicated an independent behaviour of the tread near the supports and a similar one to the riser near mid-span. That is, although the tread, as a structural section itself, developed compression and tension at top and bottom faces near the supports, the entire section was below the neutral axis of the riser (and therefore in tension) near the centre.

Figure 8. Terrace unit I, tests 1 and 2, comparison between strains SG1, D1, D3, D4, loading-unloading

Based on Table 2, the total serviceability and ultimate state loads were 24.1 kN and 36.3 kN respectively. The longitudinal strain, measured at D7 and D6, turned tensile at 24 kN and 30 kN respectively (Figure 9). Also, the lateral strain at D4 turned tensile at 30 kN (Figure 8). This would indicate that when the unit is about to reach its allowable serviceability

load, part of it does not obey classical RC theory as tension develops on the top surface. This has not been taken into account when designing the terrace units. The sensitivity of all three demec pairs was greatly reduced at test 2, resulting in strain readings very close to zero. It is envisaged that this was due to the development of a series of cracks outside the effective zone of the demec pairs. SG1, the strain gauge attached to the lateral bottom reinforcement of the tread, recorded tension in both tests. It is clear from Figure 8 that the top of the tread develops cracks at 12 kN (plain concrete), whereas the bottom develops its first cracks at 30 kN (composite action). It is important to remember that the top of the tread near the centre behaves in a different manner, with the whole (tread) section being in tension, following the behaviour of the riser. Yet, for cracking in the same direction, the bottom face will still crack under tension before the top face.

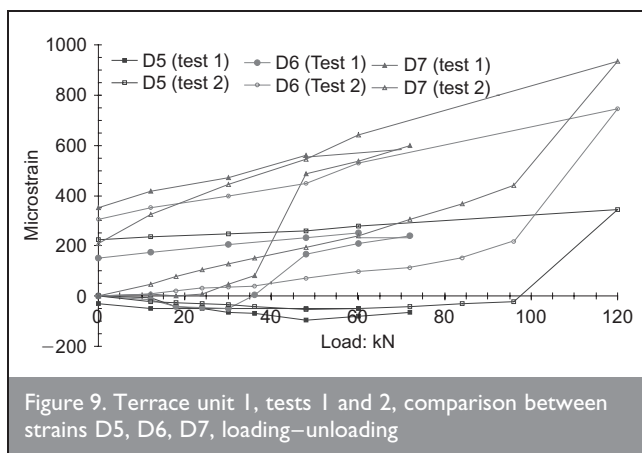
Figure 9. Terrace unit I, tests 1 and 2, comparison between strains D5, D6, D7, loading-unloading

Demec point pairs D5, D6 and D7 were placed at mid-span measuring longitudinal strain as shown in Figure 3. Figure 9 shows the variation of strain with load as measured across these points. It is interesting to note that D5 has followed a compressive path, reaching strain of $-100 \mu\epsilon$ at 48 kN and then somehow 'softening', to finish with $-70 \mu\epsilon$ at the maximum load of 72 kN allowed for test 1.

In contrast, D6 and D7 have recorded considerably larger tensile strains. Tension in this region is somehow surprising, especially when this is developing along the span of the unit. It shows that the tread at the region identified between the riser and demec points D2 and D5 (Figure 3) follows the behaviour of the riser; that is, it is in tension and forms a 'trough'. The familiar pattern at 12 kN and 30 kN, discussed previously, is repeated here. There is, however, an enormous strain jump between load increments of 30 kN and 50 kN. This is more obvious from demec readings D6 and D7. As strain is recorded tensile, it confirms that concrete has yielded locally.

The loading and unloading paths during test 2 (fully cracked unit) were much smoother than the corresponding in test 1. D5 (Figure 9) showed a negative initial tendency with most of the readings appearing below the horizontal axis. This was also the norm of the corresponding demec pair for the uncracked unit in test 1. New cracks, or further opening of the existing cracks, appeared at 96 kN. The final strain values at 120 kN reached 350, 725 and 925 microstrain for D5, D6 and D7 respectively, whereas residual strains were 225, 300 and 200 microstrain for the same transducers.

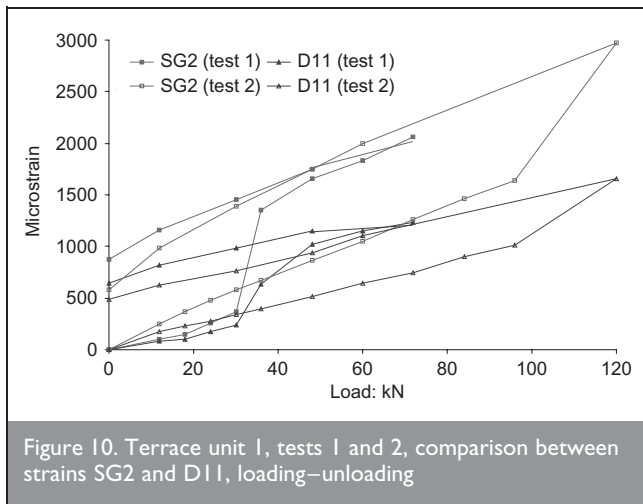
Figure 10 shows a comparison between strains measured by strain gauge SG2, attached to the tension reinforcement of the riser and demec points D11, attached 40 mm above the bottom of the same riser. That is, both SG2 and D11 were at approximately the same level from the soffit of the riser. Initially, and up to the load of 18 kN, both strains showed good correlation, turning reasonably good up to 30 kN. Beyond the branded 30 kN load, however, SG2 produced considerably higher strain values than D11, although both strain paths were remarkably similar. This would indicate the beginning of failure for the surrounding concrete. Also, as new cracks

Figure 10. Terrace unit 1, tests 1 and 2, comparison between strains SG2 and D11, loading–unloading

Maximum values of strain recorded for the final load of 72 kN were 2100 $\mu\epsilon$ and 1200 $\mu\epsilon$ for SG2 and D11 respectively.

The unloading procedure was carried out without surprises giving residual strain values of 880 $\mu\epsilon$ and 640 $\mu\epsilon$ for SG2 and D11 respectively.

The behaviour of the curve in test 2 was smoother and more linear compared with that of test 1. Although both strain paths are similar, SG2 produced higher strain values for reasons already explained above. Maximum strain was reached at 120 kN, with magnitudes equal to 3000 $\mu\epsilon$ (600 N/mm²) and 1650 $\mu\epsilon$ (49.5 N/mm²), for SG2 and D11 respectively. Both stress values were well beyond the yield stress values of the materials. Finally, unloading produced residual strains of 600 $\mu\epsilon$ and 500 $\mu\epsilon$ for SG2 and D11 respectively.

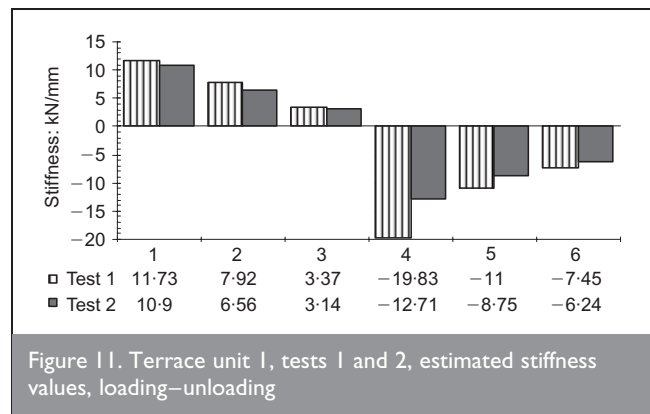
1–2)—are shown in Figures 11 and 12. It is apparent that when a new crack appeared on the unit, its stiffness was reduced. It is also clear that although stiffness values extracted from the uncracked unit were higher than those of the cracked, the former were not, in general, significantly higher. Also, the difference between the two reduced with increasing load, in some way highlighting the importance of steel reinforcement and the concept of ductility.

Figure 11. Terrace unit 1, tests 1 and 2, estimated stiffness values, loading–unloading
