Application of acoustic emission in diagnostic of bearing faults within a helicopter gearbox

Elasha, F. , Greaves, M. , Mba, D. and Addali, A. (2015) Application of acoustic emission in diagnostic of bearing faults within a helicopter gearbox. Procedia CIRP, volume 38 (Proceedings of the 4th International Conference on Through-life Engineering Services): 30-36.

The Fourth International Conference on Through-life Engineering Services

Application of Acoustic Emission in Diagnostic of Bearing Faults within a Helicopter gearbox

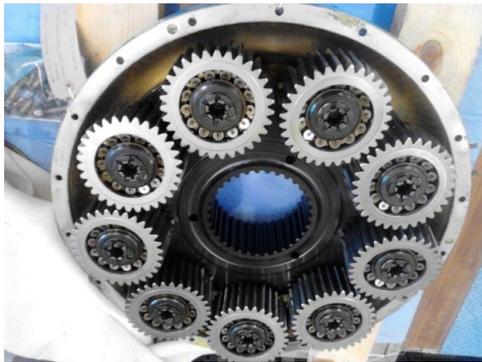
Figure 1 Second stage epicyclic gears

The main rotor gearbox consists of two sections, the main module, which reduces the input shaft speed from 23,000 rpm to around 2,400 rpm. This section includes two parallel gear stages. This combined drive provides power to the tail rotor drive shaft and the bevel gear. The bevel gear reduces the rotational speed of the input drive to 2,405 rpm and changes the direction of the transmission to drive the epicyclic reduction gearbox module. The second section is the epicyclic reduction gearbox module which is located on top of the main module. This reduces the rotational speed to 265 rpm which drives the main rotor. This module consists of two epicyclic gears stage, the first stage contains 8 planets gears and second stage with 9 planets gears, see figure 1. The details of the gears are summarised in table 1.

The epicyclic module planet gears are designed as a complete gear and bearing assembly. The outer race of the bearing and the gear wheel are a single component, with the bearing rollers running directly on the inner circumference of the gear. Each planet gear is ‘self-aligning’ by the use of spherical inner and outer races and barrel shaped bearing rollers (see Figure 1).

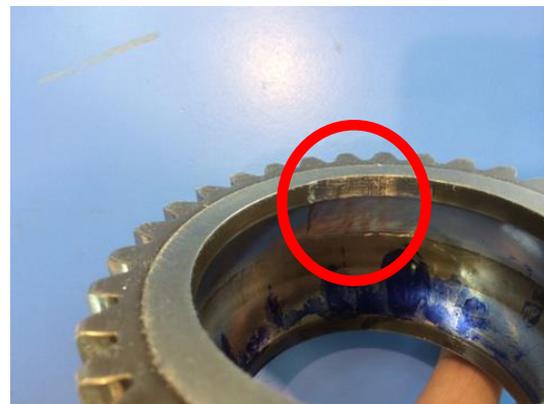
Figure 2 Slot across the bearing outer race

This investigation involved performing the tests for fault-free condition, minor bearing damage and major bearing damage. The bearing faults were seeded on one of the planet gears of the second epicyclic stage. Minor damage was simulated by machining a rectangular section of fixed depth and width across the bearing outer race (10mm wide and 0.3mm deep), see figure 2, and the major damage simulated as a combination of both a damaged inner race (natural spalling around half of the circumference) and an outer race (about 30mm wide, 0.3mm deep), see figure 3. Three load conditions were considered for the each fault condition, 110% of maximum take-off power, 100% and 80% of maximum continuous power; the power, speed and torque characteristics of these load conditions are summarised in table 2.

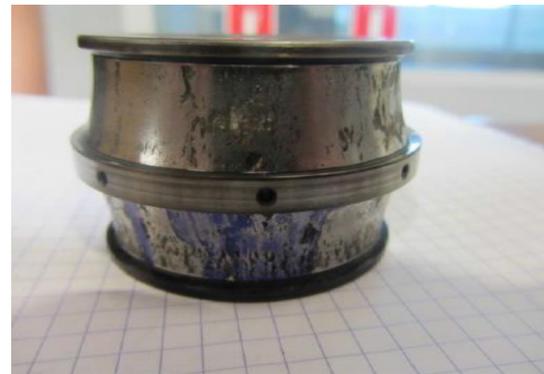
Figure 3 Inner race natural spalling

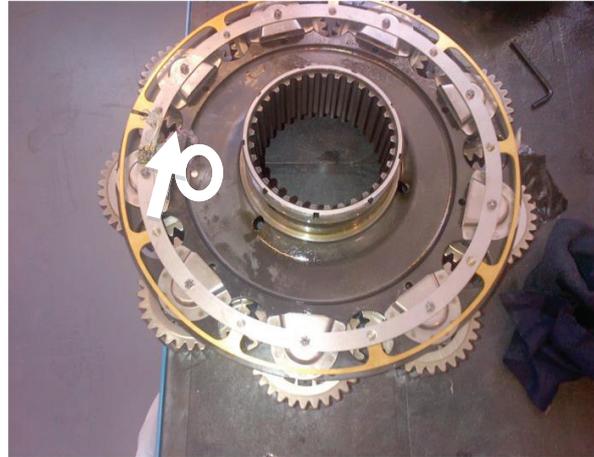
Figure 4 Moving coil mounted on the planetary carrier (coil arrowed, sensor circled)

Acoustic Emission data was collected using a PWAS sensor [46], 7mm diameter and approximately 0.2mm thick, bonded to the upper face of the planet carrier, see figure 4. The sensor was connected to a conditioning board attached to the planetary carrier and transmitted wirelessly using two coaxial copper coils and a new wireless transfer technique. The new wireless transfer technique utilise two single turn brass coils of approximately 400 mm diameter which were cut to size using water jets for accuracy. The stationary (upper) coil was suspended from two clamping rings which were

attached to the top case of the gearbox with a spacer through the holes to retain location. The moving (lower) coil was attached to a circular mounting ring which was in turn mounted on top of the oil caps on the planet carrier, see figures 4 and 5. Electrical isolation of the coils from the mounts and surrounding metallic structure was achieved through the use of nylon washers and bushes. AE data was acquired at a sampling rate of 5 MHz using an NI PCI-6115 card connected to a BNC-2110 connector block.

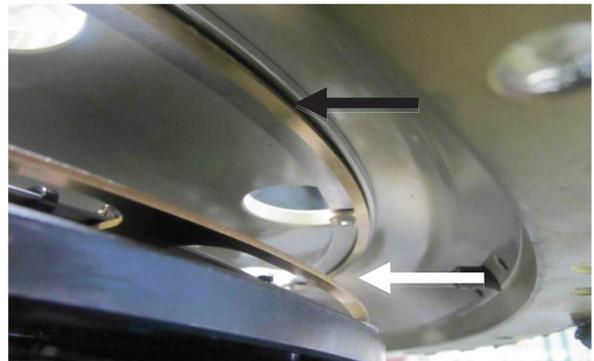
Figure 5 Coils in position prior to assembly (static coil black arrow, moving coil white arrow)

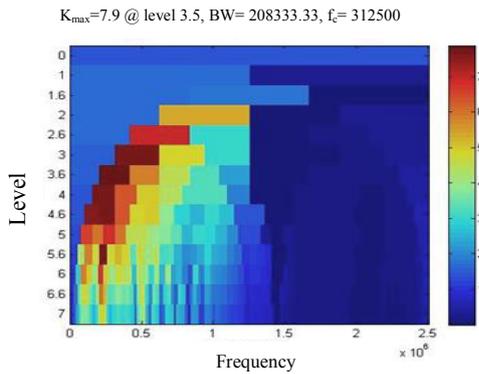
Figure 6 SK kurtograms major defects (110% maximum take-off power)

The Spectral Kurtosis was employed to extract the filter characteristics which were utilised for envelope analysis on measured AE signatures. Associated typical kurtograms of SK analysis are shown in Figure 6. The result of maximum kurtosis showed there were no noticeable differences between healthy and faulty conditions.

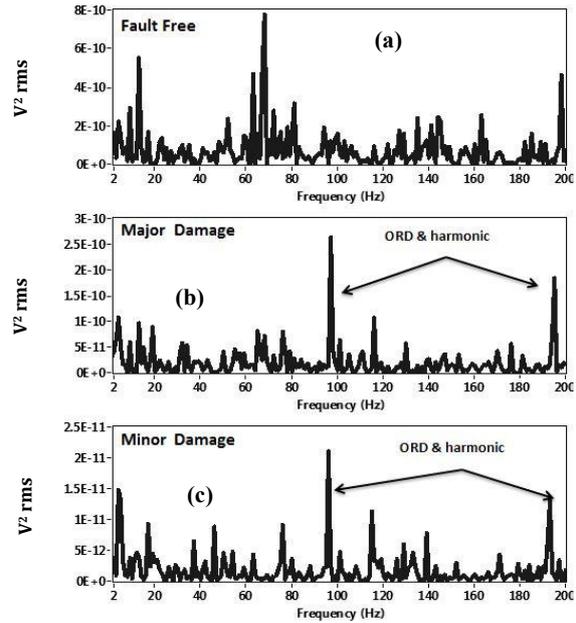
Figure 7 Enveloped spectra of AE signal (a) Fault-free (b) Major (c) Minor bearing defects at 110% maximum take-off power

table 4. Observations of figures 7, 8 and 9 showed the presence of the bearing outer race defect frequency (96 Hz) and its harmonic (192 Hz) for both minor and major damages under different loading conditions. The results showed the AE is very capable in detecting the faults of different sizes, in addition the results showed the defect amplitude increased significantly for major fault compared to minor fault, which provide measure for fault severity. Moreover, the fault detection was independent of load condition. However, comparisons of defect amplitude should be performed under similar condition.

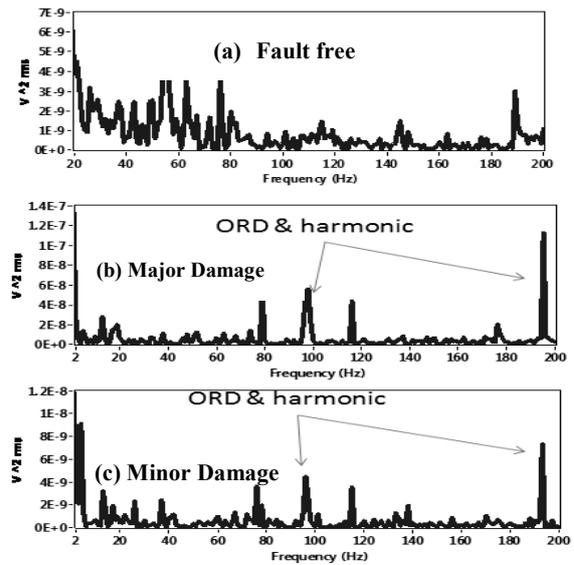
Figure 8 Enveloped spectra of AE signal (a) Fault-free (b) Major (c) Minor bearing defects at 100% maximum continuous power

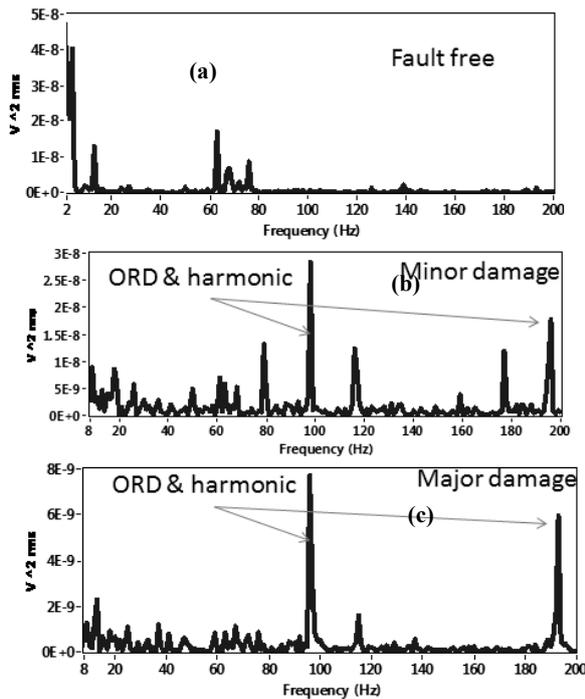
Figure 9 Enveloped spectra of AE signal (a) Fault-free (b) Minor (c) Major bearing defects at 80% maximum continuous power
