Experimental and Numerical Investigation of Post-tensioned Concrete Flat Slabs in Fire

Abstract: Four tests of post-tensioned high-strength self-compacting concrete flat slabs were conducted under fire conditions. Tendon distributions of the slabs including the Distributed-Distributed and Banded-Distributed patterns as well as various loading ratios were considered. Two of the specimens with lower moisture contents demonstrated excellent fire resistance performance, while the others with slightly higher moisture contents experienced severe concrete spalling. The test results are presented and discussed in respect of thermal profiles, deflections, crack patterns and concrete spalling. Moreover, numerical modelling employing the commercial package ABAQUS was conducted to help interpret the test results in order to get better understanding of such slabs in fire.

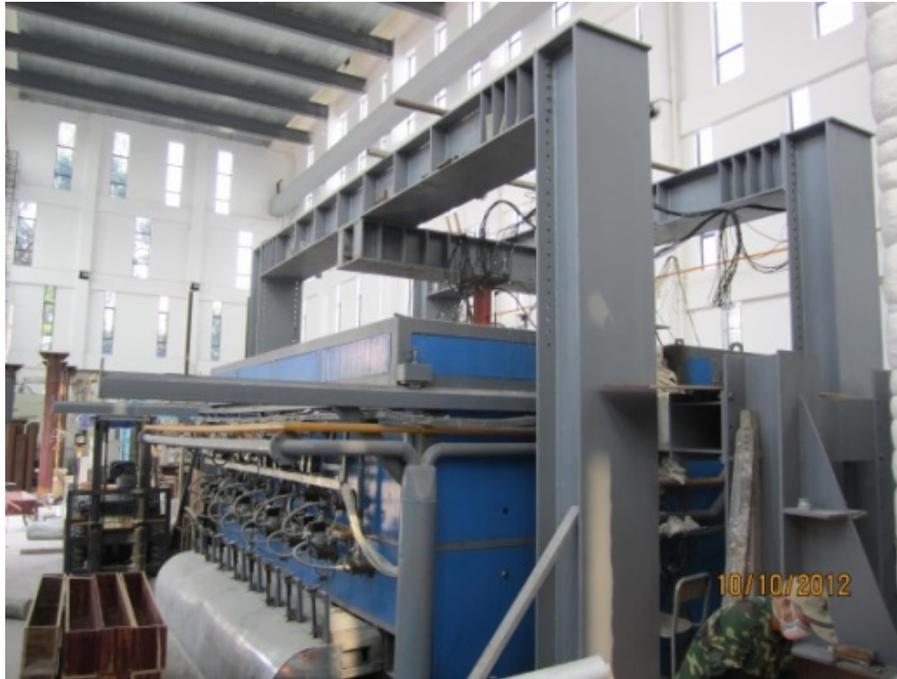
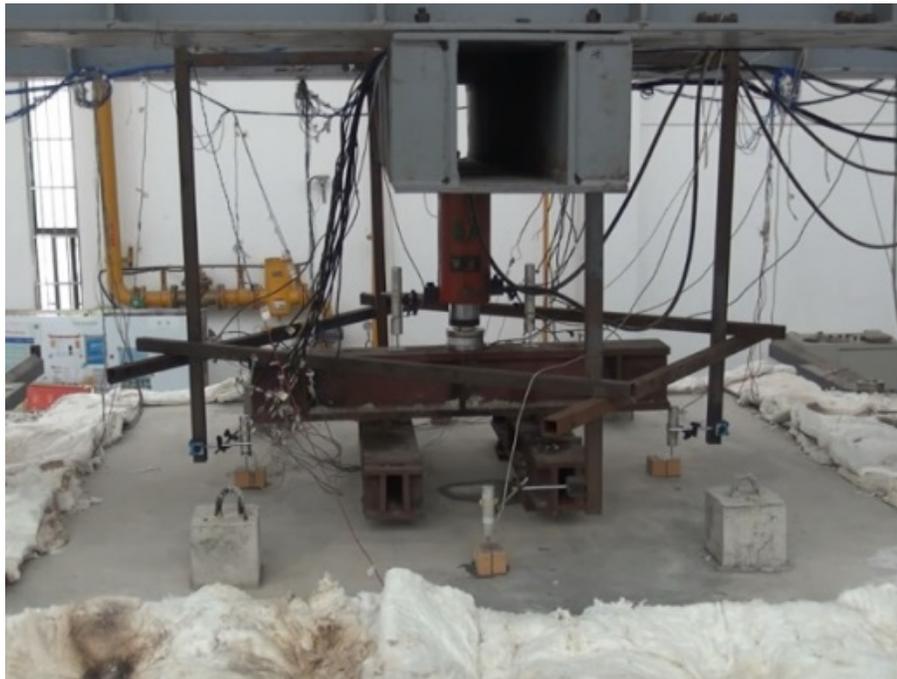
(a) Furnace

(b) Loading system

Figure 5: Test furnace and loading system

The furnace used as shown in Figure 5(a) has a clear height of 1.8 m, clear width of 3.0 m and clear length of 4.0 m. The loading system is comprised of a hydraulic jack with a loading capacity of 500kN and simply-supported steel beams in contact with four steel load spreaders, as shown in Figure 5(b). Firstly, loads were applied on the slab through the loading system and were kept constant for 15 mins for stability. Afterwards, fire was started in the furnace for testing with the applied loads maintained. The fire curves monitored in the four tests are compared with the ISO 834 standard fire curve in Figure 6, which shows reasonable agreement.
