Non-invasive damage detection and classification of the bond beneath thin overlays in rigid pavements. A pilot study

Khan, Adil Idrees

***A thesis submitted in partial fulfilment of the University's requirements
for the Degree of Doctor of Philosophy***

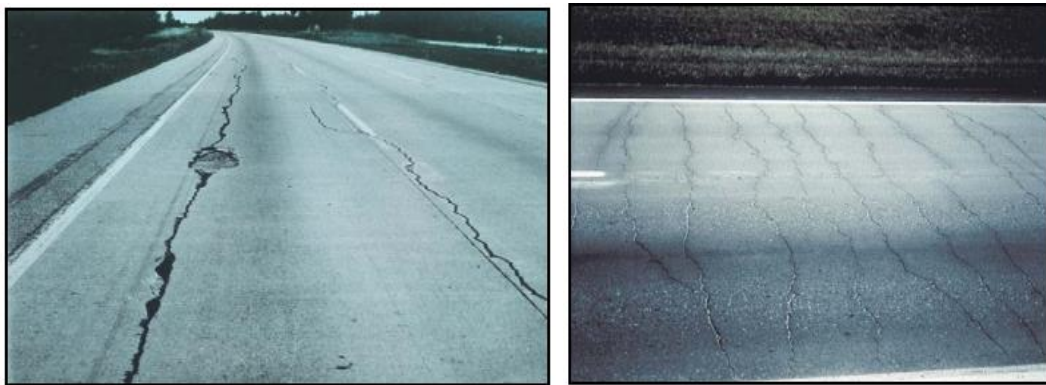
Transverse Cracks are defined to be the perpendicular cracks (Figure 2-4) to the centreline (Miller et al. 2003). Huang (2006) has noted that, 'Transverse cracks are usually formed due to repeated heavy loading, temperature gradient, moisture gradient and dry shrinkage'. Yu et al. (1998) found out that the higher risk of these cracks in the longer joint spacing are in drier climates due to the fact of the high temperature gradient.

Figure 2-4: Longitudinal cracking (L) and Transverse cracking (R) in concrete pavements (FHWA 2003).

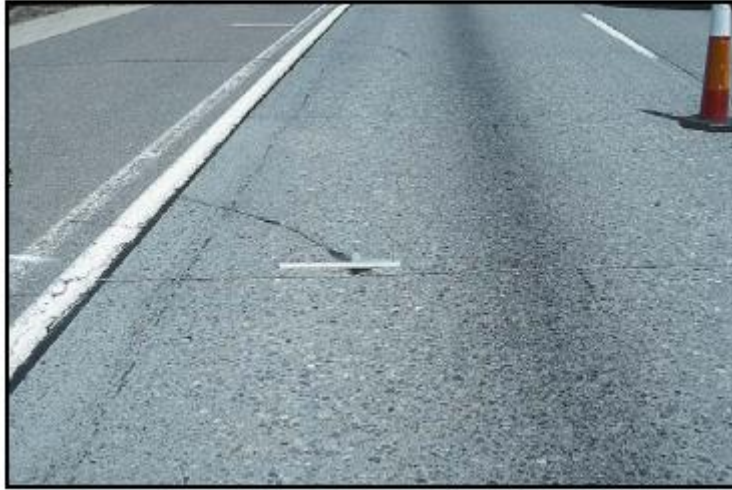
- b. Corner Breaks:** Corner breaks occur at the corner of concrete slabs (Figure 2-5). Usually a triangular concrete piece from 0.3m to half the width of the slab, breaks off from the edge (Miller et al. 2003). These occur more likely in longer slabs, and when heavy vehicles travels across them, the edges warp or curl upwards, therefore, leaving unsupported at the edge, which eventually breaks off (Delatte 2008).

Figure 2-5: Corner Breaks in concrete pavement (FHWA 2003).

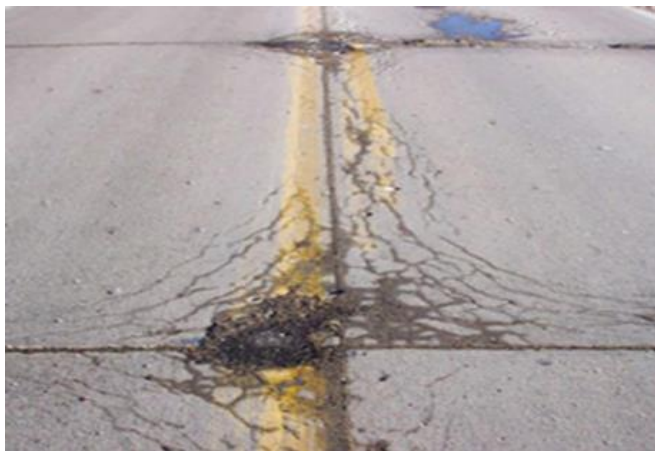
- c. **Durability ('D') Cracking:** Durability or 'D' cracking occurs more likely near joints (Figure 2-6), and is manifested as 'closely spaced crescent shaped hairline cracking pattern' (Miller et al. 2003). Yoder and Witczak (1975) found out that the phenomenon is regional, and is caused by the inability of concrete to withstand severe climatic conditions or due to use of non-durable material. The cracks are mostly dark than the sound areas. According to Huang (2006), freeze-thaw expansion is the cause of these cracks in some types of coarse aggregate. Mindess et al. (2003) noted that there is a critical size of coarse aggregates, below which they are not susceptible to fracture.

Figure 2-6: D-cracking in concrete pavement (Desta 2014).

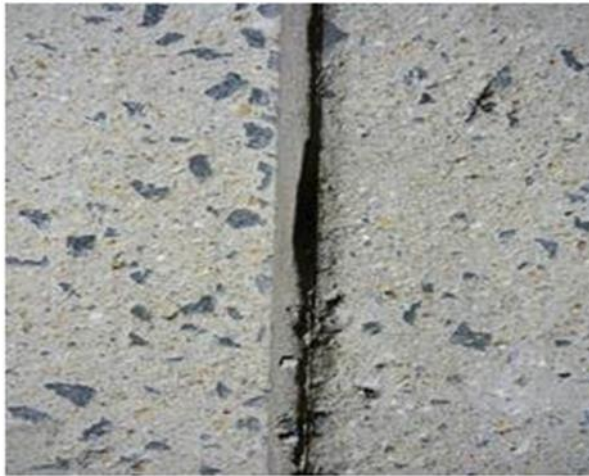
Figure 2-7: Medium level of joint seal damage (FHWA 2003).

Typical joint seal failure includes extrusion (coming out of seal from the joints), adhesive failure (bonding loss), complete loss of sealant (Figure 2-7), foreign material intrusion or weed growth (Miller et al. 2003).

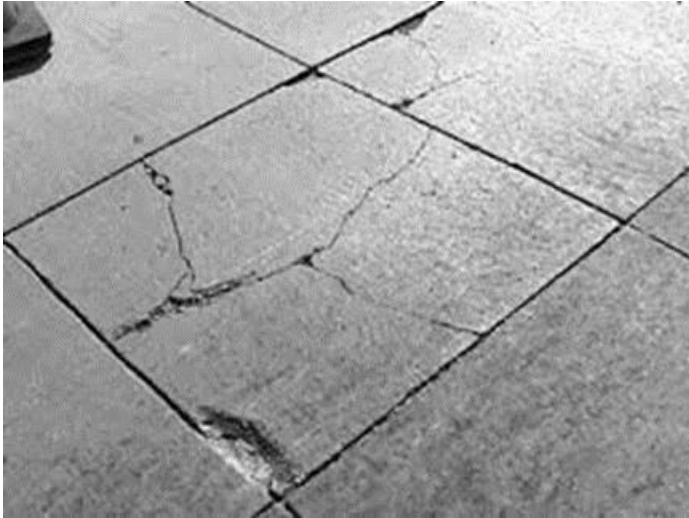
- e. **Shattered Slab:** The shattered slabs are defined by The Constructor-Civil Engineering Home (2017), as slabs, in which the intersecting cracks breaks the whole slab into four or more pieces (Figure 2-8). This may be caused by overloading or inadequate support. Usually it is the combination of the two.

Figure 2-8: Shattered Slab (The Constructor-Civil Engineering Home 2017).

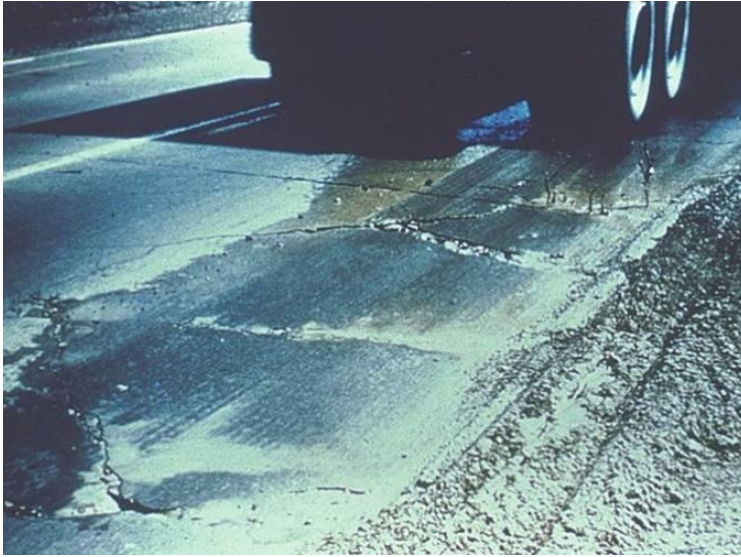
These types of distresses (Figure 2-9) refer to ‘seeping or ejecting of water beneath the slab surface through cracks’ (Delatte 2008). Sometimes, it could be detectable from the fine material deposits, near the pavement surface, that have been eroded or pumped from the support layers, and therefore, stains the surface (Miller et al. 2003). Yoder and Witczak (1975), found out, and gave an excellent discussion on pumping, saying, active pumping just happens after the rainfall, and was first noticed when the pavements were directly built on the plastic clay soils. Compression of the soil due to heavy loadings, led to the creation of the voids spacing under the pavement, therefore, making a way out for the water to be stored here, which further under the traffic loading and with pump-able material like high plasticity clay, was then pumped out. This phenomenon may be gradual, and couldn’t be noticed until years after construction. According to Huang (2004), when pumping takes place, the material under the slab must be saturated, the traffic loading must be frequent, and the material should be erodible.

Figure 2-9: Water bleeding in concrete pavement (FHWA 2003).

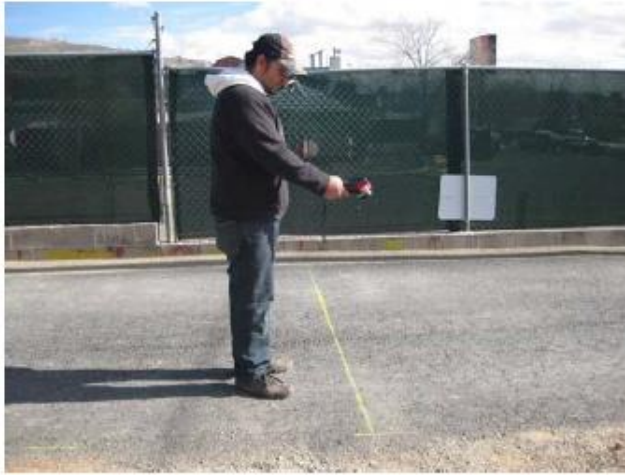
Another passive approach in infrared thermography was carried out by Celaya (2011) on the asphalt surface with an area of approximately 610x610mm, where the camera was used at the height of 1.2m from the surface (Figure 2-20).

Figure 2-20: Infrared inspection of the HMA pavement (Celaya 2011).

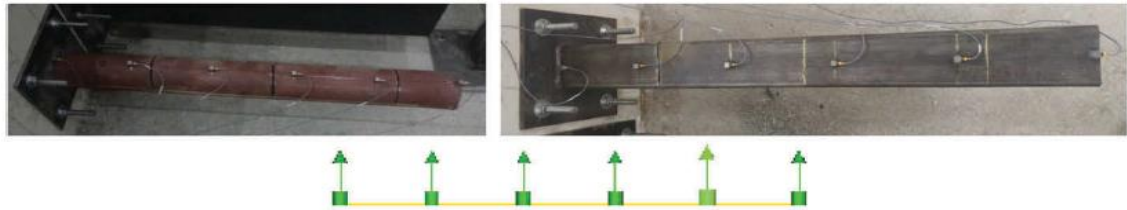
Figure 2-25: Lab scaled model of steel cantilever beams, mounted with accelerometers (Altunışık et al. 2019).

vibrations were performed on the laboratory models of cantilever beams. A 17 channel data acquisition system accompanied by 6 uniaxial accelerometers were deployed for the data collection, by exciting a 1000mm long beam (Figure 2-25).

The measurements were taken and compared for the undamaged and damaged beams within the selected bandwidth of 0-1500Hz. A successful indication of the damages was illustrated by the computed mode-shapes, and by the variations in natural frequencies. It was observed that with the increase in the number and severity of cracks, there was a decrease in the natural frequencies, for both beams. An error of 10% for the lower modes and more than 10% for higher modes was observed between the experimental and analytical readings. This showed that for the higher modes, the discrepancies were more. However, model updating was required here, but it was not in the scope of this study.

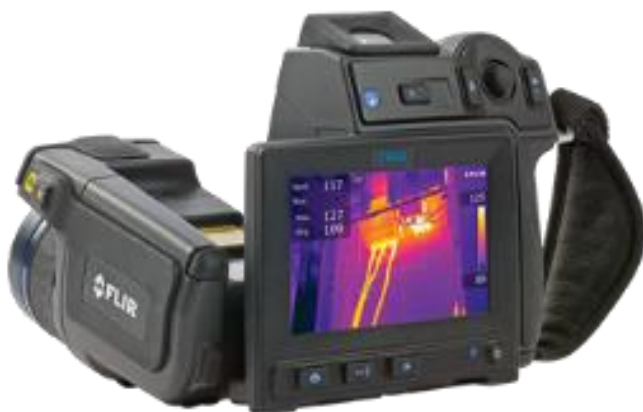
Figure 4-3: Infrared Camera (FLIR Systems 2013).

First is the IR camera, which apparently looks like a portable video camera (Figure 4-3), used with interchangeable lenses.

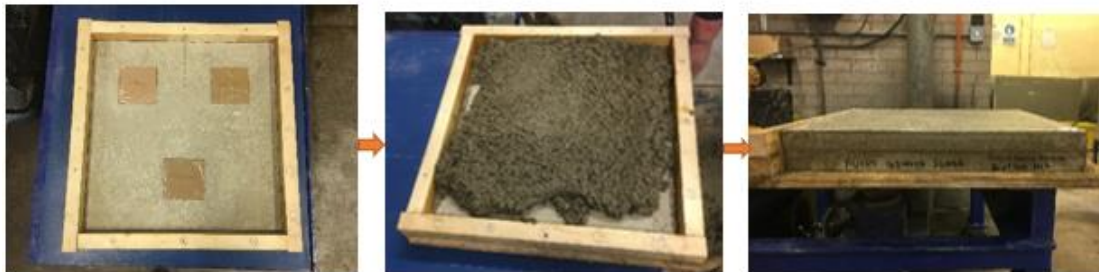
Figure 4-30: Casting of Two-slabs stacked system with three delaminations at the interface.

After drawing preliminary conclusions from testing on the single cast concrete slab (with designed voids at various thicknesses and depths), it was decided to apply the gained knowledge to a more realistic scenario. Therefore, in this test, an effort was made to replicate the real life delamination flaw, which is largely present at a constant depth i.e at the interface between the top overlay (40-50mm) and base. In order, to reproduce this, two concrete slabs of the same sizes were casted, one on top of another, with three deliberate delaminations (introducing similar patterns of corrugated cardboards as per Test 01), at their interface and at known depth of 40mm (Figure 4-30). However, this time, delaminations of very small thicknesses (1mm, 2.5mm and 5mm) were introduced, to represent the ‘evolution’ of delamination from ‘*Initial*’ to ‘*Intermediate level*’ and finally to ‘*Severe-delamination*’. The details of delaminations are shown in Figure 4-31.

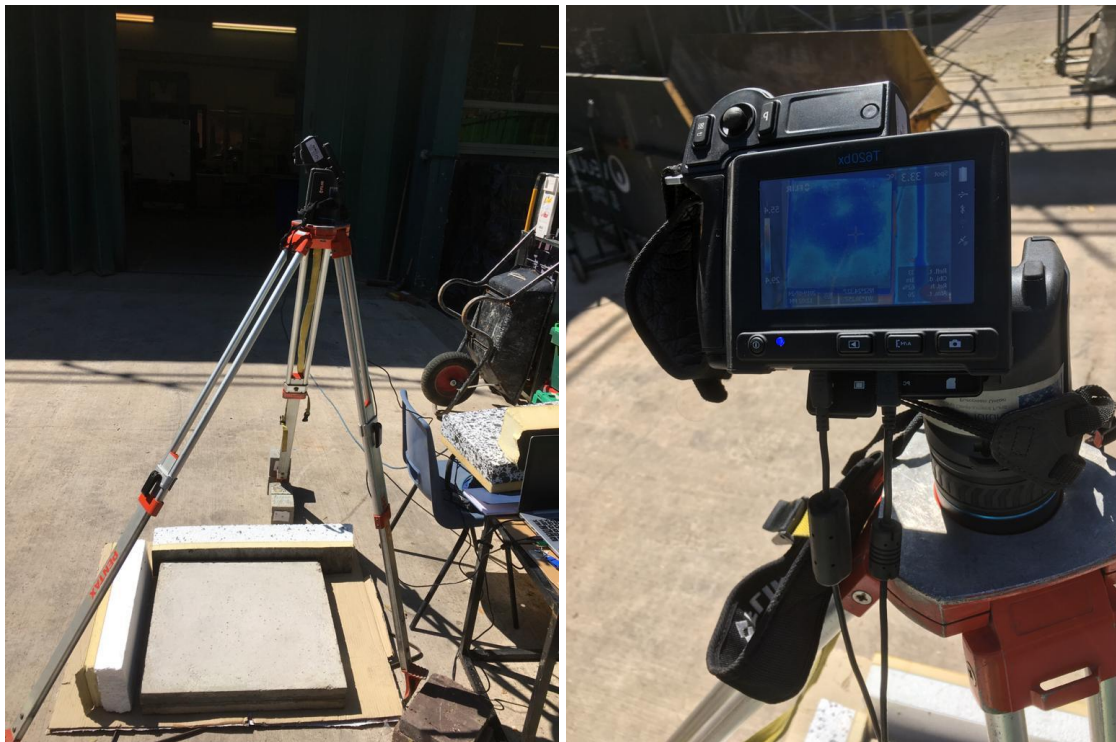
Figure 4-32: Setup of Test 02-IRT. Thermograms recording during the heating phase.

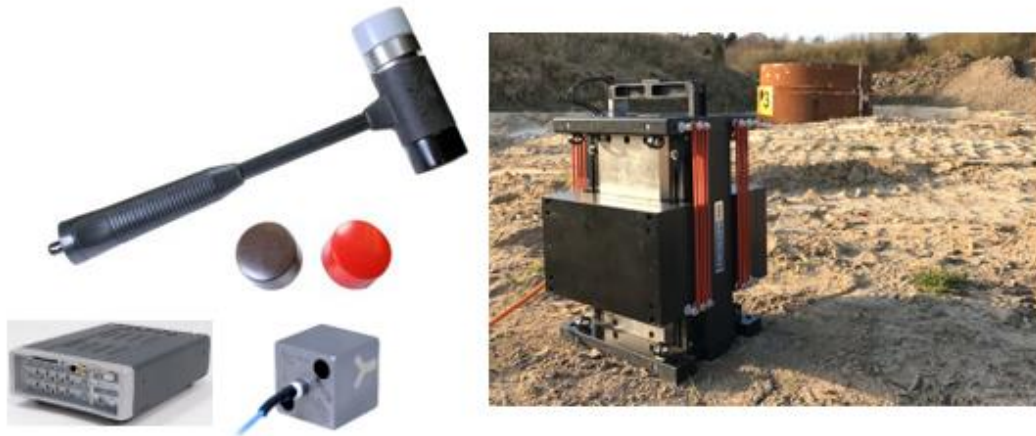
Figure 5-4: Impact Hammer, Piezoelectric triaxle accelerometer and Data logger. A Shaker, as an excitation source (PCB 2011).

It is known that to estimate the dynamic characteristics of structures, they have to be excited and the response signal is measured. For excitation, there are two non-destructive instruments, namely instrumented impact hammer and electromagnetic vibration shaker (Figure 5-4). Due to its availability, relatively low cost and its accessibility to the various points of measurements, impact hammer is more popular and is also adopted for this study. Moreover, it can be operated by one person only, by easily moving hammer to the various points on the structure under test. In addition to these merits, impact hammer is also fast to use as compared to its counterpart and has got various tips, ranging from softer rubber tip to the stiffest steel tip. These tips basically control the frequency content under study. It is understood that the harder the tip, the shorter the pulse duration and higher the frequency content. However for massive structures, more energy is required to excite the structure in addition to the

For response measurement, any of the motion transducers for measuring displacement, velocity and acceleration can be used. However, accelerometer is a generally used transducer for measuring the vibrational response signal of the structure under test in the form of acceleration response time histories. In this study also, a uniaxial piezoelectric accelerometer is adopted to acquire the response data (Figure 5-4).

Conventionally, the data acquisition system has three main units, namely, signal amplification unit, data acquisition unit (Figure 5-4) and personal computer. These units can come separately and are operated via a software interface. The data loggers are connected to the PC via cables and are operated by their software. Excitation source (impact hammer/ shaker) is connected to one of the input channels, whereas, the response source (accelerometer) is connected to one of the output channels of the data logger. For instance in this study, the 4 channel data logger used, had one channel dedicated to the hammer (also known as the *reference channel*) and the second channel was connected to the uniaxial accelerometer. This data logger also had the capacity to connect to a Shaker.

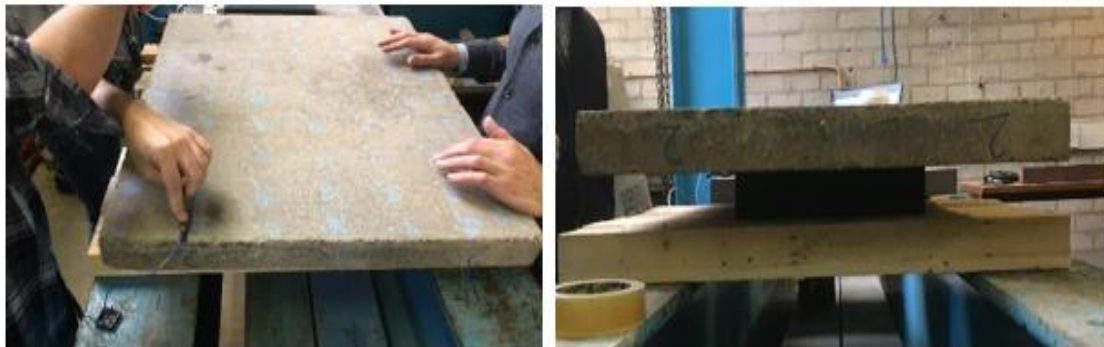
Figure 5-12: Test 01. Single 'robust' concrete slab, supported on ETHAFOAM 220.

Modal analysis was carried out with the concrete slab supported on a block of ETHAFOAM 220. Conventional setup for the excitation of slab was employed (Figure 5-12). A small impact hammer (D86C03) with the sensitivity of 2.25mV/N was connected to the force channel (reference) of the 4channel data logger. The blue tip was selected due to its high stiffness properties. For the response measurement a triaxle piezoelectric accelerometer with a sensitivity of 101.4907mV/N was connected to the output channel. The data logger was connected to a PC and operation took place via the dedicated software, LMS Test.Lab 17 (LMS 2017).

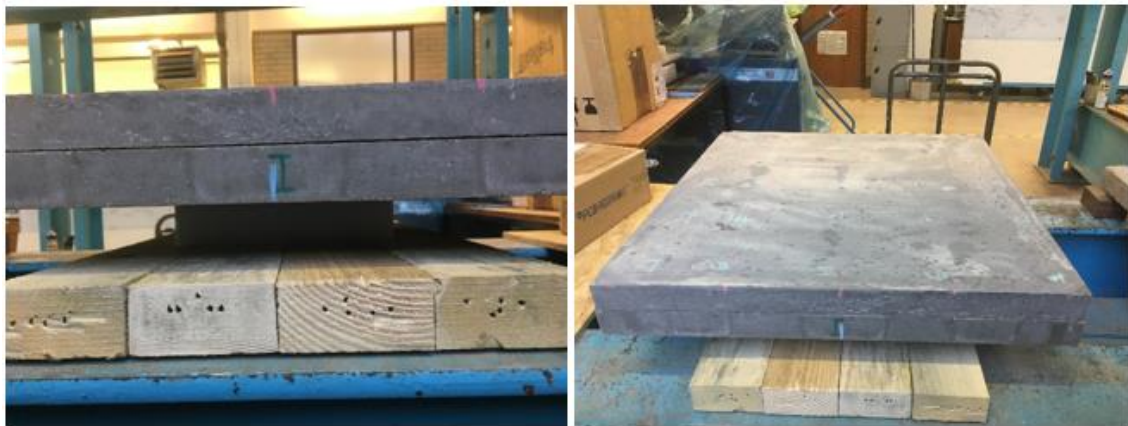
Figure 5-18: Test 02. Two slabs 'fully-debonded', supported on ETHAFOAM 220.

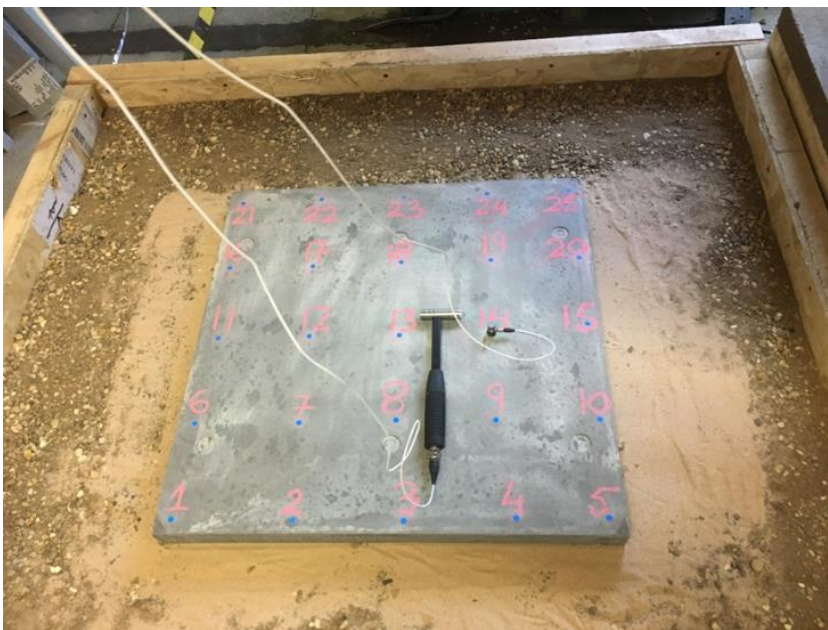
Figure 5-24: Test 03. Single ‘robust’ concrete slab, supported on subgrade.

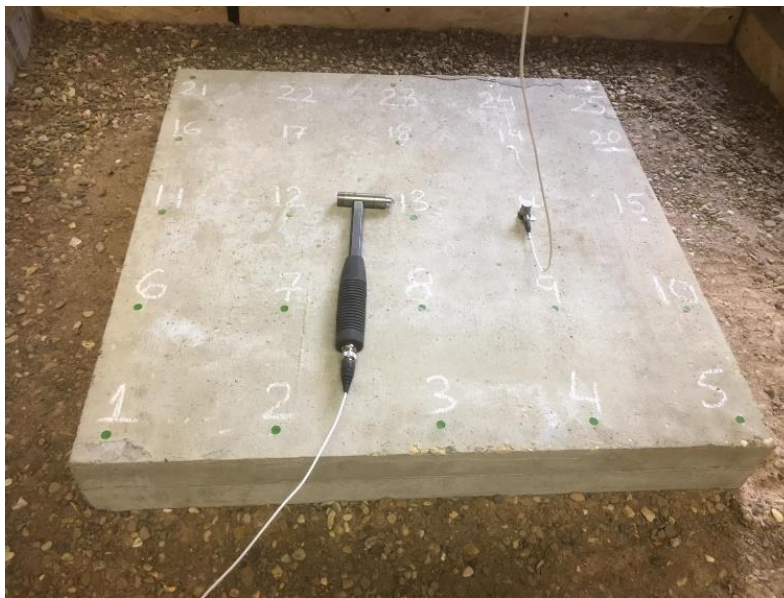
Figure 5-29: Test 05. Two slabs, 'full-debonded' supported on subgrade.

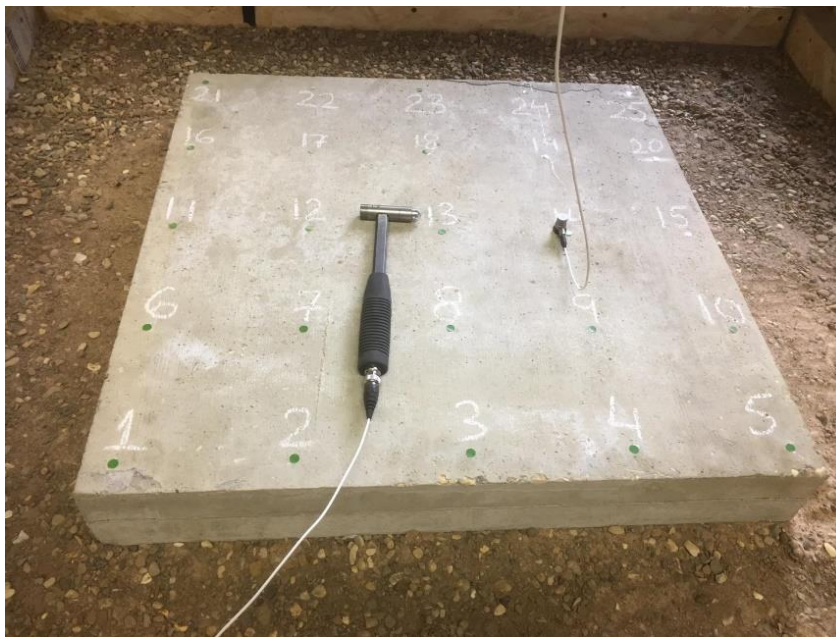
Figure 5-31: Test 06. Two slabs, 'fully-bonded' supported on subgrade.

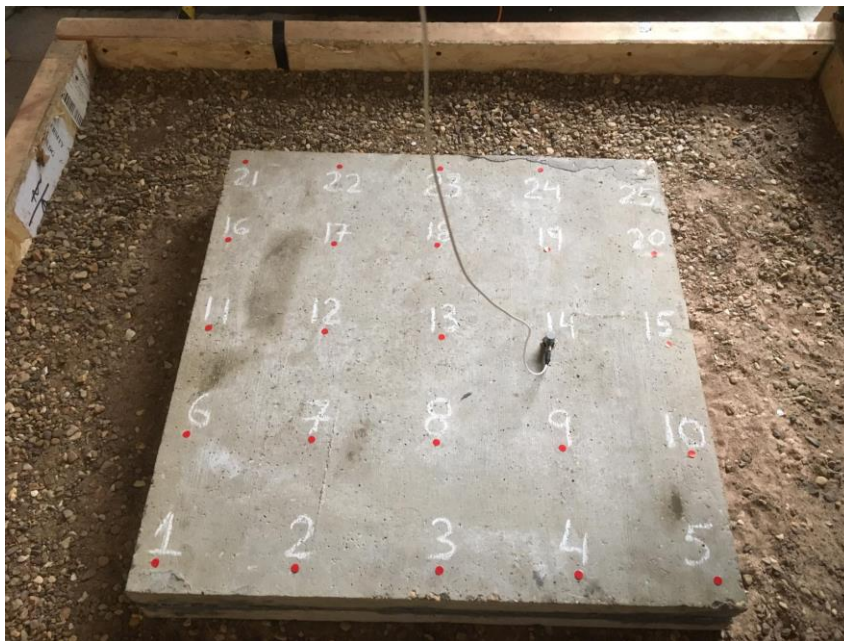
Figure 5-33: Test 07. Two slabs with '3 Delaminations' supported on Subgrade.
