Cracking Behavior of $\text{Gd}_2\text{Zr}_2\text{O}_7/\text{YSZ}$ Multi-Layered Thermal Barrier Coatings Deposited by Suspension Plasma Spray

Abstract: A new multi-layered thermal barrier coating system (TBCs) containing gadolinium zirconate (GZ, $\text{Gd}_2\text{Zr}_2\text{O}_7$) and yttria-stabilized zirconia (YSZ) was developed using suspension plasma spray (SPS) to improve the overall thermal cycling performance. This study focuses on the cracking behavior of the GZ/YSZ TBC after thermal exposure to find out the key factors that limit its lifetime. Different cracking behaviors were detected depending on the thermal treatment condition (i.e., horizontal cracks within the ceramic layer and at the thermally grown oxide (TGO)/YSZ interface) which can be related to stresses developed through thermal expansion mismatch and increased TGO thickness beyond a critical value, respectively. A reduction in hardness of bond coat (BC) was measured by nanoindentation and linked with the thermally activated grain growth mechanism. The hardness and elastic modulus of ceramic layers (GZ and YSZ) showed an increased trend after treatment that contributed to the interfacial cracks.

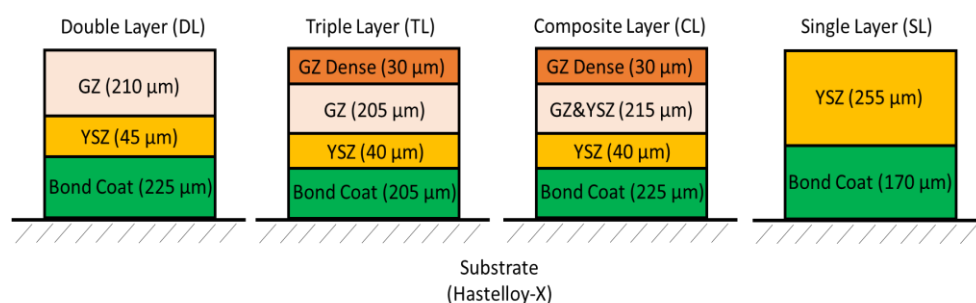
Figure 1. Schematic representation of the investigated multilayer and single layer TBC.

In this study, four TBC systems were deposited by suspension plasma spray (SPS) (Figure 1). (1) Double layer (DL) TBC comprising Gd₂Zr₂O₇ and YSZ layers. (2) Triple layer (TL) TBC consisting of a dense GZ top layer that can provide better resistance to CMAS attack and erosion, GZ intermediate layer, and YSZ base layer. (3) Composite layer (CL) TBC that include a dense GZ top layer, GZ + YSZ composite intermediate layer, and YSZ base layer. (4) Single layer (SL) TBC composed of YSZ as a benchmark. The performance and durability of these coatings were assessed with a focus on the fracture toughness, erosion performance, thermal conductivity, and thermal shock lifetime [7,8,27,41,42]. All the multi-layered TBCs had a longer thermal cyclic life compared to single layer (SL) TBC. The composite layer (CL) has relatively better fracture toughness and erosion performance as compared to triple layer (TL) TBC. This study is a continuous work with in-depth investigations on the failure analysis of these multilayered TBCs using a combination of SEM/EDX/EBS/D/XRD and nanoindentation techniques to better understand the failure behavior of multilayered TBCs aiming for a better coating design.

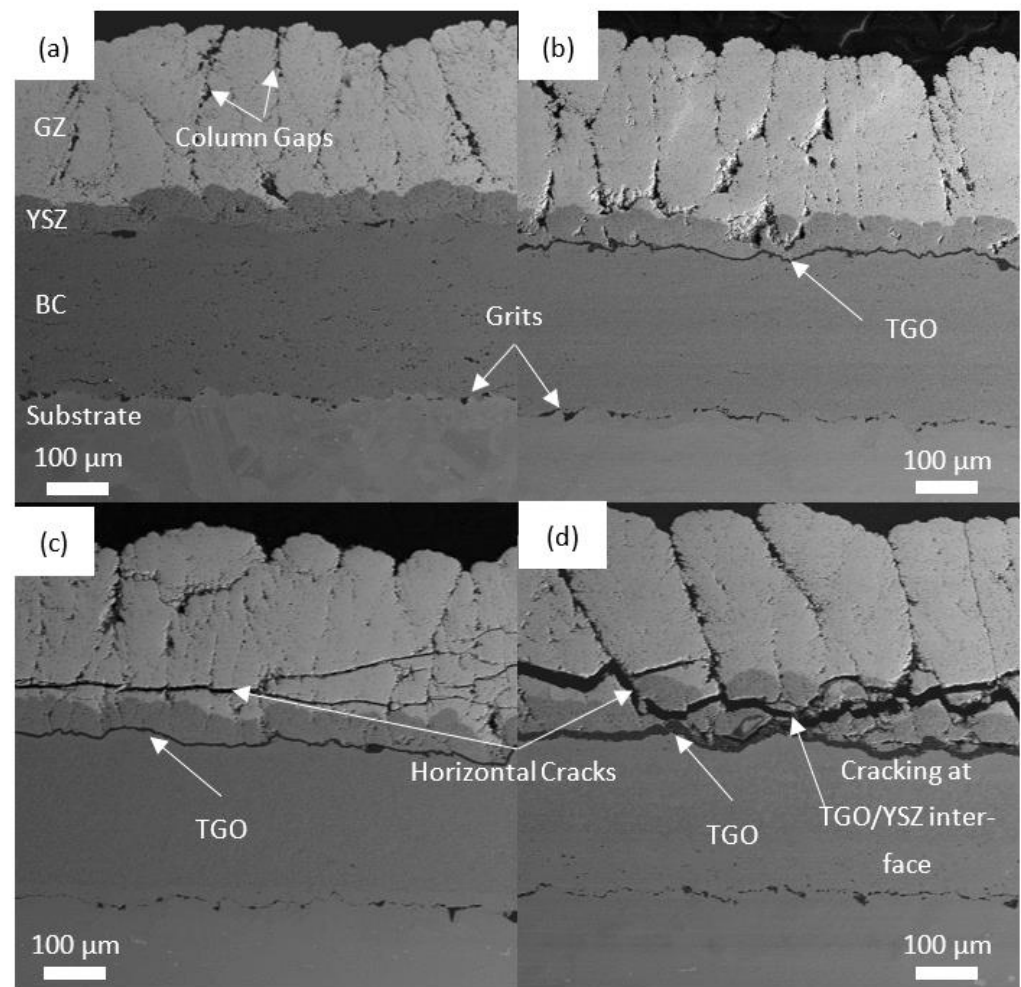
Figure 2. BSE of the double layered TBC (a) as sprayed, (b–d) 1, 10, and 100 h, respectively.

The cross-sectional SEM images of DL samples revealed a columnar microstructure (Figure 2a–d). The thickness measurements for the DL samples layers (GZ/YSZ/BC) were determined using Image J software [45]. The top layer (i.e., GZ) thickness was measured to be 210 ± 16.8 μm , whereas the YSZ was measured to be 43.2 ± 5.3 μm and the BC was 225.5 ± 11.2 μm . Figure 2c reveals that horizontal cracks developed within the GZ segment at nearly 60 μm away from TGO scale after 10 h. While Figure 2d illustrates cracking of DL-TBCs through the TGO/YSZ interface after 100 h. Furthermore, linking up of the cracks developed within the GZ layer, and the cracking that occurred through the YSZ/BC interface resulted in delamination of the coating as shown in Figure 2c.

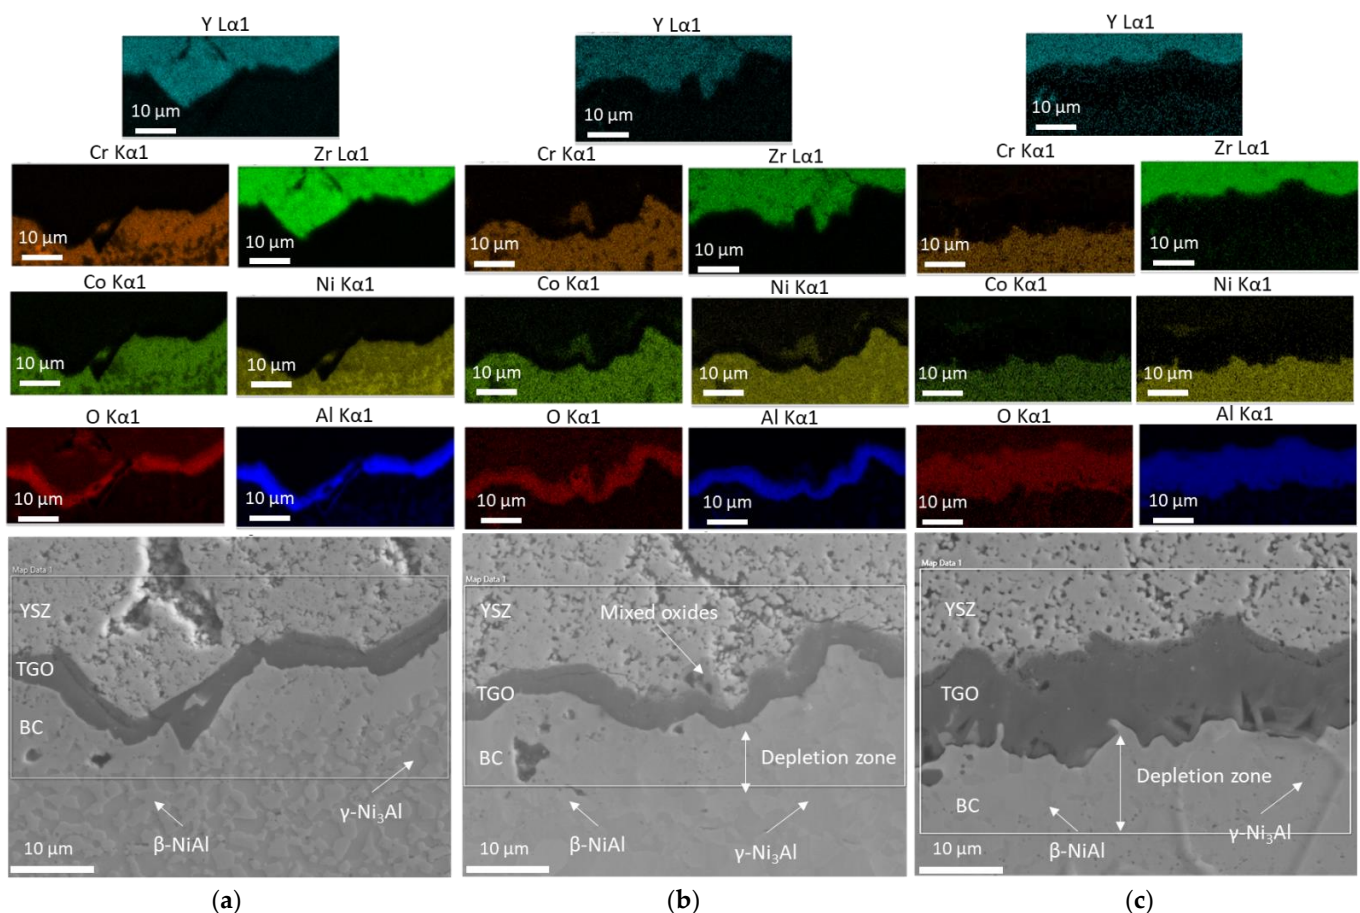
Figure 3. EDS elemental mapping of TGO region for the double layered DL TBC after (a) 1 h, (b) 10 h, (c) 100 h.

The TGO thickness for 1, 10, and 100 h were measured to be $3.2 \pm 0.4 \mu\text{m}$, $3.4 \pm 0.5 \mu\text{m}$, and $10 \pm 1.4 \mu\text{m}$, respectively (Figure 3). Dong et al. [46] investigated the TGO thickness effect on the failure of plasma-sprayed TBCs and reported that the critical TGO thickness was nearly $6 \mu\text{m}$. The cracking behavior (Figure 2c) is recognized at a TGO thickness below the critical value and can be attributed to thermally induced residual stresses developed within TBCs during thermal loading due to thermal expansion mismatch [46]. For instance, the thermal expansion coefficient (CTE) of ceramic layers (about $10.4 \times 10^{-6} \text{ K}^{-1}$ and $11 \times 10^{-6} \text{ K}^{-1}$ for GZ and YSZ, respectively [9]) is typically lower than that of both the substrate and bond coat (about $15 \times 10^{-6} \text{ K}^{-1}$ [47]), which leads to higher thermal stresses in the TBC system [46,48]. The developed horizontal cracks can directly contribute to spallation and delamination of the coatings from the substrate surface. Beyond critical thickness of TGO, this layer results in strain incompatibilities and mismatch stresses, thereby the TBCs system is subjected to damage and final delamination. The alternate failure behavior (Figure 2d) is evident at a TGO thickness greater than the critical value. This failure can be related to the oxidation-induced volume increase of the TGO and the variances in the thermal expansion between TGO and the remaining TBC layers [46,48]. It is known that TGO growth is one of the most important factors that lead to the failure of TBCs due to the induced stress and strain fields. The growth of TGO layer considerably changes stress intensity and its distribution [46]. For instance, compressive stresses are present at the valleys and tensile stresses are present at the peaks with thin TGO, whereas the nature of the stresses in the ceramic layer (YSZ) valley alternates from compression to tension as TGO becomes thicker. Hence, TGO growth can significantly affect the interface

structure between the top and bond coat leading to reduced interfacial adhesion strength and delamination of the coatings [46]. Depending on temperature and time, the TGO scale grows as the aluminum in β -NiAl phase depletes, which leads to phase transformation within the bond coat from β to γ/γ' phases. Also, as a result of β -NiAl phase depletion, metal oxides such as Cr_2O_3 , NiO, CoO, or spinel $(\text{Co, Ni})(\text{Cr, Al})_2\text{O}_4$ can be formed [28]. The EDS elemental mapping for the TGO regions at different thermal exposure duration of DL-TBC samples are shown in Figure 3a–c. Based on the EDS analysis, alumina (i.e., Al_2O_3) is the dominant metal oxide in the TGO layer, whereas very little spinel or mixed oxide was present (overlapped Co, Cr, Ni, and O trace) just above the continuous alumina layer in the center (Figure 3b). The same observations were detected for the other TBC samples (i.e., triple, composite, and single layer structures) investigated in this research work. Therefore, EDS analysis and the related discussion are only presented in this section for the DL-TBC samples.

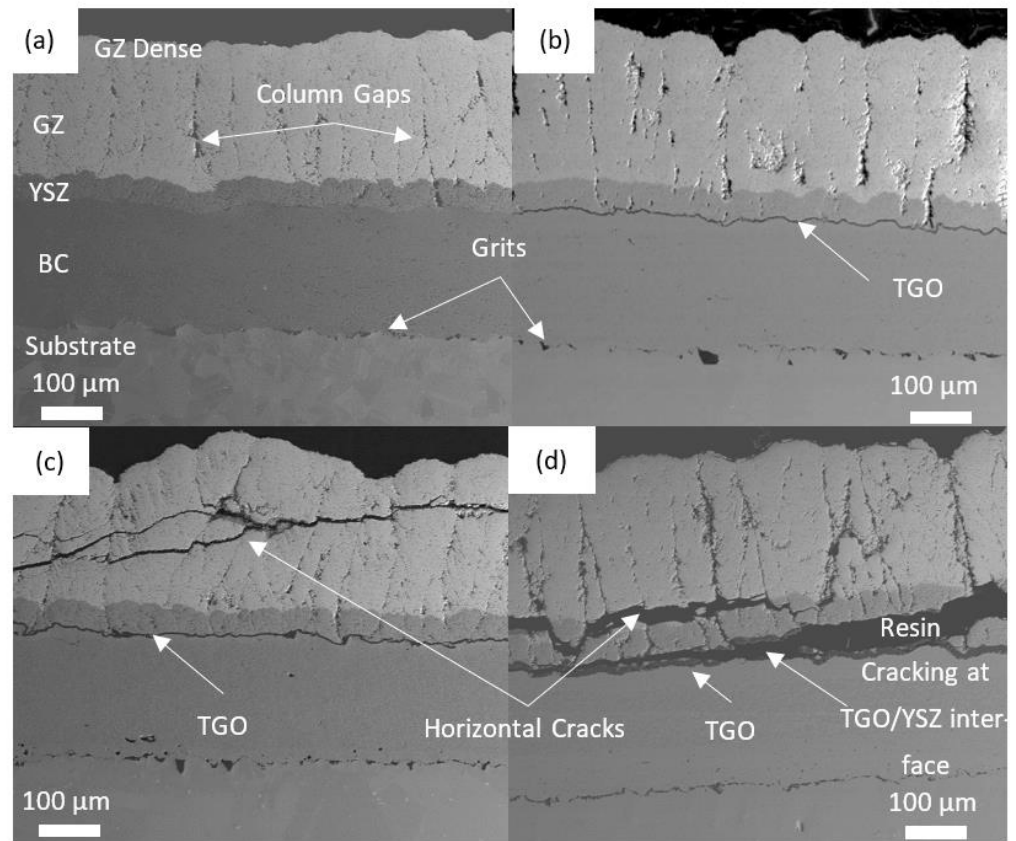
Figure 4. BSE of the triple layered TL TBC (a) as sprayed, (b–d) 1, 10, 100 h, respectively.

As seen in Figure 4a–d, the TL-TBC samples comprise a dense GZ top layer, which can be characterized by non-columnar, micro-gaps-free, and a relatively brighter contrast region. A columnar microstructure of the GZ and YSZ layers with in-between column gaps can be seen. The thickness of the GZ dense layer was measured to be $28.8 \pm 2.8 \mu\text{m}$. The intermediate GZ segment has a thickness of $203.4 \pm 10.4 \mu\text{m}$, whereas the thickness of YSZ (with dark contrast under BSE) is $41.8 \pm 4.3 \mu\text{m}$, and the bond coat is $205.2 \pm 9.5 \mu\text{m}$. The thickness of the TGO scale after 1, 10, and 100 h is $3.1 \pm 0.5 \mu\text{m}$, $3.4 \pm 0.7 \mu\text{m}$, and $10.5 \pm 1.3 \mu\text{m}$, respectively. Furthermore, horizontal cracking occurred for the TL-TBC system after being thermally loaded for 10 h (Figure 4c). These cracks were developed within the intermediate GZ layer and at a distance of nearly $130 \mu\text{m}$ away from the TGO

scale. Figure 4d shows the failure of TL-TBC after 100 h which can be recognized by cracking at the TGO/YSZ interface coupled with horizontal cracks developed within the GZ segment at approximately 60 μm away from the TGO scale. Delamination of the coating was observed after 100 h as the TGO thickness exceeded the critical value.

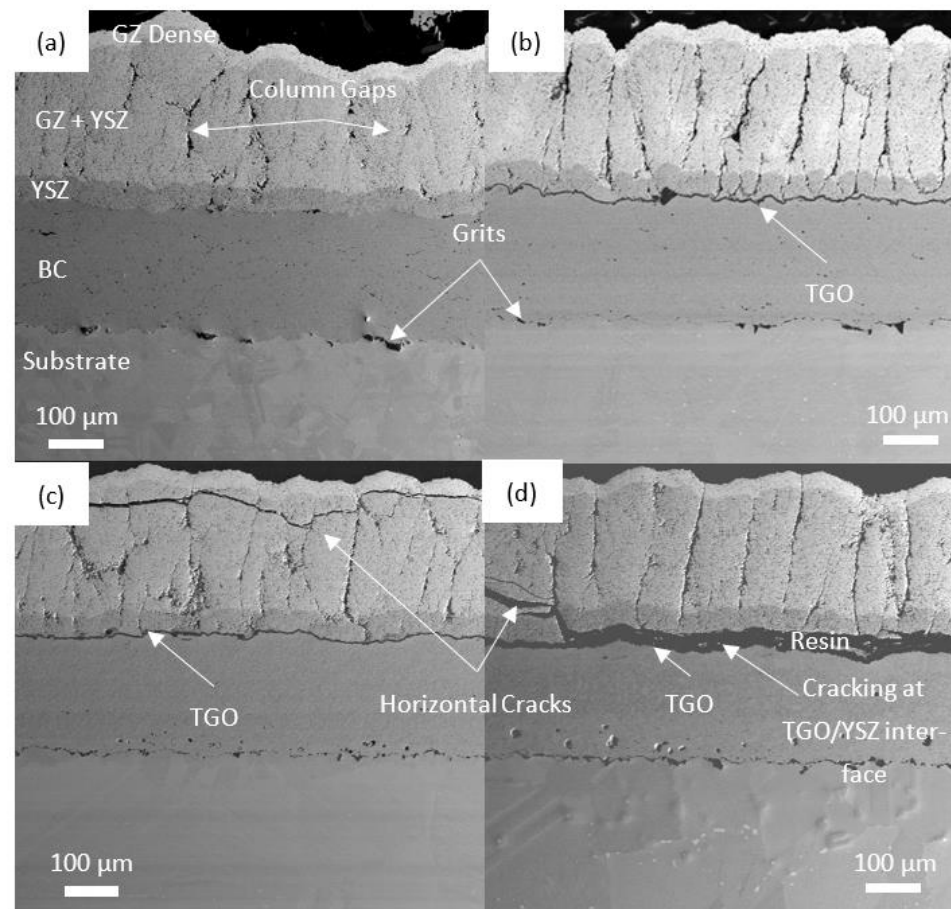
Figure 5. BSE of the composite layered TBC (a) as sprayed, (b–d) 1, 10, 100 h, respectively.

Figure 5a–d shows the composite TBC samples (GZ dense/GZ + YSZ/YSZ). The GZ dense top layer appears to have bright contrast under BSE with a thickness of $27.6 \pm 4.2 \mu\text{m}$. The intermediate composite layer (GZ + YSZ) was measured to be $214.1 \pm 25.3 \mu\text{m}$. Whereas the thickness of YSZ base layer and metallic bond coat are $41.5 \pm 4.8 \mu\text{m}$ and $224.7 \pm 9.6 \mu\text{m}$, respectively. The thickness of TGO after 1, 10, and 100 h are $3.1 \pm 0.3 \mu\text{m}$, $3.6 \pm 0.6 \mu\text{m}$, and $9.7 \pm 1.1 \mu\text{m}$, respectively. The CL-TBC sample after 10 h experienced failure that can be seen as horizontal cracks generated within the intermediate GZ + YSZ layer (Figure 5c) 180 μm away from the TGO layer. After 100 h, the CL-TBC sample reveals cracking and delamination at the interface between YSZ and TGO layers.

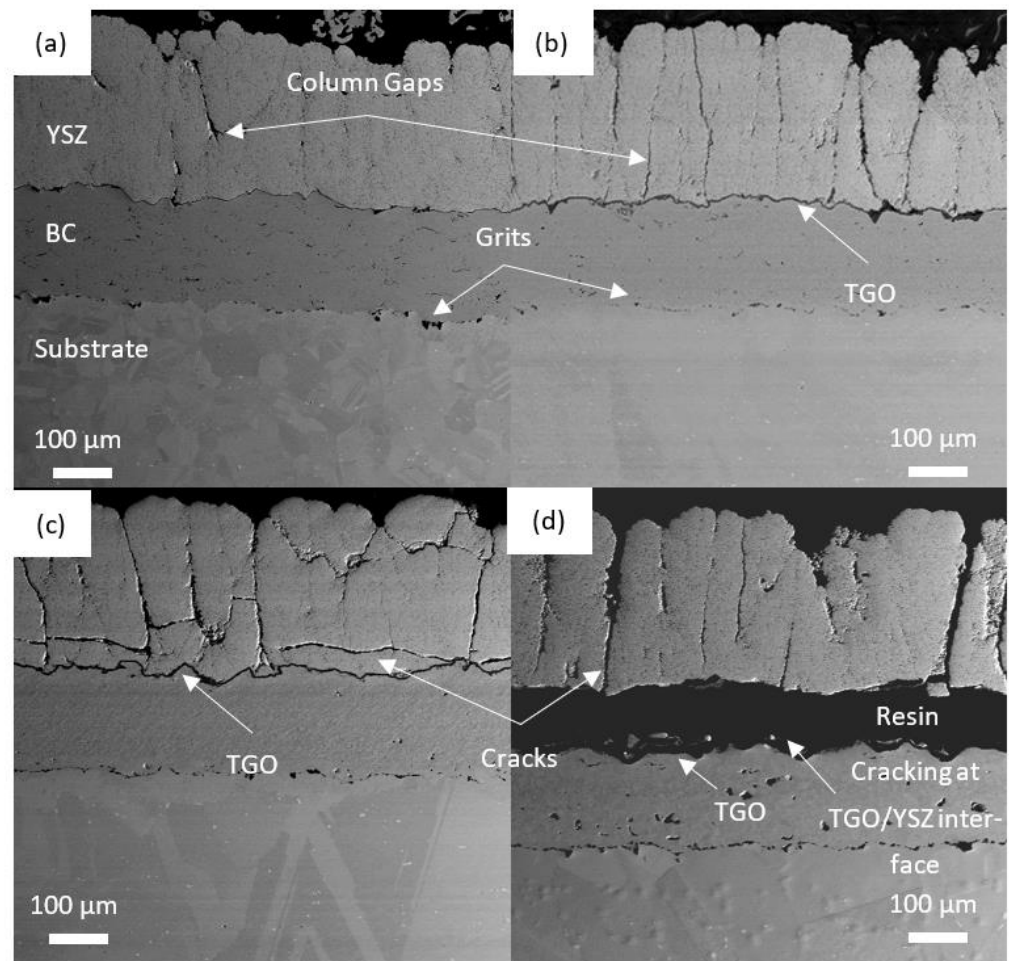
Figure 6. BSE of the single layered TBC (a) as sprayed, (b–d) 1, 10, 100 h, respectively.

For comparison, Figure 6a–d shows the thickness of single layer YSZ is $256.1 \pm 21.5 \mu\text{m}$ with a bond coat of $171.6 \pm 8.8 \mu\text{m}$, with a TGO thickness of $3 \pm 0.5 \mu\text{m}$, $3.4 \pm 0.5 \mu\text{m}$, and $11.4 \pm 1.4 \mu\text{m}$, respectively. After 10 h, a horizontal crack is observed in YSZ which is $60 \mu\text{m}$ from TGO (Figure 6c). Also, vertical cracks formed at the YSZ columnar interfaces can be observed, which can influence the thermal barrier efficiency. After 100 h, cracks are observed at the TGO/YSZ interface which leads to final delamination of the coatings (Figure 6d) with a TGO thickness above critical value.

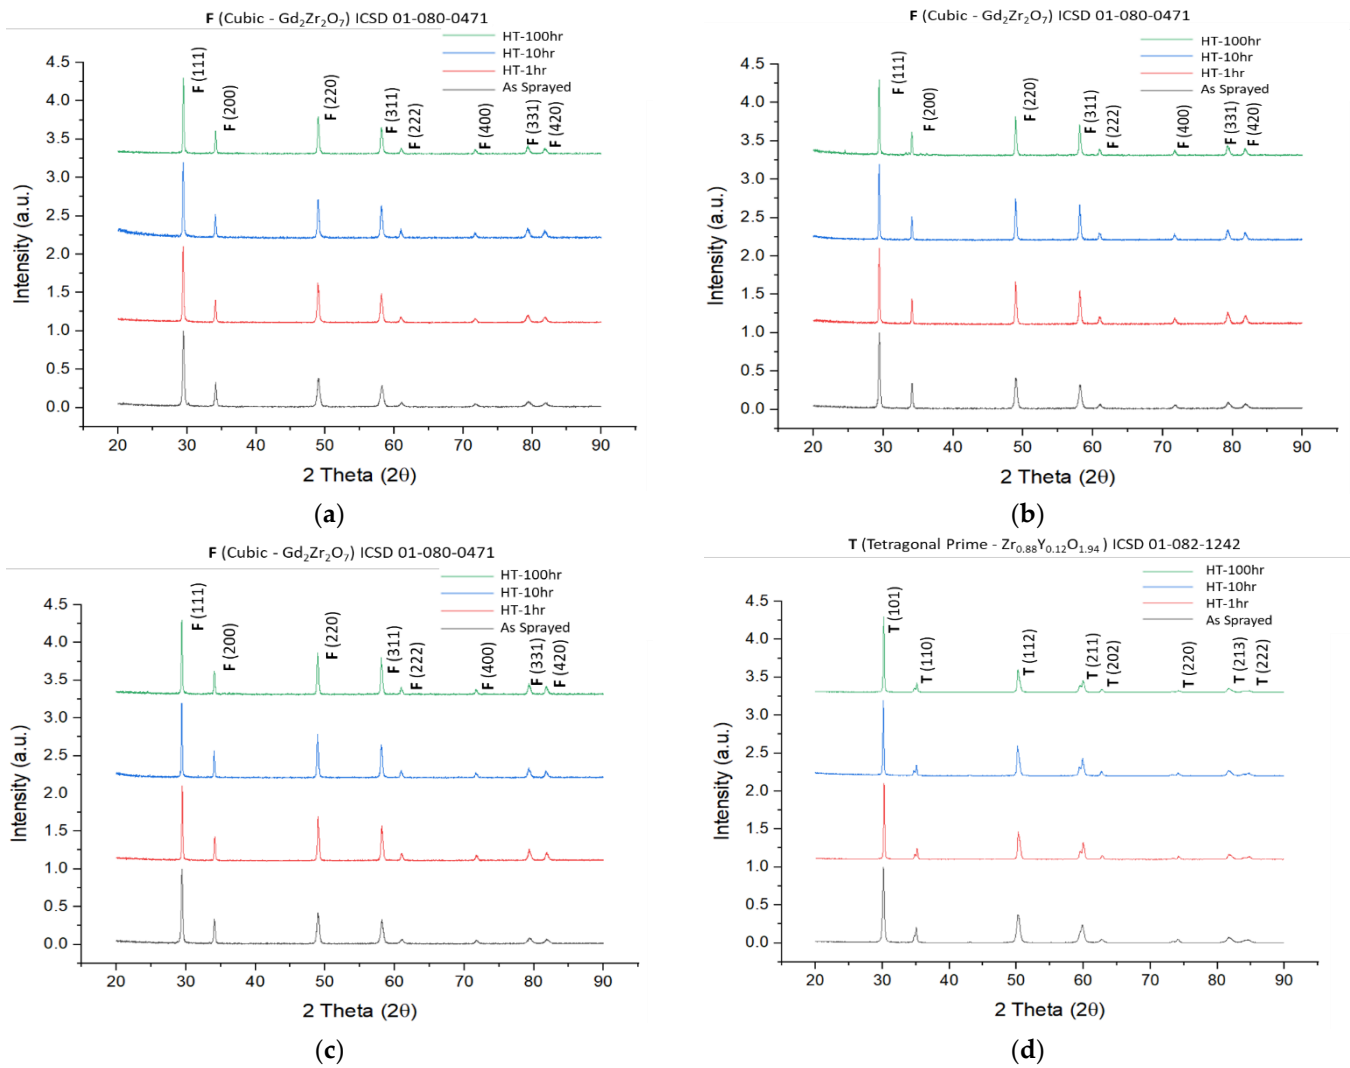
Figure 7. XRD of as-sprayed and heat-treated TBC samples (a) double layer, (b) triple layered, (c) composite layer, (d) single layer.

Good stability of the cubic GZ phase can be noted alongside all the recorded XRD patterns (Figure 7a–c). For the SL-TBCs, t' -YSZ decomposed into tetragonal (t) and cubic (c) phases after exposure to the applied thermal loading duration (see Figure 7d), which can be recognized as one peak at 35 and 60 2 theta transformed to two peaks as shown in Figure 7d, and further explanation can be found in Bai et al. [49].

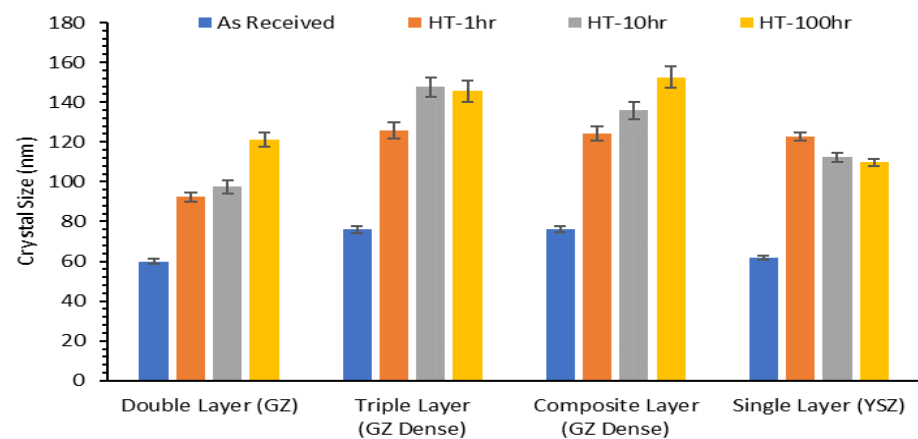
Figure 8. Crystallite sizes evolution of the investigated TBC systems (as-sprayed and heat-treated) obtained by Rietveld Refinement of the XRD patterns.

In addition, all peaks appear to be sharper after treatment indicating crystallite growth (Figure 8). For DL-TBC samples, crystallite growth in GZ layer is observed to be 60 ± 1.3 nm at the as-sprayed condition and increased to be almost doubled (121.1 ± 3.4 nm) after 100 h. The same behavior was detected for TL-TBC samples as the crystallite size of GZ dense layer was measured to be 76 ± 1.7 nm for the as-sprayed condition and increased approximately two fold after heating for 100 h, 145.6 ± 5.4 nm. The crystallite size of CL-TBC specimens (GZ dense layer) for the as-sprayed and the 100 h treatment condition were determined to be 76.2 ± 1.7 nm and 152.5 ± 5.4 nm, respectively. For the SL-TBC samples, the crystallite size of YSZ layer (as-sprayed condition) was 61.8 ± 0.8 nm and increased to 122.6 ± 2 nm after 1 h, and no significant changes afterwards.

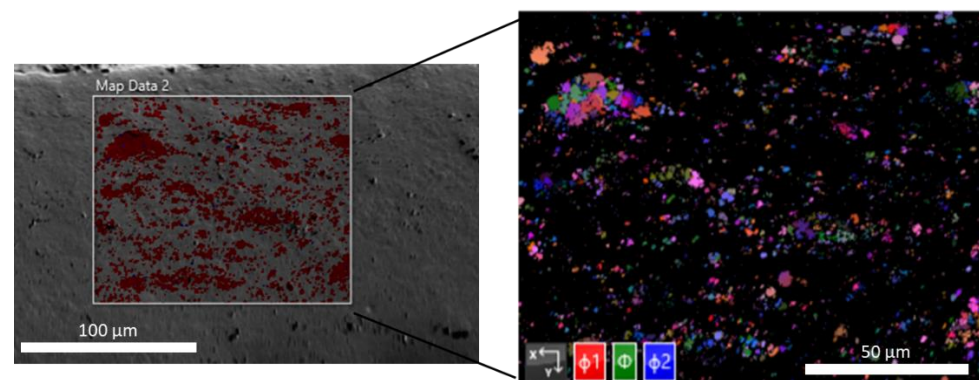
Figure 9. EBSD (Euler map) of bond coat for the as-received sample.

EBSD was conducted to analyze grain size evolution, grain orientation, and phase analysis after thermal treatment. EBSD analysis was attempted on the as-sprayed samples; however, Kikuchi patterns for the layers of as-sprayed samples were too weak to be indexed (see Figure 9 as an example). This may be attributed to large residual stresses developed in the coating during the deposition process, its nano crystallinity structure, and some micro-strain retained within the coatings. Since HVAF was used to deposit the bond coat, the MCrAlY powder is deposited in a semi-molten state, with some of larger particles below their melting point. Deposition with high kinetic energy leads to a highly distorted structure. Therefore, it needs the initial thermal energy from the heat treatment to crystallize. Whereas for the as-received ceramic layers (i.e., YSZ and GZ), no clear EBSD mapping can be generated. This can be attributed to the complex stresses developed within the as-sprayed coating due to rapid cooling from plasma state temperature to room temperature, resulting in difficult EBSD mapping.

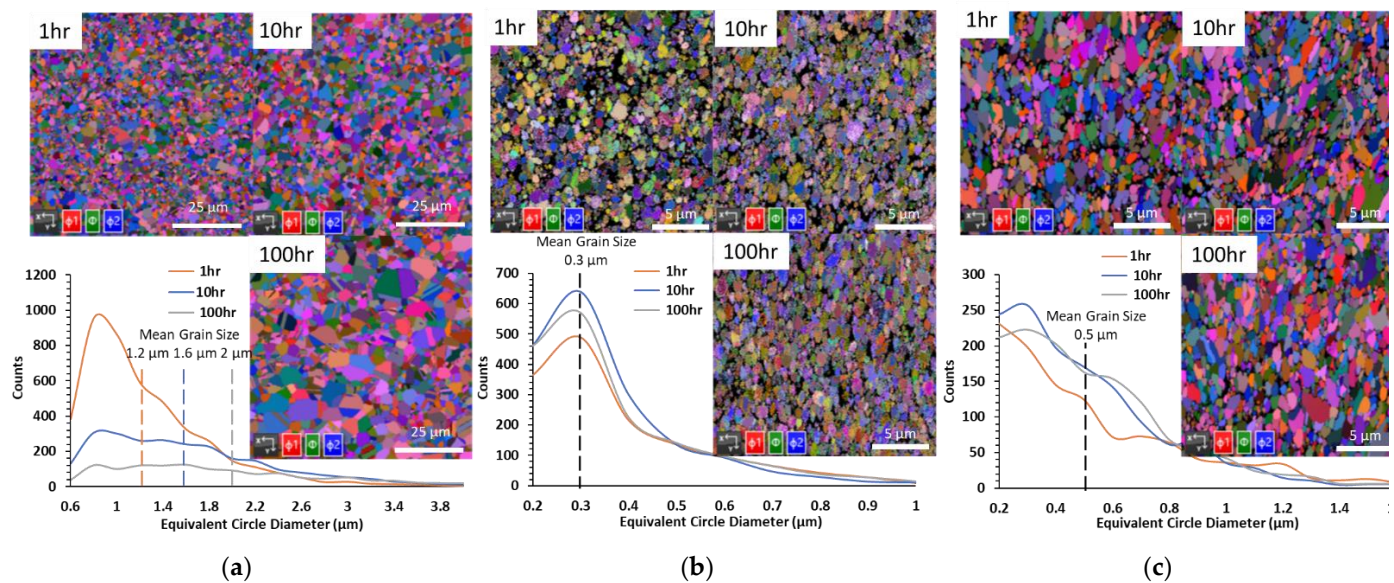
Figure 10. Grain size distribution and orientation for the double layer TBC (a) bond coat, (b) YSZ, (c) GZ layers.

After heating, the TBC samples exhibited improved crystallinity, and EBSD mapping can be generated. The grain size distribution and orientation based on Euler angle maps for the DL-TBC after exposure for thermal loading of 1150 °C for 1, 10, and 100 h are shown in Figure 10. For the bond coat (Figure 10a), it was found that average grain size (dashed line) increased from $1.2 \pm 0.6 \mu\text{m}$ to $1.6 \pm 0.8 \mu\text{m}$ and $2 \pm 1.3 \mu\text{m}$, respectively. Also, the count of detected grains shown in the line graph (see Figure 10a), reduced from increased treatment duration from 1 h (4356 grain) to 100 h (1349 grain), is another indication for the induced grain-growth mechanism. We can conclude that application of thermal loading to the DL-TBC contributed to grain growth and was a prime mechanism aside from the grain formation mechanism. Furthermore, the EBSD maps obtained for the BC showed a balanced phase distribution of the β -phase and γ/γ' -phase; however, at the 100 h condition, a noticeable increase in the γ/γ' -phase percentage was detected. This phase transformation from β to γ -phase is accompanied with volume changes that can contribute to the failure of the TBC system [50]. For GZ/YSZ (Figure 10b,c), new grain formation is the dominant mechanism rather than grain growth as the average grain size (dashed line) remains at $0.3 \mu\text{m}$ and $0.5 \mu\text{m}$, respectively. While the count of grains captured by EBSD scanning for YSZ at 1, 10, and 100 h increased from 1455 to 1740 and 1652 grains, respectively, the GZ grain count for 1, 10, and 100 h treatment duration were found to be 1105, 1344 and 1327, respectively. The total grain counts for ceramic layers were notably increased after 10 h and then stabilized after 100 h.

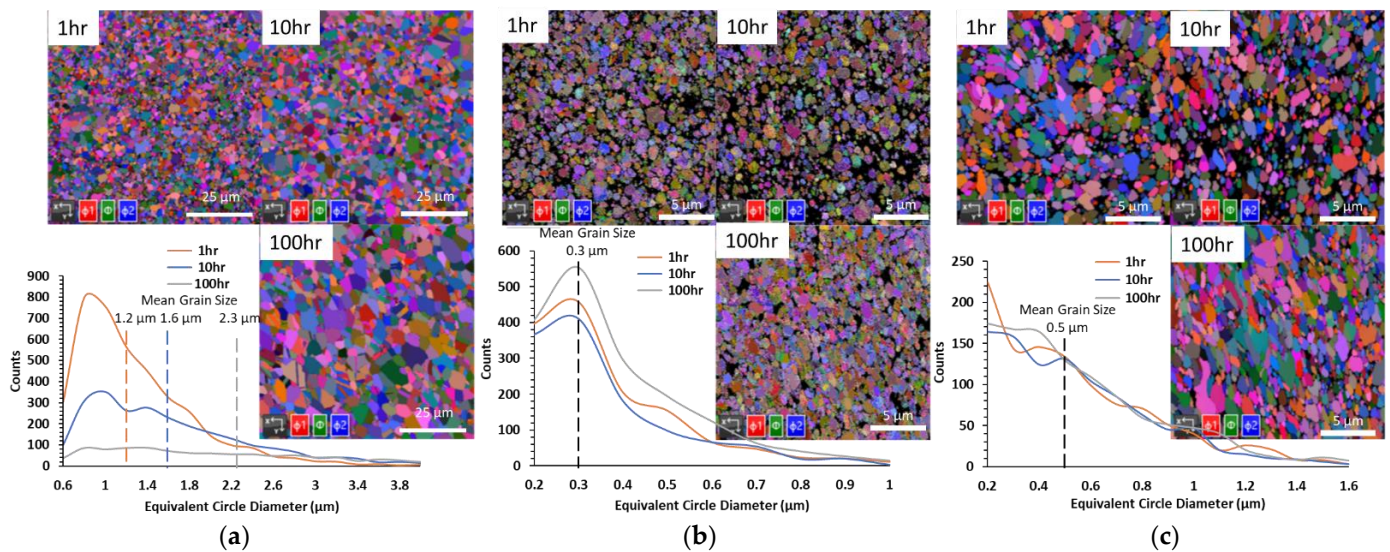
Figure 11. Grain size distribution and orientation for the triple layer TBC (a) bond coat, (b) YSZ, (c) GZ layers.

For TL-TBC (Figure 11a–c), the grain size determined through EBSD analysis for the bond coat showed increased trends corresponding to the extended heating duration as shown in the line graph in Figure 11a. The average grain size measurement (represented by dashed lines in Figure 11a) obtained for the 1, 10, 100 h conditions are $1.2 \pm 0.6 \mu\text{m}$, $1.6 \pm 0.8 \mu\text{m}$, and $2.3 \pm 1.4 \mu\text{m}$, respectively. The metallic bond coat experienced grain coarsening that confirmed by the reduction in the count of indexed grains for the same recorded EBSD mapping area (grain count was 3947 and 1088 at 1 and 100 h, respectively), see Figure 11a. Mostly, the bond coat attained improved the crystalline structure after being thermally treated for 1 h, and further exposure for the thermal load contributed to the growth of the formed gains. The grain size distribution for the YSZ ceramic layer revealed insignificant changes between 1 and 10 h conditions; however, at the 100 h condition, a noticeable increase in the number of indexed grains were detected as presented in the line chart in Figure 11b. The average grain size for the YSZ layer was determined to be $0.3 \mu\text{m}$. The grain size distribution (line graph, Figure 11c) for the GZ layer demonstrated an unnoticeable effect for the elongated exposure to heating load. However, it can be seen clearly from the Euler maps that grain growth is significant at the 100 h treatment condition. Also, the 10 h map shows black detected regions (unindexed grains), that may result from localized residual stresses. These unindexed regions might contribute to the unrealistic grain size distribution. The average grain size for the GZ layer were measured to be $0.5 \mu\text{m}$, represented by the dashed line in Figure 11c. The orientation analysis from Euler maps, demonstrated that the YSZ and GZ grains have no preferred orientation.

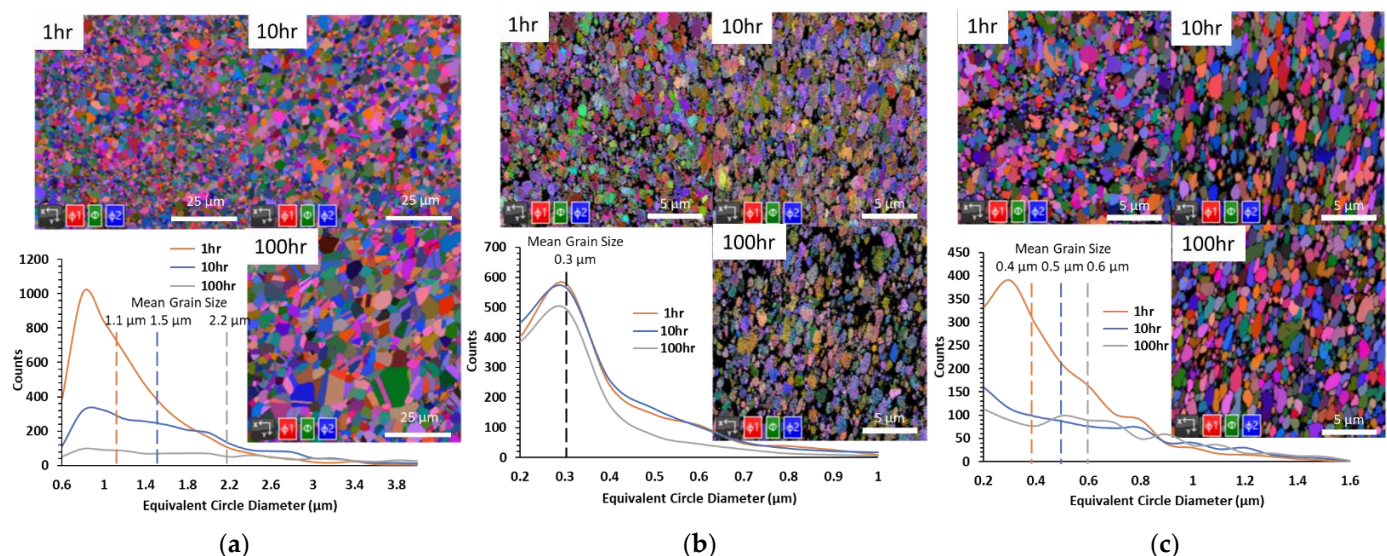
Figure 12. Grain size distribution and orientation for the composite layer TBC (a) bond coat, (b) YSZ, (c) GZ + YSZ layers.

For CL-TBC (Figure 12), the average grain size (dashed lines) for the bond coat after heating for 1, 10, and 100 h was $1.1 \pm 0.6 \mu\text{m}$, $1.5 \pm 0.8 \mu\text{m}$, and $2.2 \pm 1.5 \mu\text{m}$, respectively. The number of grains recorded by EBSD Maps were reduced at 100 h condition (1119 grain) as compared to the 10 and 1 h treatment durations (2505 and 4392, respectively). The GZ + YSZ composite layer showed grain growth (Figure 12c) with the average grain size of $0.4 \pm 0.3 \mu\text{m}$, $0.5 \pm 0.4 \mu\text{m}$, and $0.6 \pm 0.4 \mu\text{m}$, respectively. Also, the grain count drops from 1705 at 1 h to below 800 grains at 10 and 100 h as another indication for the induced grain growth. While there is no significant change in YSZ layer (Figure 12b) as the average grain size of YSZ remains as $0.3 \mu\text{m}$. The orientation analysis from Euler maps demonstrated that the YSZ and GZ + YSZ grains have no preferred orientation.

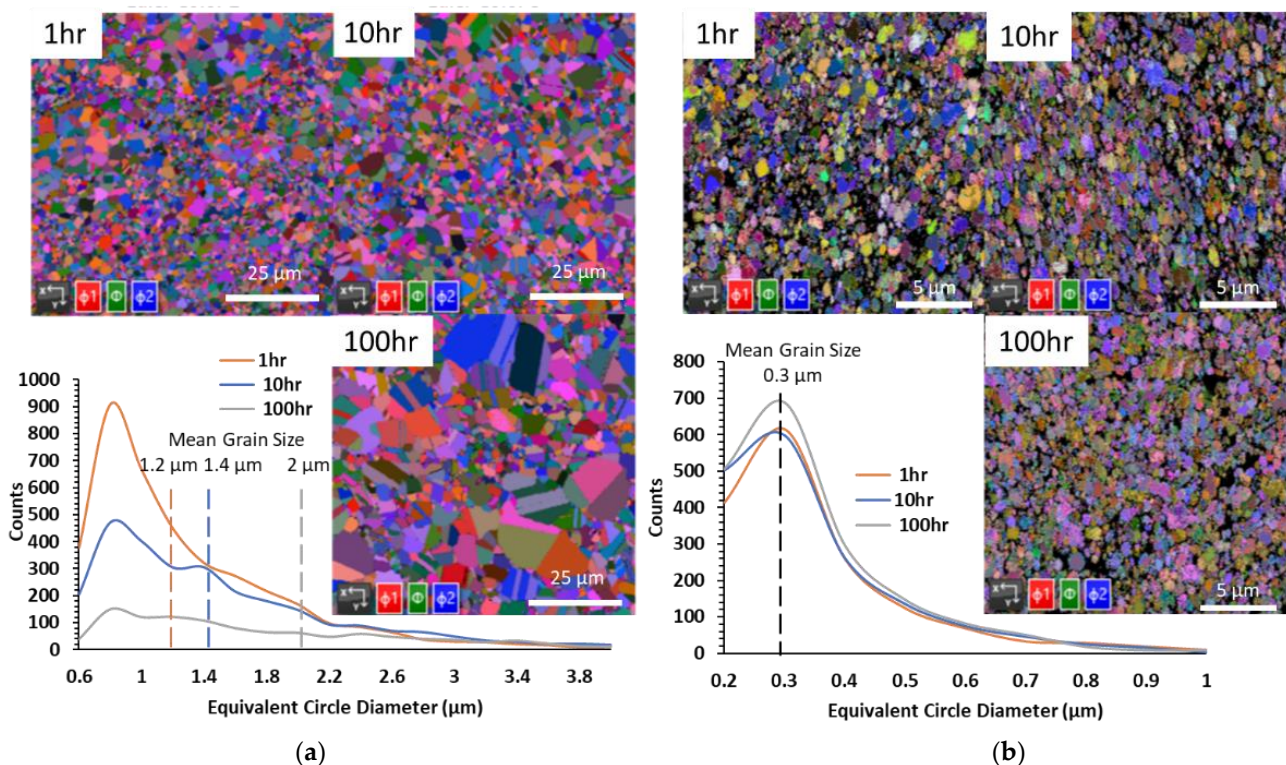
Figure 13. Grain size distribution and orientation for the single layer TBC (a) bond coat, (b) YSZ layers.

For the SL TBC (Figure 13), the average grain size of BC is $1.2 \pm 0.7 \mu\text{m}$, $1.4 \pm 0.8 \mu\text{m}$, $2 \pm 1.5 \mu\text{m}$, respectively, with no significant changes in YSZ (Figure 13b) with the average grain size being $0.3 \mu\text{m}$. The Euler maps show no preferred orientation for the YSZ grains.

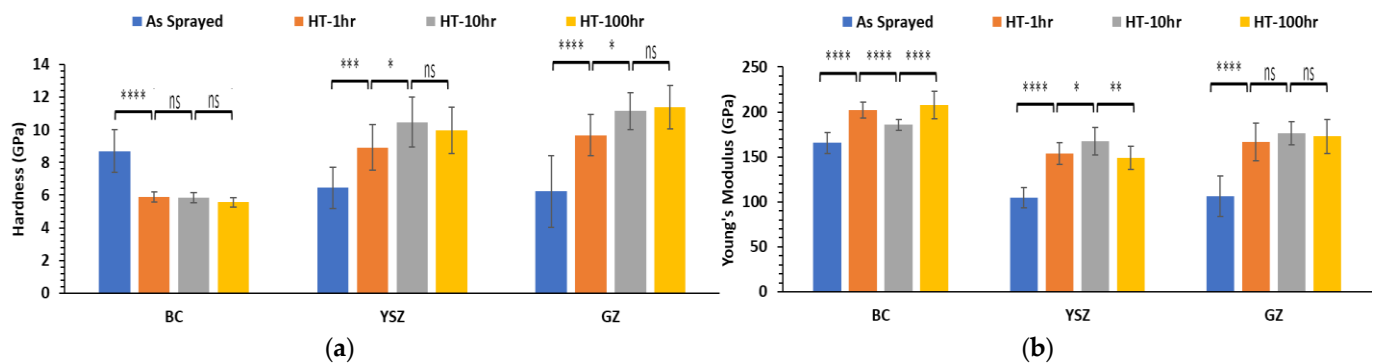
Figure 14. Nanoindentation data of the double layer TBC before and after thermal treatment (a) hardness (H), (b) elastic modulus (E). Asterisks indicate a statistical difference (* $p < 0.05$, ** $p < 0.01$, *** $p < 0.001$, **** $p < 0.0001$, as obtained using Tukey test, which computes a confidence interval for the difference between two means).

The hardness and elastic modulus measurements obtained for the DL-TBC samples are shown in Figure 14. The average hardness of the bond coat was significantly reduced from 8.69 ± 1.31 GPa at the as-sprayed condition down to 5.88 ± 0.31 GPa after 1 h and remained stable afterwards (Figure 14a). The high hardness is caused by its heavily strained structure along with the high residual stress developed during the deposition process. The elastic modulus measurement of BC layer experienced fluctuating response to the heating conditions as shown in Figure 14b. The elastic modulus of BC varied between 165.8 GPa (as sprayed) to 207.4 GPa (100 h treatment). This variation can be correlated to the microstructure changes observed before, that is diffusion of aluminum out of BC resulted in the transformation from β -phase to γ phase, which is also reported by Vignesh et al. [51]. The hardness measurements for the ceramic layers (YSZ and GZ) revealed an increased trend at 1 and 10 h, whereas there was no significant change after 100 h (Figure 14a). The hardness of YSZ increased from 6.44 GPa to 10.47 GPa, whereas the GZ increased from 6.22 GPa to 11.14 GPa at as-sprayed and 10 h, respectively. The same tendency was observed for the elastic modulus measurements of the DL-TBC samples as presented in Figure 14b. For the YSZ layer, the elastic modulus varied between 104.7 and 167.1 GPa, as-sprayed, and 10 h conditions, respectively. While the modulus of GZ layer changed from 106.3 GPa (as sprayed) to 176.2 GPa (10 h condition) which agree well with Zou et al. [52], who studied the performance of the suspension plasma-sprayed YSZ-TBC with different bond coat systems (i.e., APS and HVOF) after isothermal treatment at 1150 °C.

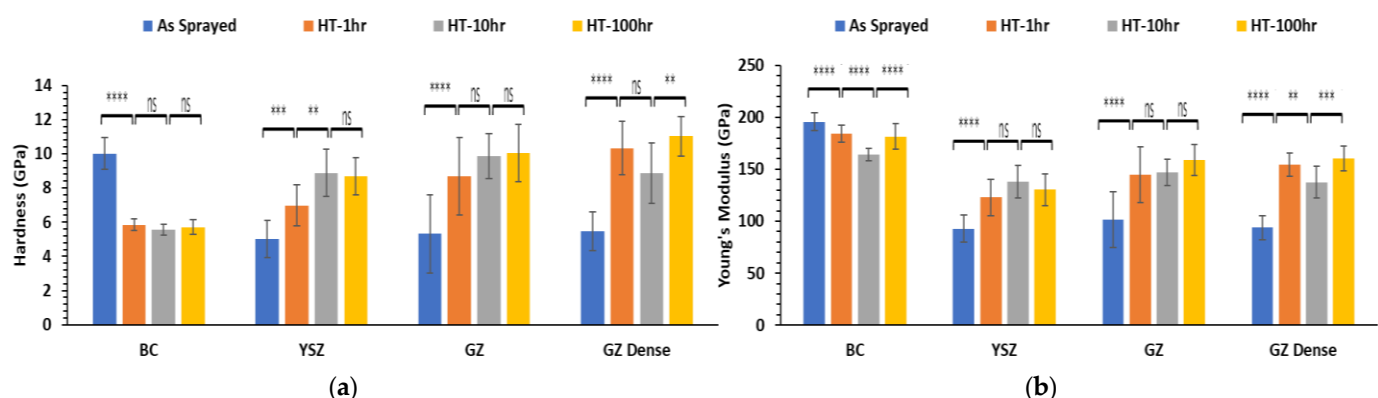
Figure 15. Nanoindentation data of the triple layer TBC before and after thermal treatment (a) hardness (H), (b) elastic modulus (E). Asterisks indicate a statistical difference (* $p < 0.05$, ** $p < 0.01$, *** $p < 0.001$, **** $p < 0.0001$, obtained using Tukey test, which computes a confidence interval for the difference between two means).

For TL TBC (Figure 15), similar behavior is observed in the bond coat as the previous one. Generally, there was an increase in hardness measurement for the ceramic layers (YSZ, GZ, and GZ dense) as compared to the as-sprayed state as shown in Figure 15a. For example, the hardness of the YSZ layer increased from 5.01 GPa (as sprayed) to 8.87 GPa (10 h treatment), whereas there was an unnoticeable change in hardness for the 100 h treatment sample referred to in the 10 h specimen. For the GZ layer, the hardness was raised to 8.7 GPa after the 1 h heating condition (as-sprayed hardness = 5.31 GPa), whereas elongated exposure to the heating temperature (i.e., 10 and 100 h) had an unremarkable effect on determined hardness values. The hardness measurement for the GZ dense layer fluctuated between 5.48 GPa and 11.02 GPa. The Young's modulus of the ceramic layers (YSZ, GZ, and GZ dense) increased after thermal treatment compared to the as-sprayed state (see Figure 15b). The elastic modulus for YSZ and GZ layer went up from 92.9 GPa to 122.8 GPa and from 101.6 GPa to 144.5 GPa at as-sprayed and 1 h treatment conditions, respectively. Whereas no significant change was detected for 10 and 100 h on elastic modulus of YSZ and. The Young's modulus values of the GZ dense layer varied between 93.9 GPa and 160.3 GPa.

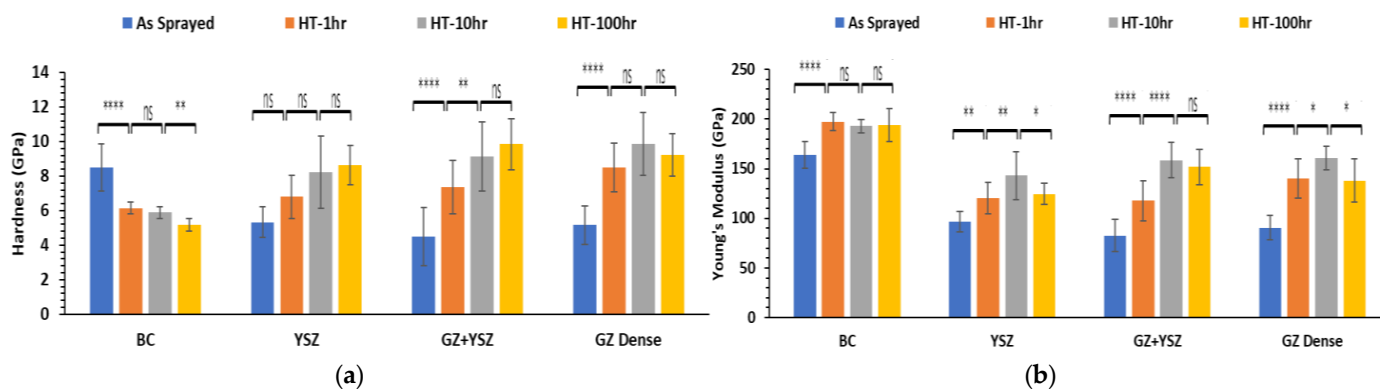
Figure 16. Nanoindentation data of the composite layer TBC before and after thermal treatment (a) hardness (H), (b) elastic modulus (E). Asterisks indicate a statistical difference (* $p < 0.05$, ** $p < 0.01$, *** $p < 0.001$, **** $p < 0.0001$, obtained using Tukey test, which computes a confidence interval for the difference between two means).

For CL TBC (Figure 16), there was no significant change in the hardness measurement of the YSZ layer through the comparison of each two successive conditions (e.g., as sprayed and 1 h, 10 h, and 100 h conditions). This is attributed to the variations in the hardness measurement of this layer (represented by the error bars). However, there is an increase in

the hardness of the YSZ layer after applying thermal treatment. For instance, the as-sprayed YSZ hardness was measured at 5.33 GPa and increased to 8.62 GPa at 100 h. The hardness of the composite layer (GZ + YSZ) was increased from 4.49 GPa (as sprayed) to 9.15 GPa (10 h), without noticeable difference in the hardness measurement between 10 h and 100 h. The GZ dense layer experienced an increase in the hardness from 5.16 GPa (as sprayed) to 8.49 GPa (1 h), without further significance in the obtained data for the remaining treatment conditions. The elastic modulus measurements for the ceramic layers were increased after thermal treatment as compared to the as sprayed state, see Figure 16b. For instance, the elastic modulus for the YSZ layer varied between 96.5 GPa (as sprayed) and 142.9 GPa (10 h condition). While the elastic modulus for the composite layer was measured as 82.7 GPa at the as-sprayed state and increased to 158.7 GPa after thermal treatment for 10 h. The Young's modulus of the GZ dense layer was altered within the range of 90.6 GPa (as sprayed) to 160.6 GPa (10 h treatment).

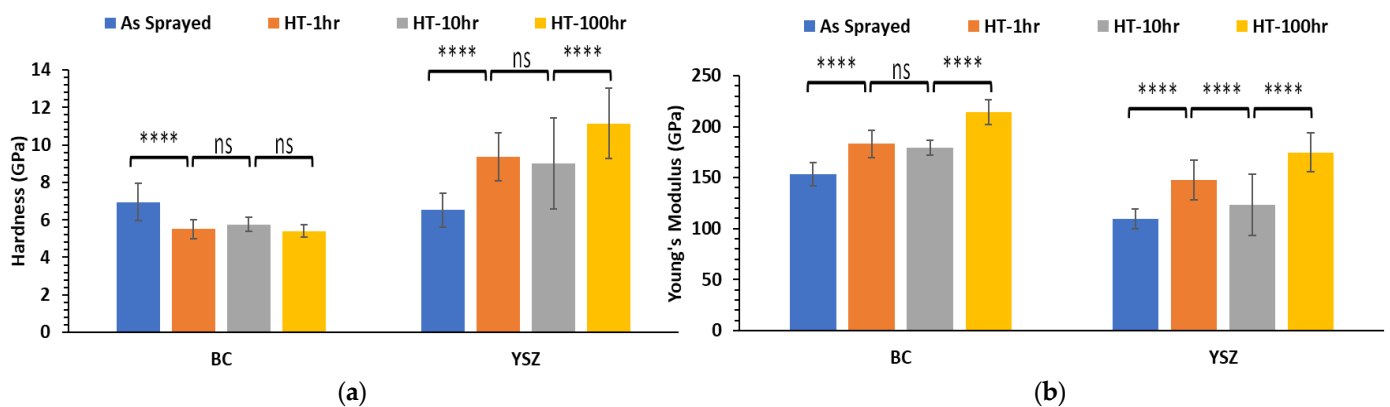
Figure 17. Nanoindentation data of the single layer TBC before and after thermal treatment (a) hardness (H), (b) elastic modulus (E). Asterisks indicate a statistical difference (* $p < 0.05$, ** $p < 0.01$, *** $p < 0.001$, **** $p < 0.0001$, obtained using Tukey test, which computes a confidence interval for the difference between two means).

For SL-TBC (Figure 17), the observation of the changes occurred in hardness and elastic modulus measurements for both the metallic BC layer and the YSZ ceramic layer matches with the other coating systems discussed before. The detected increase in the mechanical characteristics of the ceramic layers can be attributed to the occurred healing of micro-cracks through induced sintering at high temperature along with the developed residual stresses within the ceramic layer due to thermal expansion mismatch [52,53].
