The role of nodules in the growth of Zn whiskers from alkaline cyanide-free Zn electrodeposits

L. Wu, M. A. Ashworth and G. D. Wilcox

Department of Materials, Loughborough University, Loughborough, Leicestershire, LE11 3TU, UK

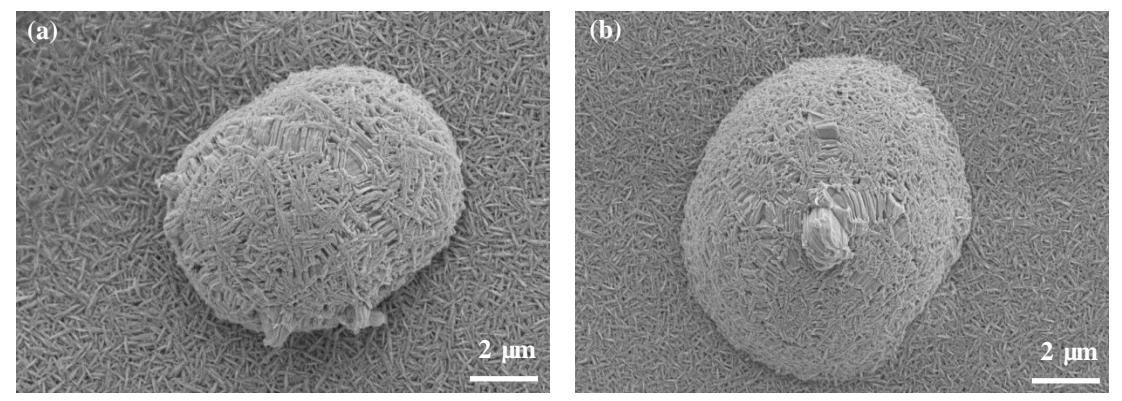
Figure 1 (a) and (b) SEM images showing incipient whisker growth present on the deposit surface 4 weeks after deposition

SEM analysis showed that a few small (< 1 μ m in length) whiskers (shown in Figure 1) had started to grow from the deposit surface 4 weeks after deposition. After 4 months storage, an increased number of whiskers, the majority of which were in the form of large

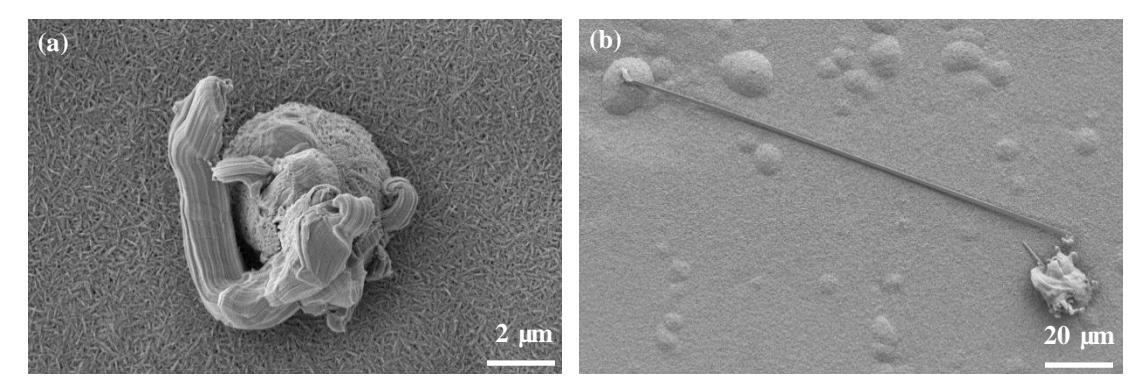
Figure 2 SEM images showing large whisker growth present on the deposit surface 4 months after deposition: a) a large irregular eruption-type whisker and b) a long filament-type whisker

irregular eruptions, were observed on the deposit surface (shown in Figure 2a). A few filament-type whiskers were also observed, some of which were greater than 100 μ m in length (shown in Figure 2b). Importantly, it was found that, up to 4 months after deposition, all the whiskers were associated with raised hemispherical features. These features are henceforth referred to as "nodules". The nodules should not be confused with the eruption-type whiskers, since they did not exhibit any typical whisker characteristics, such as striations, and were comprised of the same surface morphology as the remainder of the deposit. The nodules varied in size and some of the larger nodules were more than 20 μ m in diameter. SEM analysis immediately after deposition showed that the nodules were formed during electroplating rather than developing afterwards. This assumption is further supported by SEM analysis of the nodules after 6 months storage, which showed that the size and the shape of the nodules remained unchanged.

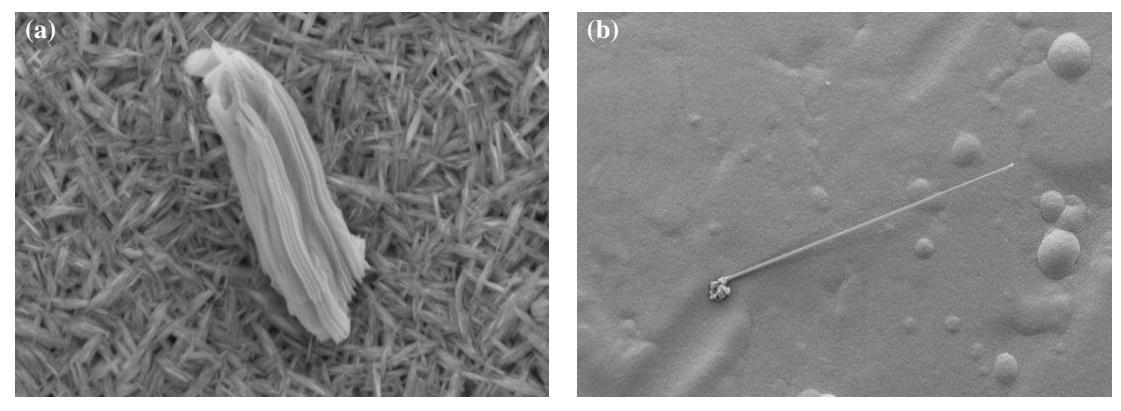
Figure 3 SEM images showing whiskers growing from the planar regions of the deposit surface: a) a small whisker present 5 months after deposition and b) a longer filament whisker present 10 months after deposition

5 months after deposition, a few small whiskers had started to grow from a planar region of the deposit (shown in Figure 3a), and 10 months after deposition, an increased number of longer whiskers growing from the planar regions of the deposit were observed (shown in Figure 3b). These results suggest that the formation of the nodules is not a prerequisite for zinc whisker growth, but significantly promotes whisker growth by shortening the incubation time. The incubation time for whisker growth associated with

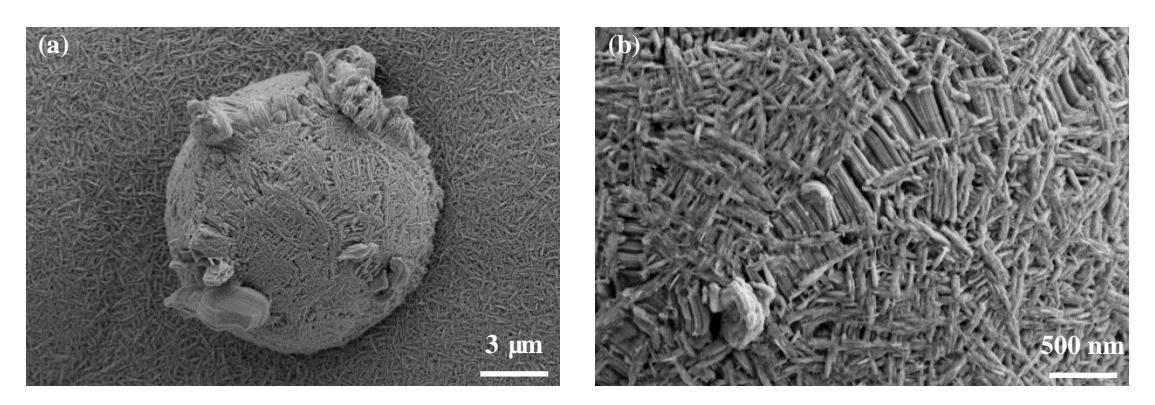
Figure 4 SEM images showing whisker growth associated with staircase structures on nodules: a) whisker growth associated with the staircase structures and b) a high magnification image showing a whisker "extrusion" from the staircase structures

Another important observation is that, for zinc whisker growth from the nodules, a series of parallel lines were always associated with whisker growth (shown in Figure 4). These lines have the appearance of a "staircase" and are henceforth termed "staircase structures". It was found that numerous staircase structures were present on the surface of the nodules approximately 1 month after deposition. Staircase structures were not evident on the planar regions of the deposit. Once a staircase structure appeared, subsequent whisker growth would typically follow. It was noted that whiskers only grew from the staircase structures rather than other regions on the nodules, i.e. it appears that a whisker was "extruded" from one or more steps of the staircase structures. These results suggest that the staircase structures are pre-cursors to the growth of zinc whisker growth. A more detailed discussion of the relationship between nodules, staircase structures and whisker growth will be published at a later date.

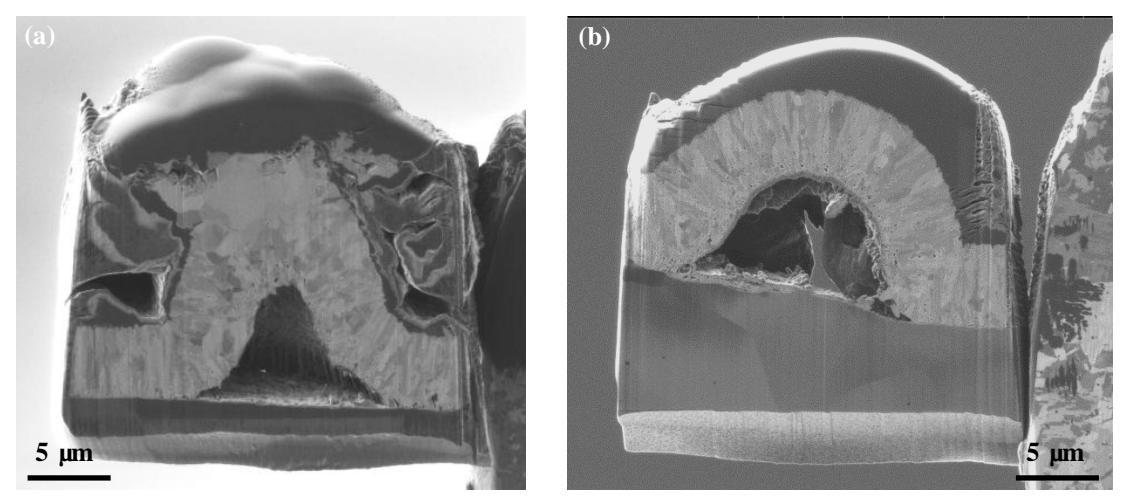
Figure 5 FIB images showing the cross-sectional microstructure of nodules: a) with whisker growth and b) without whisker growth

The nature of the nodules is clearly very important for understanding zinc whisker growth. To more fully investigate the structure of the nodules, a focused ion beam (FIB) technique was utilised to characterise the cross-sectional microstructure of the nodules. Two nodules, one with a whisker growing from it and one without whisker growth were FIB cross-sectioned (shown in Figure 5). In both cases, a cavity was present beneath the nodule. To date, a cavity has been observed beneath every cross-sectioned nodule (more than 20 nodules have been cross-sectioned), irrespective of whether a whisker is growing from it or not. Also, FIB analysis, immediately after deposition, of nodules on freshly electroplated samples showed that the cavities were already present; i.e. both the nodules and the cavities were formed during deposition rather than developing afterwards.

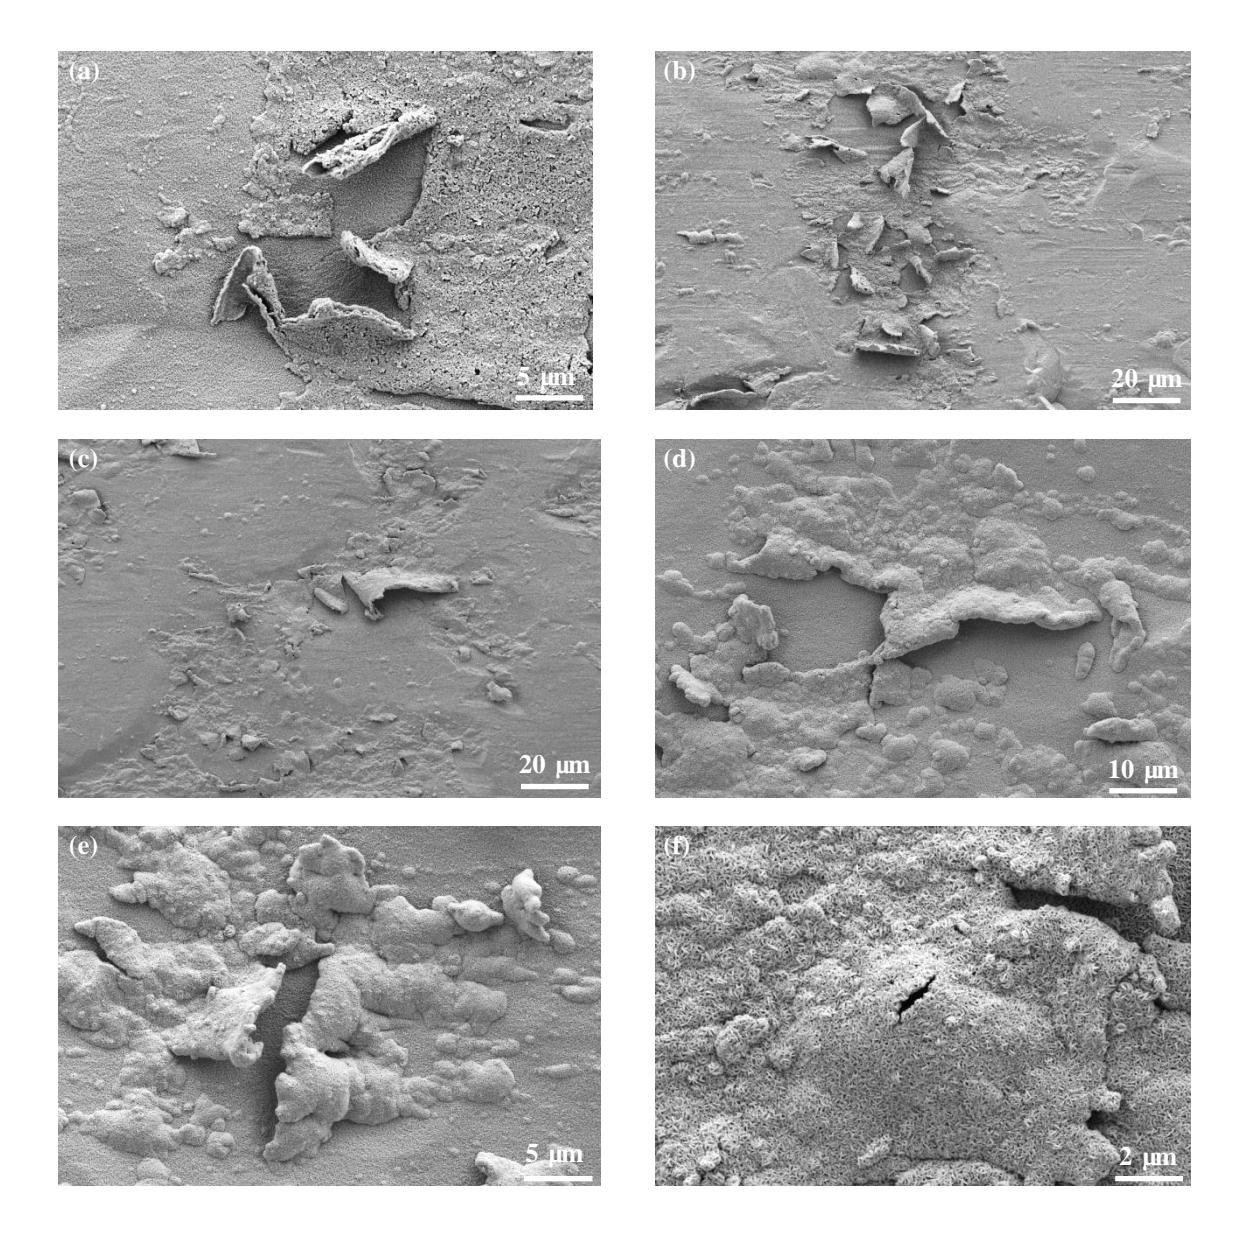
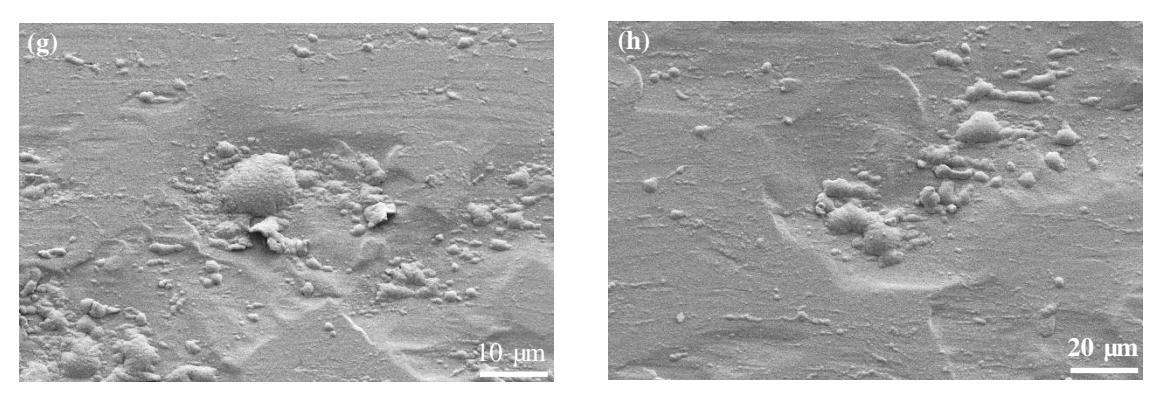
Figure 6 SEM images showing the initial development of the nodules as a function of deposition time: a) 30 seconds, b) 60 seconds, c) 90 seconds, d) 120 seconds, e) 150 seconds, f) 180 seconds, g) 210 seconds and h) 240 seconds

To understand the mechanism for the formation of the nodules and cavities, short time duration depositions were carried out to monitor their initial development using different deposition times of 30, 60, 90, 120, 150, 180, 210 and 240 seconds. Figure 6a shows the morphology of the deposit surface after only 30 seconds deposition. It was found that some regions of the deposit were fractured and had peeled away from the underlying substrate. As the deposition time was increased, the size of the fractured regions was reduced and the lifted regions of the deposit increased in thickness. When the deposition time was increased to 150 seconds, the lifted regions of the deposit typically merged together to form a complete layer (shown in Figure 5e). This is probably the preliminary stage in the development of the nodules. When the deposition time reached 180 seconds, some incomplete nodules were observed on the deposit surface (shown in Figure 5f). As the deposition time was increased to 240 seconds, no discrete lifted regions were present and the deposit surface was similar to that observed after 10 minutes. These observations suggest that the formation of the nodules and cavities is closely associated with the fractured and lifted regions of the deposit observed at short deposition times. The mechanism responsible for the formation of the nodules could be stresses developed

within the coating. The electroplating bath used was an alkaline cyanide-free zinc solution, for which the cathode current efficiency is comparatively low (~40%). Strong hydrogen evolution occurs during deposition and a large amount of gas is generated on the cathode surface, which may be absorbed by the steel and result in a highly stressed electrodeposit [9]. Also, it was observed that only part of the coating was fractured and lifted. These particular regions are potentially related to the areas where the zinc coating is poorly adhered to the steel surface. In the early stages of deposition, when the deposit is very thin, these regions with poor adherence are likely to be more prone to delamination and susceptible to fracture due to the stresses developed in the electrodeposit. This contributes to the large number of fractured and lifted regions of the deposit observed at short deposition times. The poor adherence between the coating and the substrate may be attributed to the presence of oxides and/or contaminants on the steel surface. Therefore, the stresses developed in the electrodeposit and the poor adherence between the zinc and the steel may be responsible for the development of the fractured and lifted regions of the deposit in the early stages of deposition and the subsequent formation of the nodules. Since the nodules were actually up-lifted regions of the deposit, a cavity is always present beneath them.

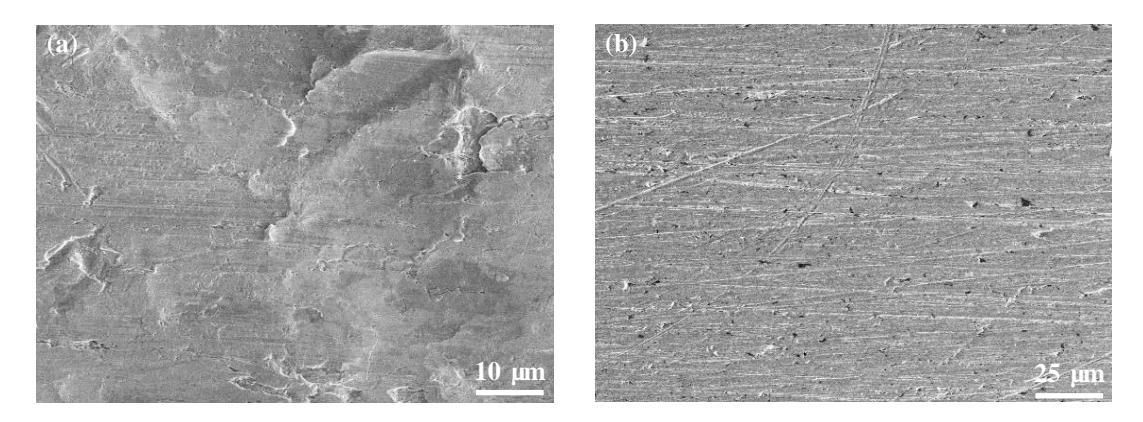
Figure 7 (a) SEM image showing the surface morphology of the as-received mild steel and (b) SEM image showing the surface morphology of the same steel after grinding to 1200 grit

On the basis of the previous results, it was determined that the presence of the nodules on the deposit surface promoted whisker growth by significantly shortening the incubation time. Hence, stopping the development of the nodules was thought a potential way to hinder whisker growth. It was observed from other trials carried out as part of this study that nodules were not evident on the surface of electrodeposited Hull cell samples produced from the same alkaline cyanide-free zinc electroplating bath. The main difference between the as-received mild steel substrate and the Hull cell panels is that the latter has a much better surface cleanness, i.e. much fewer oxides and/or contaminants are present on the surface of the Hull cell panels. Hence, the surface cleanness of substrate material could play a role in the formation of the nodules. It is thought that, on the asreceived mild steel, some surface oxides and/or organic contaminants may be embedded in the steel surface in depth during rolling process and were difficult to remove by chemical pickling. In this case, in order to achieve a clean surface, the as-received mild steel substrates were ground to a P1200 grit finish using silicon carbide paper prior to electrodeposition. Grinding was able to remove the oxides and contaminants by abrading away a thicker steel layer, and thus eliminating a favourable source for delamination of the coating and subsequent nodule formation. Figure 7 shows the surface morphology of the mild steel before and after grinding.

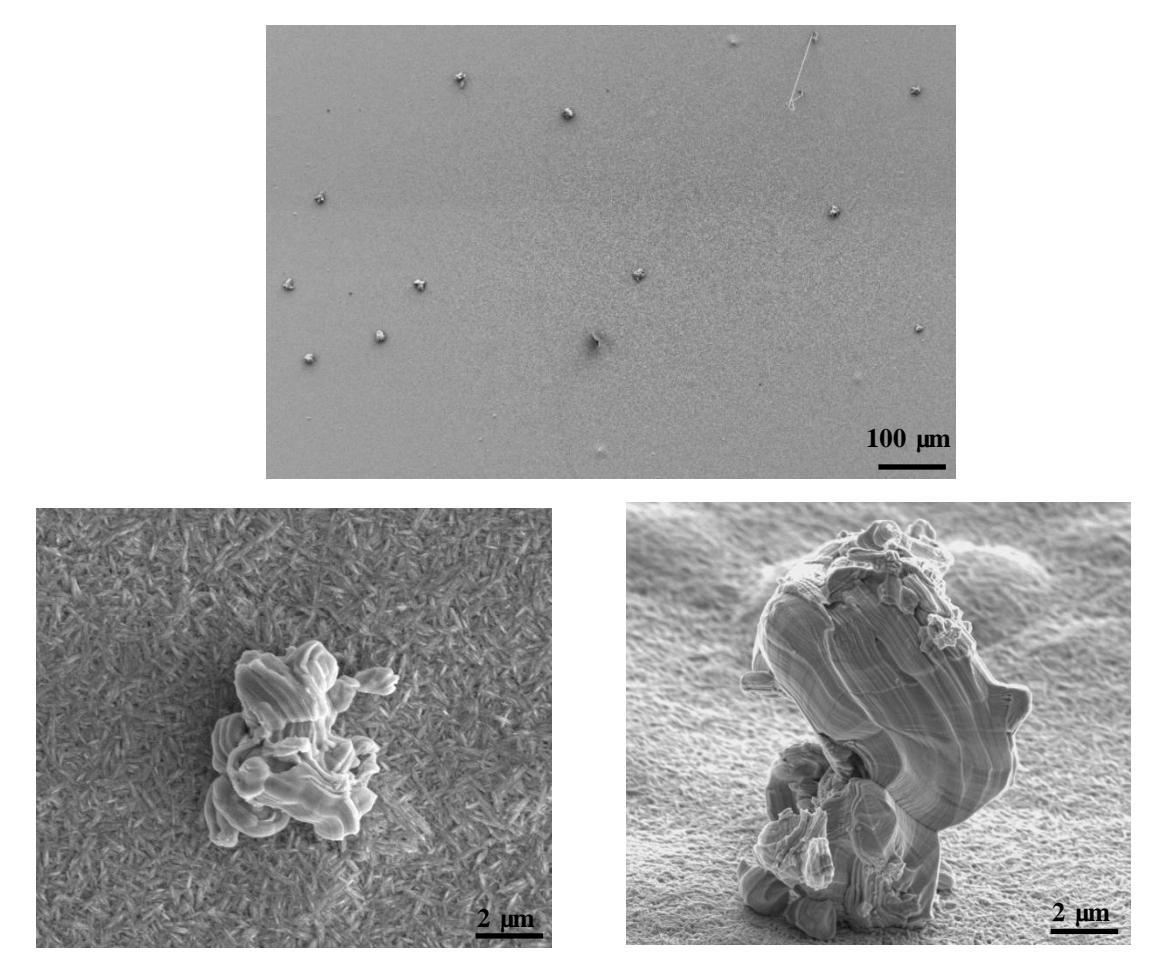
Figure 8 SEM images showing a high density of whiskers growing from the planar regions of the deposit on the ground samples electrodeposited at $25 \text{ mA/cm}^2 18$ days after deposition

In terms of nodules formation, it was found that no nodules were observed on the electrodeposits produced on the ground samples. In other words, the development of the nodules was completely prevented by grinding the surface of the as-received mild steel substrate. In terms of whisker growth, SEM analysis 18 days after deposition showed that a large number of whiskers were observed on each of the electrodeposits produced on the ground samples and all the whiskers were growing from planar regions of the deposit (shown in Figure 8). The majority of the whiskers were curved eruptions with a diameter of $\sim 2 \,\mu m$ and a few filament-type whiskers, longer than 100 μm in length, were also present, which means that these whiskers had started to grow within 18 days of deposition. Thus, elimination of the nodules did not reduce whisker growth; instead it markedly shortened the incubation time for whisker growth from planar regions of the deposit from ~5 months to less than 18 days. At present, it is not fully understood why whisker growth initiated much earlier on the electrodeposits on the ground samples than that on the as-received samples, even though the nodules, a favourable site for whisker growth, were eliminated. It is thought that the development of the nodules may serve to relieve some stress within the deposit. In other words, the zinc electroplated ground samples, with no nodule formation, were potentially more highly stressed, which resulted in accelerated whisker growth. Further investigations are ongoing to fully determine the cause of the much shorter incubation time for whisker growth on the ground samples.
