Experimental characterization and performance evaluation of geothermal grouting materials subjected to heating-cooling cycles

Indacoechea-Vega, I, Pascual-Muñoz, P, Castro-Fresno, D & Calzada-Pérez, MA 2015, 'Experimental characterization and performance evaluation of geothermal grouting materials subjected to heating-cooling cycles' *Construction and Building Materials*, vol. 98, pp. 583-592.

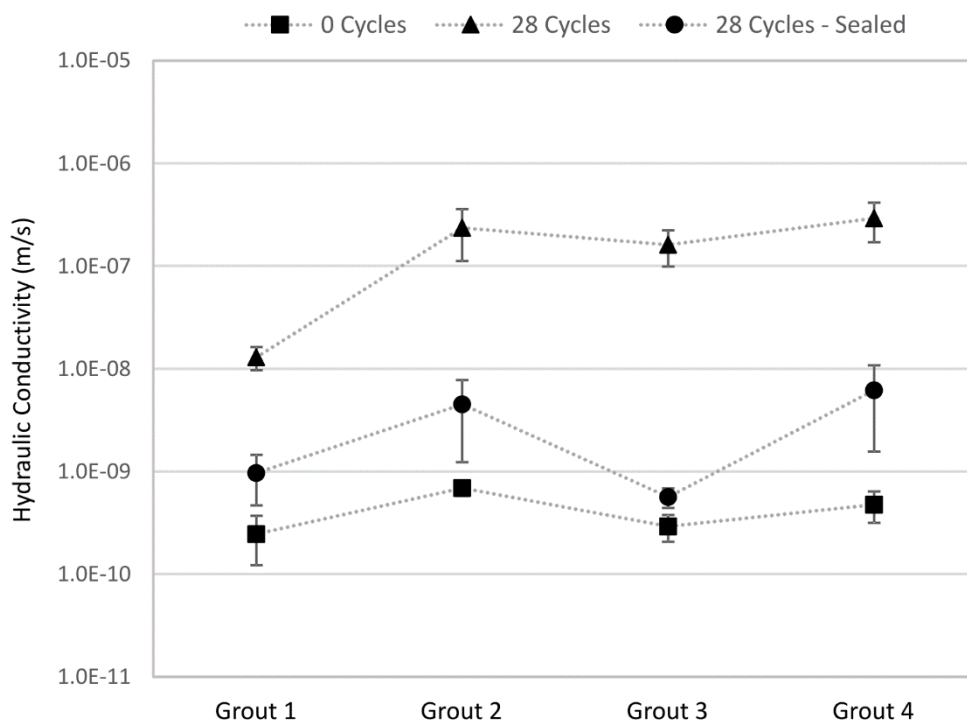
To make clear whether the increase of permeability was due to the damage in the grouting material itself or to the loss of adherence between grout and pipe, a new permeability test was carried out in agreement with the same procedure but in which the grout-pipe interface of all the specimens was sealed. Results obtained in these tests (Figure 11) clearly show how most of the permeability is recovered, thus meaning that the increase of the hydraulic conductivity mainly comes from the decrease of the bond quality, whereas the rise of important cracks and/or fissures in the material itself affect only to a minor extent. A visual inspection of the specimens (Figure 12) helped to confirm that only surface fissures arose after completing the 28 cycles of the durability treatment.

Fig. 11 - Evolution of the permeability with the treatment time when the grout-pipe interface is sealed.

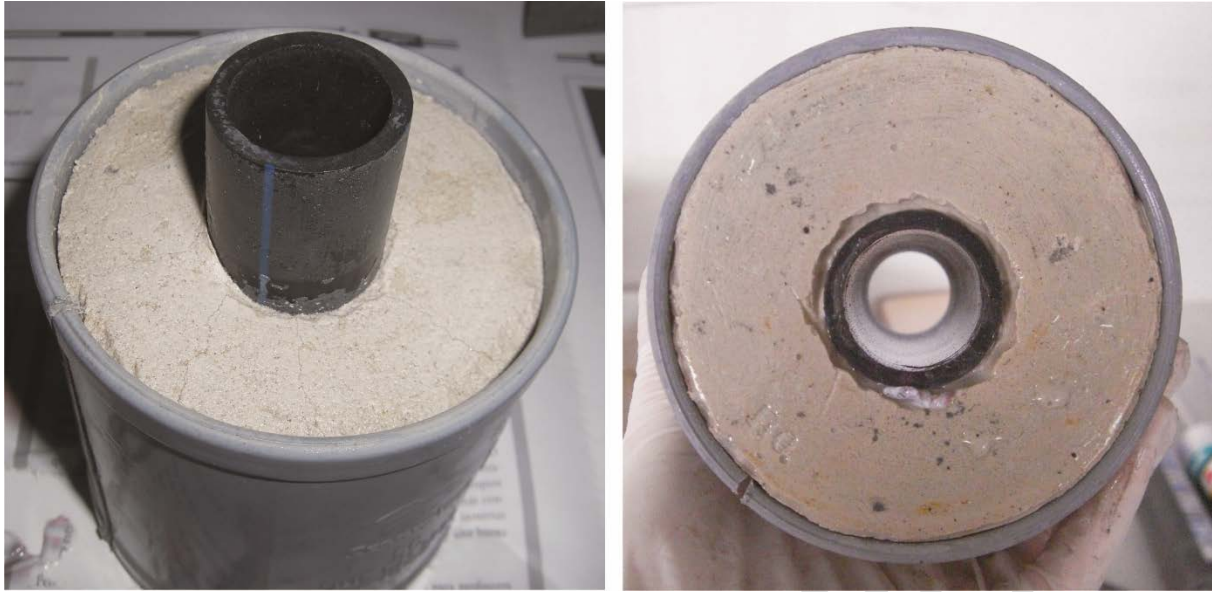
Fig. 12 - View of the grout-pipe specimen after 28 heating-cooling cycles.
