Communication

First Exploratory Study on the Ageing of Rammed Earth Material

Quoc-Bao Bui ^{1,*} and Jean-Claude Morel ²

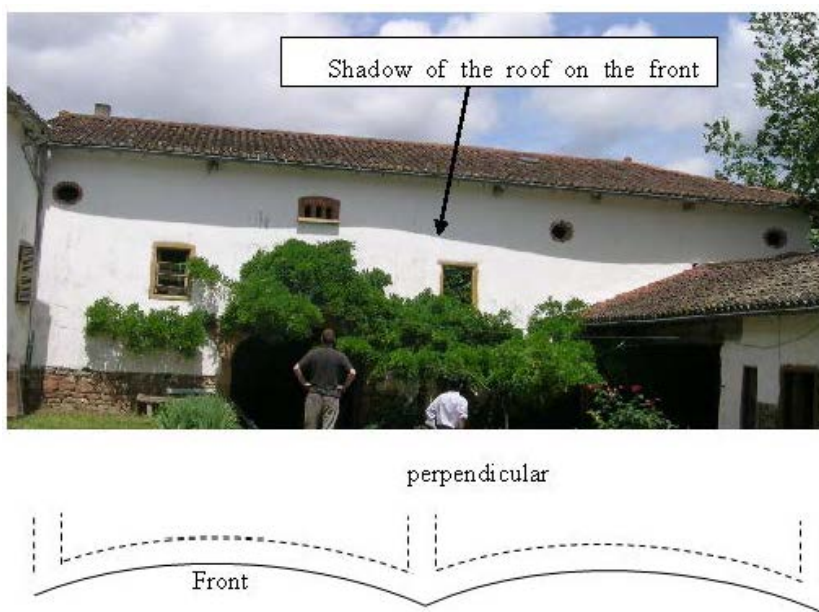
Figure 1. A rammed earth wall more than 200 years old. Upper: front view; bottom: plan.

Figure 1 presents an example of a rammed earth wall which is more than 200 years old. Note that the shadow of the roof on the front wall is not a horizontal straight line. This is due to the horizontal buckling of this wall that can be seen on the plan (Figure 1, bottom). The buckling

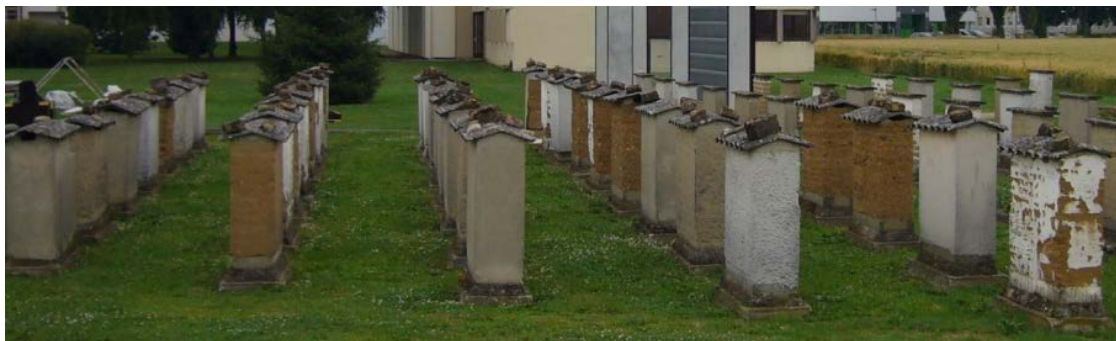
The wall specimens were built in 1985 (Figure 2) thanks to the Rexcoop program, controlled by the French Scientific and Technical Building Center (CSTB), near Grenoble, in a French Alpine valley, at an altitude of 212 m. The temperature of the site can vary from -20 °C to 38 °C for some particular years and its average varies from 2 °C to 20 °C. The annual rainfall is about 1000 mm, the direction of prevailing winds is NE-SW and the maximum wind speed is 21 m/s.

Figure 2. Rammed earth walls constructed and exposed for 22 years to natural weathering.

The rammed earth walls (1 m width \times 1.1 m height \times 0.4 m thickness) were manufactured on a concrete foundation with a 25 cm base exposed above ground level. A bituminous layer was painted on top of the base to prevent water from capillary rise penetrating into the RE walls. Local soil from a nearby site mixed with a cultivator was used for the RE walls. Three soils were used but in this study, only walls from one soil were investigated. Its grain size distribution is presented in Figure 3.

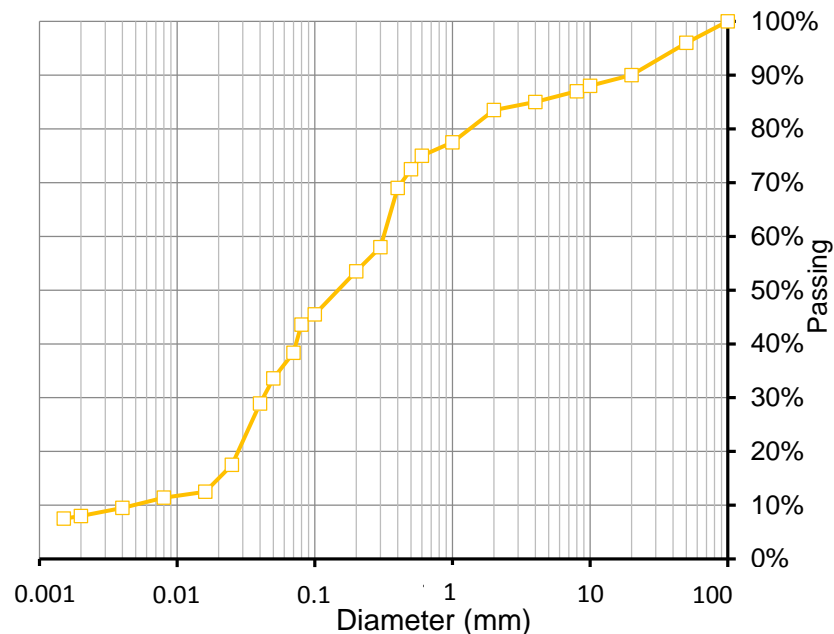
Figure 3. Grain size distribution of the used soil.

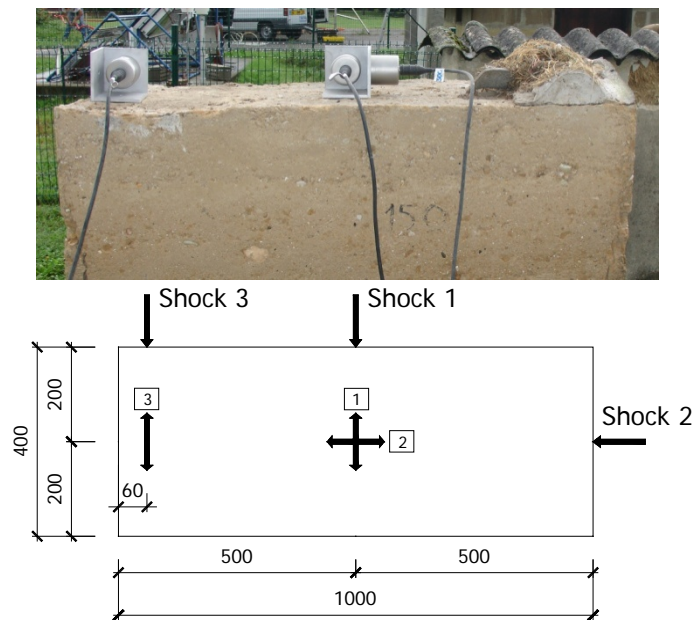
Three accelerometer sensors with a sensitivity of 1 μg (with g being the gravity field equal to 9.8 m/s^2) were placed on top of the wall (Figure 4): two sensors in the centre to measure two horizontal

accelerations following the two main axes of the wall; and another sensor on the edge to measure possible torsional movements.

The excitation consisted in a light shock (by a hammer) which was applied to the top of the wall. Three configurations were carried out (Figure 4, bottom): (1) a center shock following the transversal direction of the wall; (2) a center shock following the longitudinal direction of the wall; (3) an offset shock following the transversal direction. These configurations excite the possible vibration modes of the wall: transversal, longitudinal and torsional.

Figure 4. Arrangement of the sensors on the wall A (dimensions in mm).

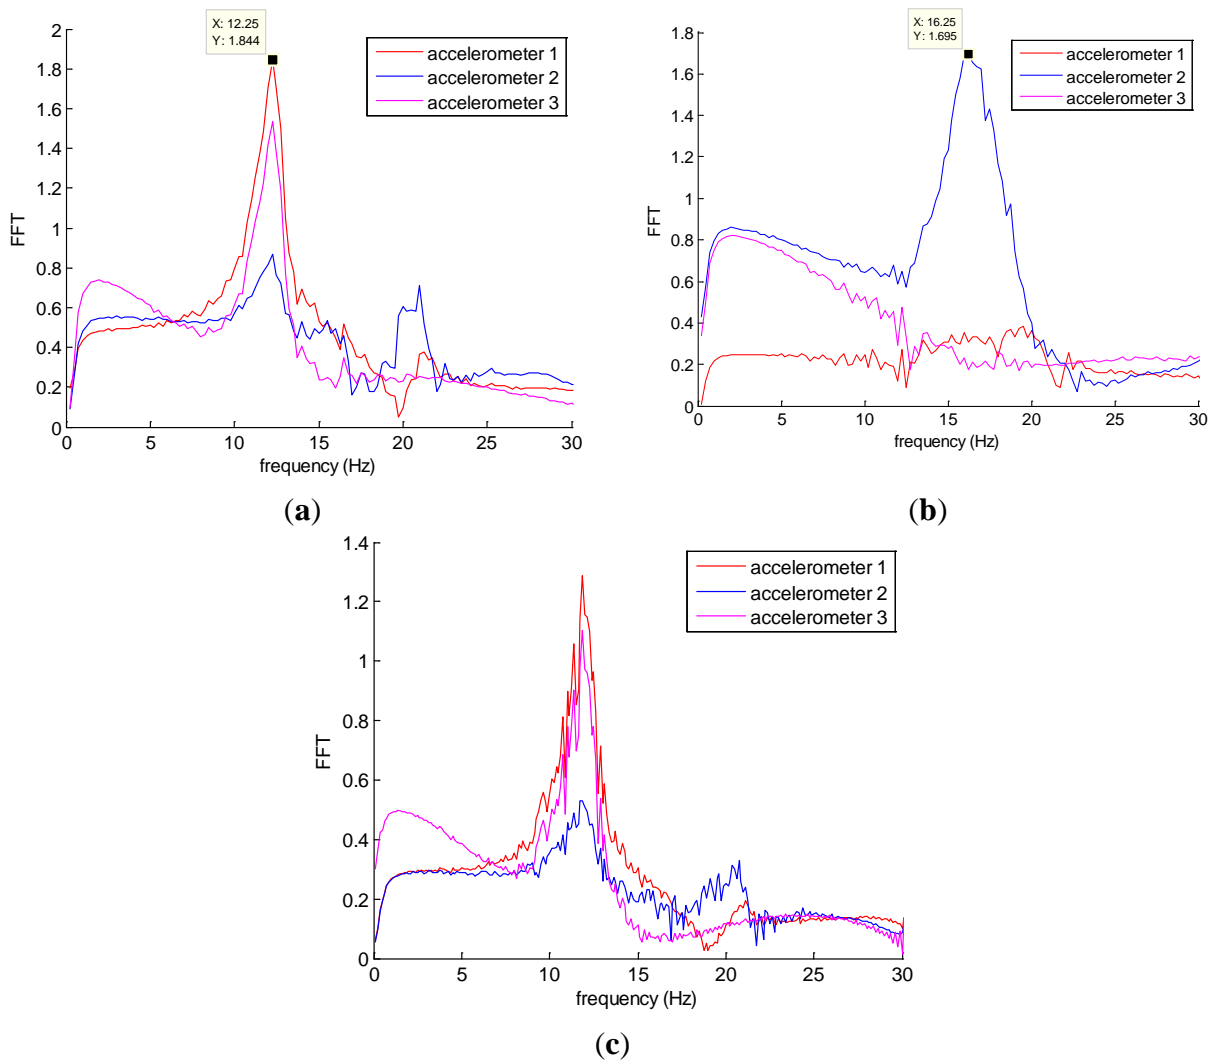
Figure 5 shows typical results obtained after a signal processing for the shocks 1, 2 and 3. Each peak corresponds to a modal frequency. In this case, the frequency of the first transversal mode is identified at 12.25 Hz. For shocks 1 and 3, sensor 2 does not give a clear signal because in these cases, excitations were perpendicular to the sensor 2; there was no major vibration in the wall's longitudinal direction. The result for sensor 3 is similar to that of sensor 1, since the torsion was not clearly captured (shocks were not important enough to solicit this mode). For shock 2, sensors 1 and 3 do not give significant information but sensor 2 captured the second vibration mode which is in the longitudinal direction. In this case, the second modal frequency is of 16.25 Hz. Results of two others walls are presented in Table 1.

Figure 5. A result of wall A induced by shock 1 (a); shock 2 (b); and shock 3 (c).

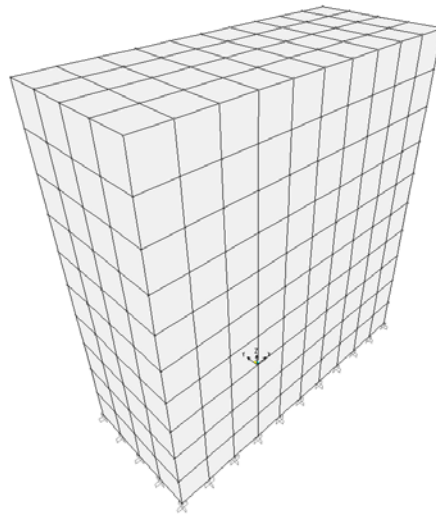
The walls are modelled with solid elements (Figure 6). Following the dynamic of structures theory, for given dimensions, the natural frequencies depend only on the density and the elastic characteristics of the material. For the modelling, the material was assumed isotropic (which is acceptable for dynamic measurements which were performed in very small strain [1]). The Poisson’s ratio was taken of 0.22 following a previous study [7]. The nodes between the RE wall and the concrete foundation were restrained in translations. This boundary condition can be justified following the results presented

Figure 6. Wall A modelled with FEM.

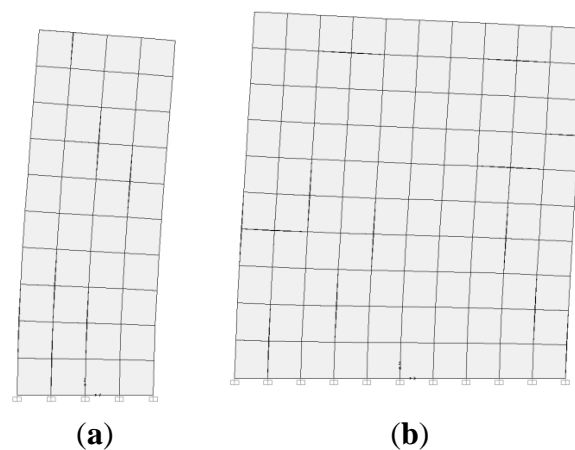
Figure 7. First vibration modes of the wall A. **(a)** First vibration mode, in the transversal direction; **(b)** second vibration mode, in the longitudinal direction.

The dry density was measured in laboratory and will be presented in Section 3.2. The results of the identified modulus are given in Table 1. The first main modes of vibration are shown in Figure 7.

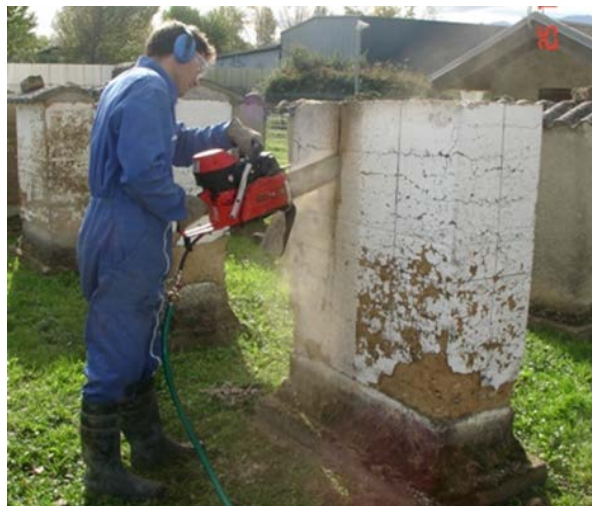
The specimens were taken from the walls using a chainsaw generally used to cut concrete and stones (Figure 8). Its blade was 30 cm long, meaning that the total thickness of the wall (roughly 41 cm) had to be cut in two steps. The disadvantages of using this method to take specimens are the generation of vibrations and the use of water, which can decrease the mechanical strength of the specimens, notably due to the splitting apart of the layers of earth.

Figure 8. Cutting a wall with chainsaw.

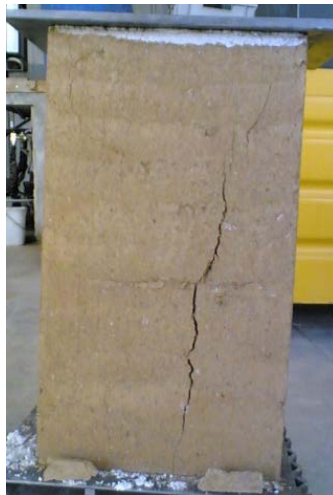
Discussions about the representativeness of specimens manufactured in laboratory were presented in the literature [1,9]. Indeed, to ensure a faithful representation of the *in-situ* wall material, the manufacturing mode and material used for laboratory specimens should be as identical as possible to those used *in situ*. The manufacturing water content and the compaction energy in the laboratory were chosen similar to that on site. The manufacturing water content was 10%. The specimens were rammed by an artisan of rammed earth with his pneumatic rammer. The dimensions of specimens tested in the direction perpendicular to the layers were $40 \text{ cm} \times 40 \text{ cm} \times 70 \text{ cm}$, with nine layers (Figure 9).

Figure 9. A specimen $(40 \times 40 \times 70) \text{ cm}^3$ after the compression test.

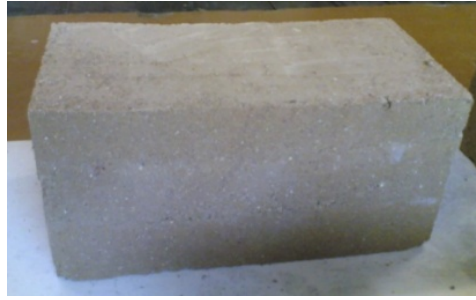
The specimens to be tested in the parallel direction were composed of three layers; their dimensions were $40 \text{ cm} \times 40 \text{ cm}$ and 20 cm high. Special attention was given during compaction of the last layer to obtain a surface that was as flat as possible. To achieve a slenderness ratio of 2, the specimens were then cut with a table saw. Two specimens $(40 \times 40 \times 20) \text{ cm}^3$ provided four specimens $(20 \times 20 \times 40) \text{ cm}^3$ for testing in the parallel direction (Figure 10). For specimens tested in the direction parallel to the layers, a surfacing was not necessary, because the two surfaces that were in contact with the formwork were sufficiently flat.

Figure 10. A specimen ($20 \times 20 \times 40$) cm³ cut from a specimen ($40 \times 40 \times 20$) cm³.
